Memorandum

Subject **Town of Orleans, MA**
Water Quality and Wastewater Planning
Task 2.a. Tri-Town Transition Requirements, Interim Use Option
Deliverable 2.1 – Extend Facility Life

From Thomas Parece, P.E., AECOM Project Manager

Date 10/22/15

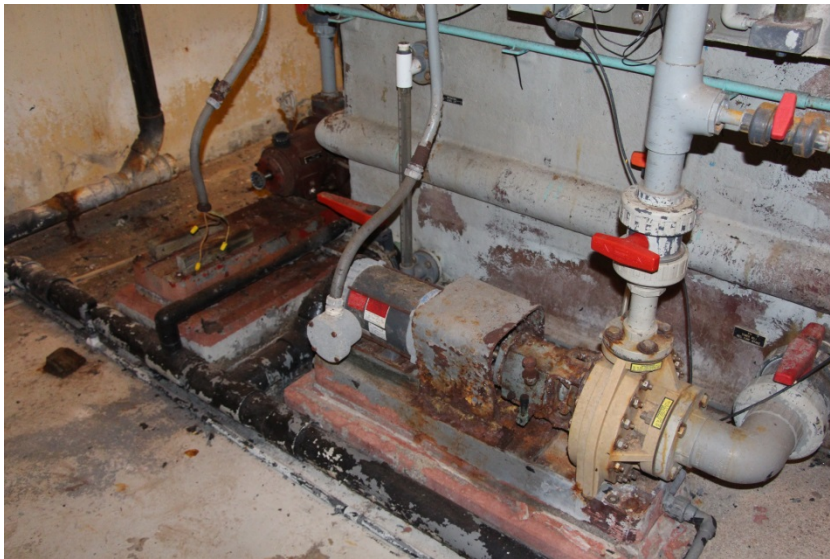
Odor Control System - The odor control system for the receiving area consists of wet scrubbers followed by carbon adsorption. This equipment, while aging, appeared to be functioning adequately as there were no noticeable odors on the day of the visit. However facility staff report that there have been recent instances of odor break-thru during periods of heavy receiving and/or processing. The carbon in at least one of the canisters will need to be replaced to mitigate odors over the interim period. Only one of three chemical recirculation pumps is operable for the wet scrubber system. Replacement of at least one pump should be considered to provide reliable redundancy.

Main Odor Control Wet Scrubber Recirc Pump

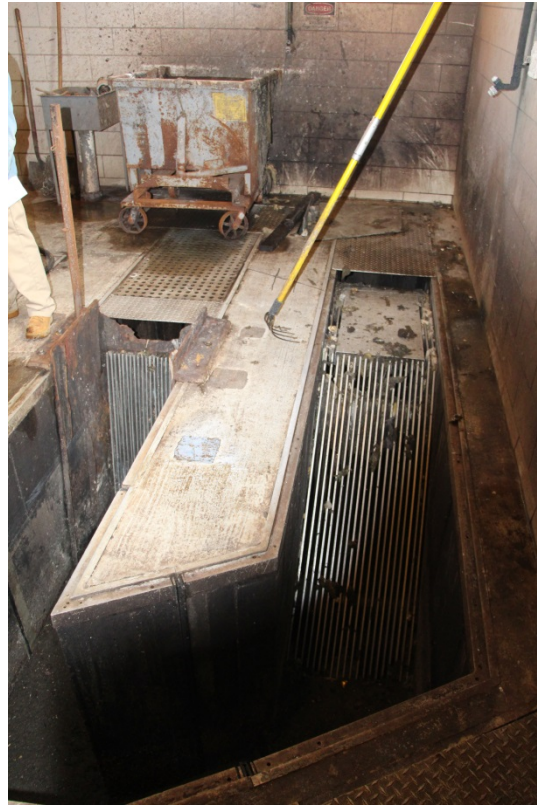
Screening - The original mechanically operated screen was inoperable and has been demolished and replaced with a manual bar rack. This requires the facility staff to clean the screenings off the bar rack manually. In addition to being a physically intensive operation, there is evidence of corrosion, to the point of impending structural failure of the main screen frame. While it is not recommended to do a complete upgrade of this area, some repair/replacement work will be necessary to keep this operation viable for an additional five years.

Severe Corrosion on Receiving Area Screen

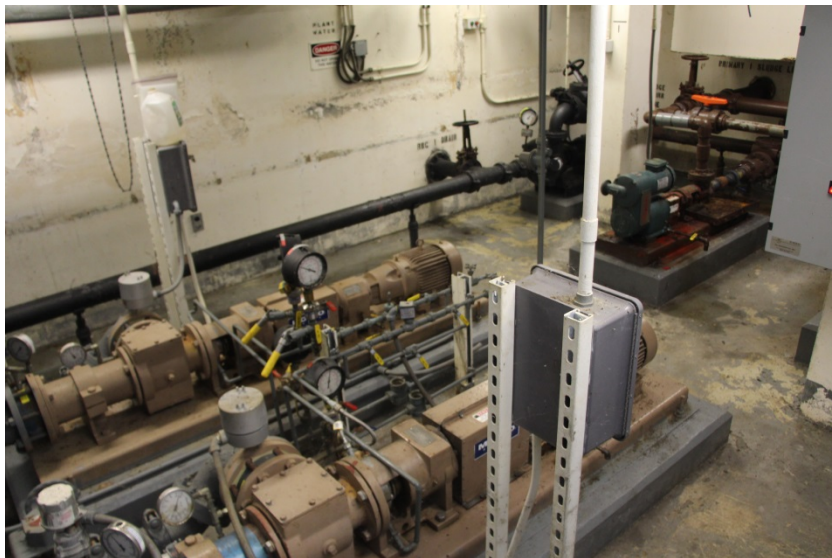
Original Lamella Clarifiers and Intermediate Pump Station - The facility was originally supplied with Lamella clarifiers for clarification of RBC effluent. They were made redundant by the addition in 1995 of more conventional secondary clarifiers, however they still are part of the flow path of effluent from the RBCs to the newer secondary clarifiers. Facility staff has expressed concern regarding the structural integrity of the Lamellas. Should they fail, they would result in a complete loss of filtrate processing capability and the flooding of the area housing the intermediate pumps that lift flow to the newer secondary clarifiers. Not being part of the current treatment scheme, the Lamellas do not require replacement per se, however piping modifications should be made to bypass them and eliminate the consequences of a vessel failure. Additionally, one of the two intermediate pumps that lift flow to the secondary clarifiers needs to be rebuilt/replaced.

Intermediate Pumps Requiring Rebuild
