# CAPITAL ASSET ASSESSMENT

## Orleans Elementary School

46 Eldredge Park Way, Orleans, MA 02653

FINAL REPORT: July 27, 2023

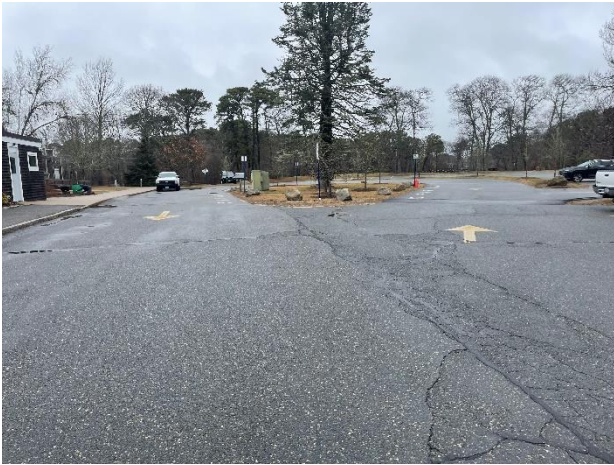
1. Pavement is patched and cracked.

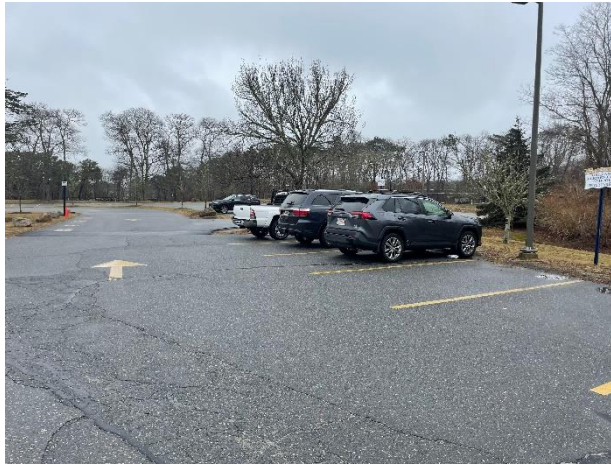
2. Not enough parking spaces and inadequate lighting.

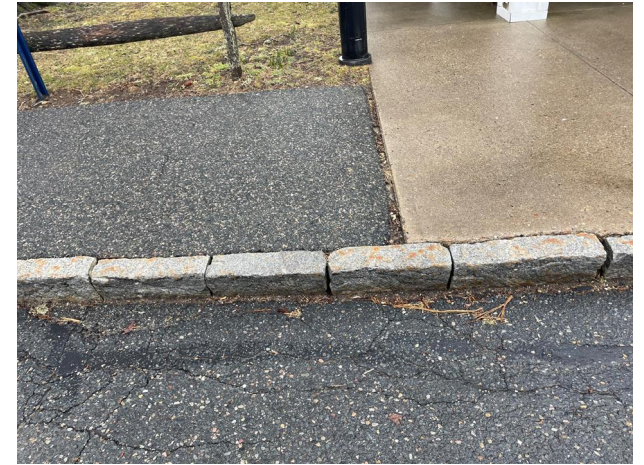
3. Deep gap between bituminous and concrete walkway.

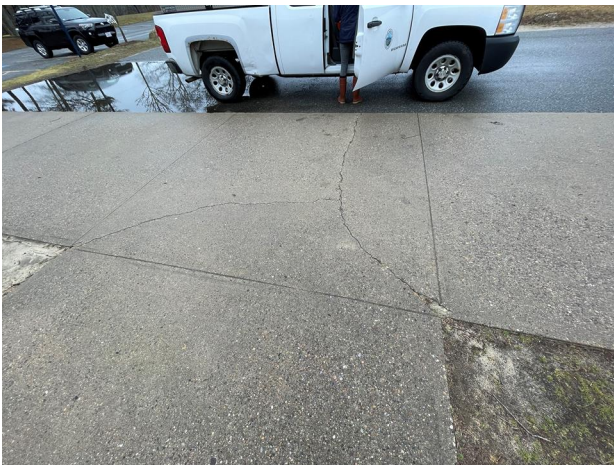
4. Concrete sidewalk is cracked.

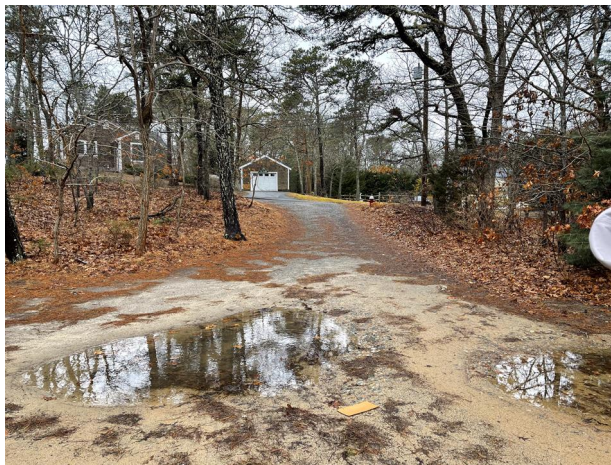
5. Teacher parking area is non-compliant and unpaved.

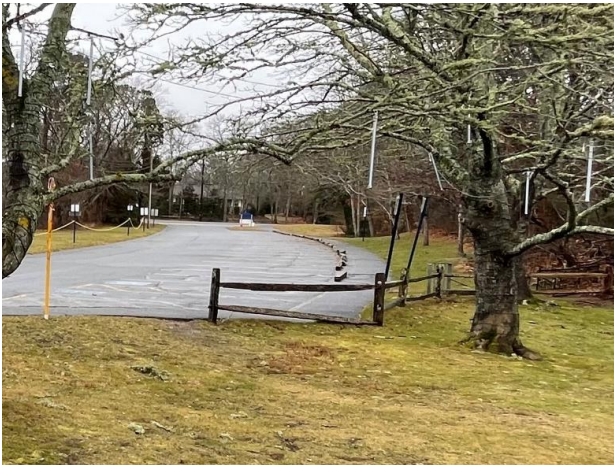
10. Inadequate walkway from Eldredge Park Way and driveway is too narrow. Wood timbers are inadequate to delineate parking from sidewalk.

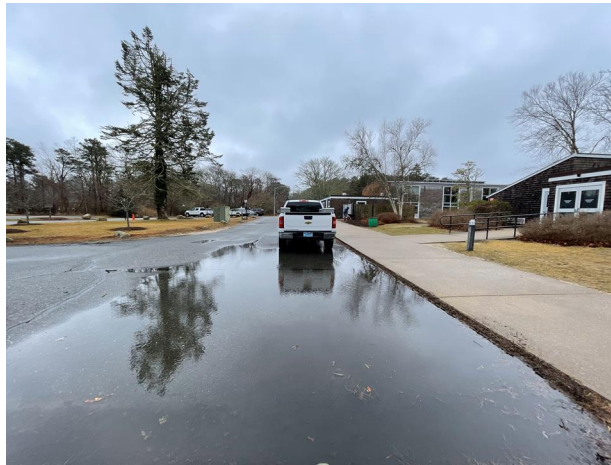
11. Large puddle in driveway.

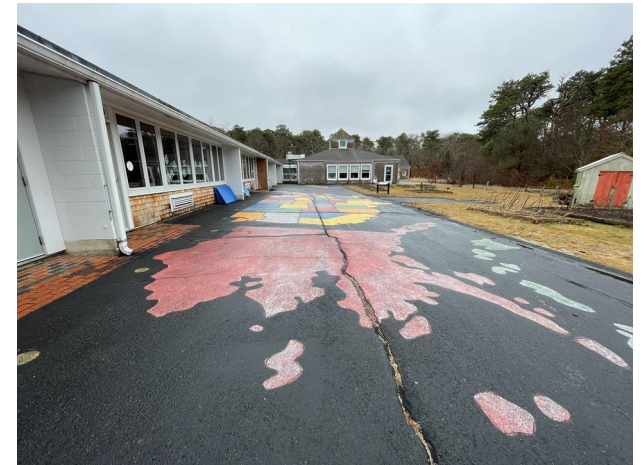
12. Bituminous play area is heavily cracked.

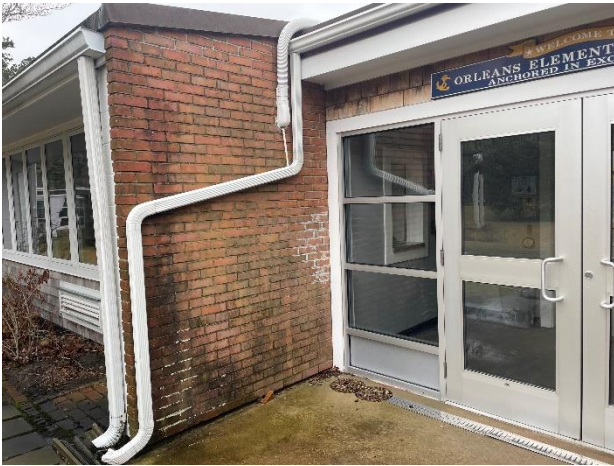
1. Brick is discolored adjacent to main entry.

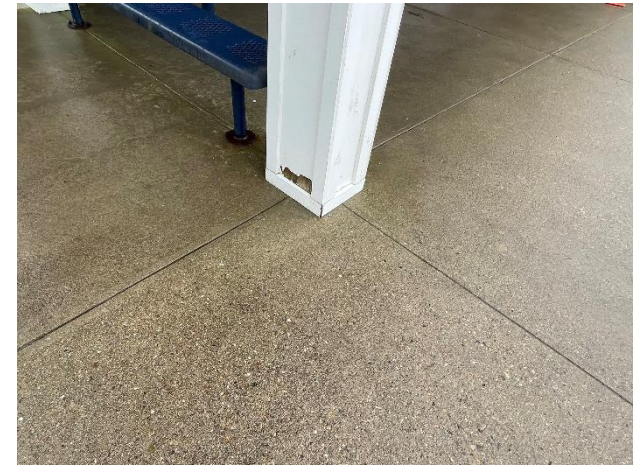
3. Column covers are water damaged.

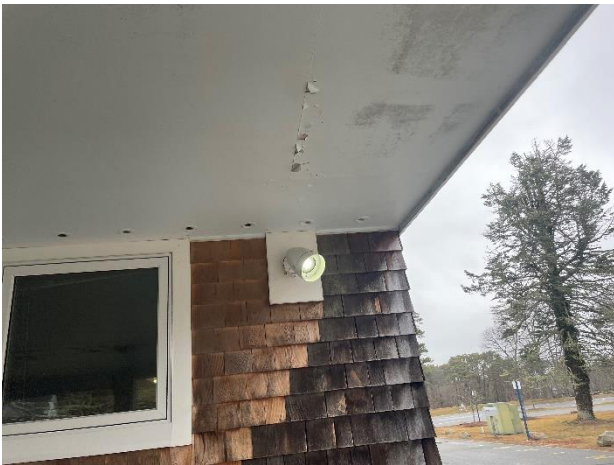
4. Paint is peeling on soffits.

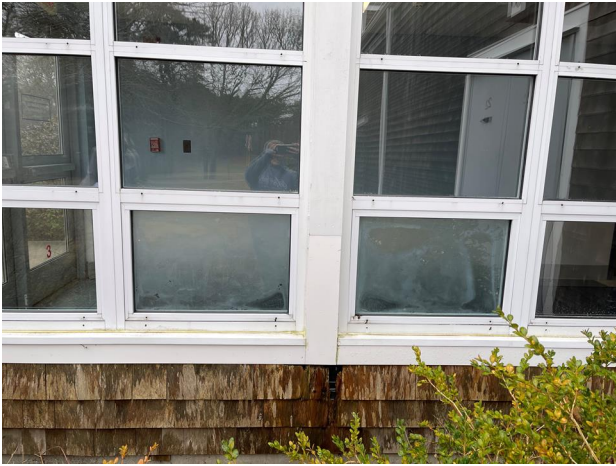
7. Many windows in 1990's addition have failed seals.

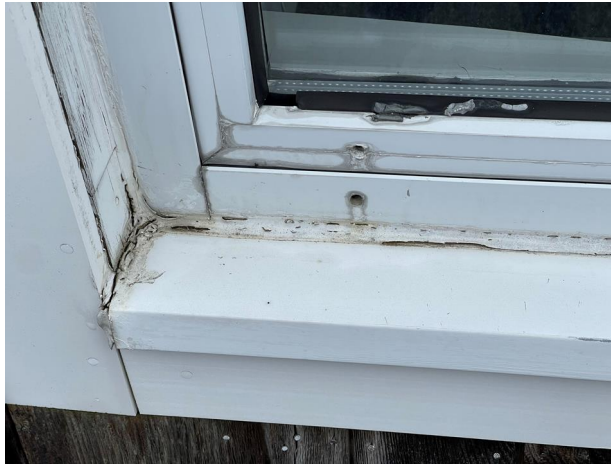
8. Sealants at windows have failed and wood trim is damaged.

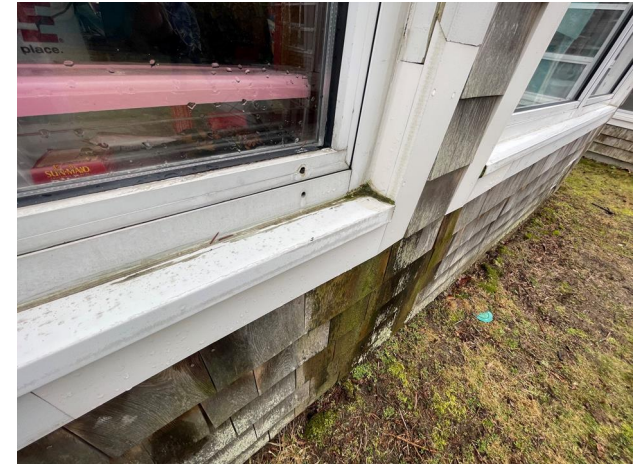
9. Damaged wall and shingles due to window failure.

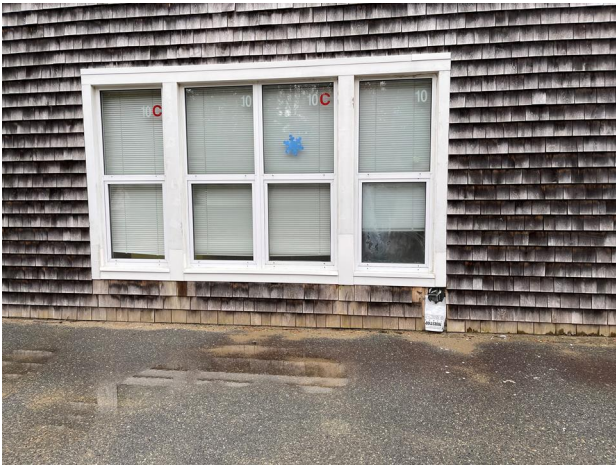
10. Window failure has caused damage to shingle siding.

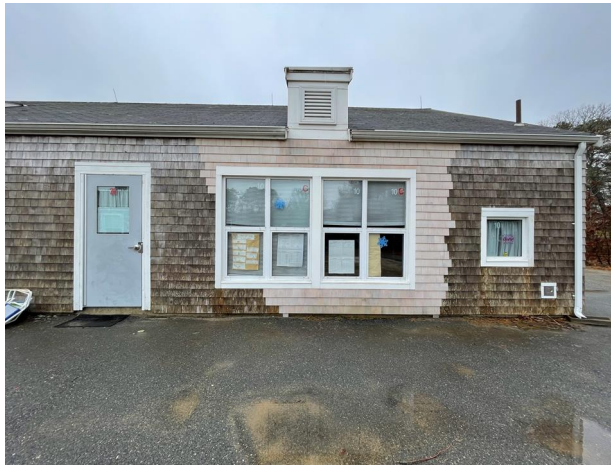
11. Indication of extent of repair required at damaged windows.

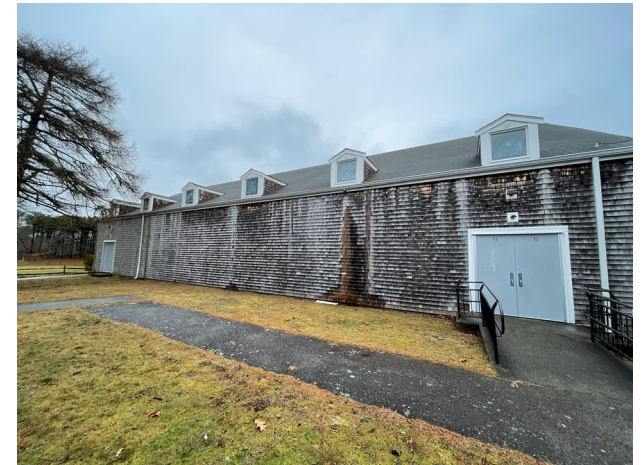
12. Eaves are lacking adequate overhang to prevent water damage.

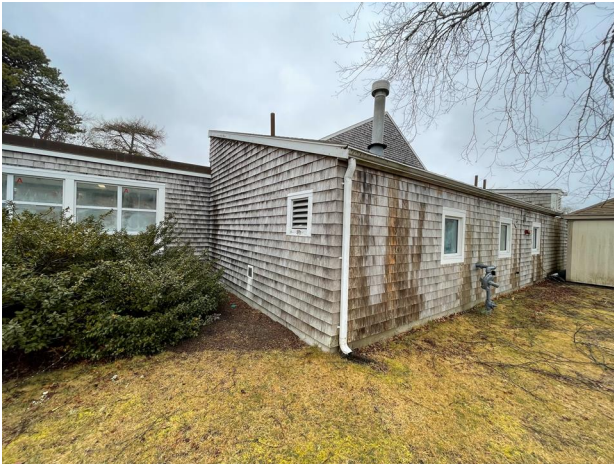
13. Window has failed and lack of adequate overhang at eave has damaged siding.

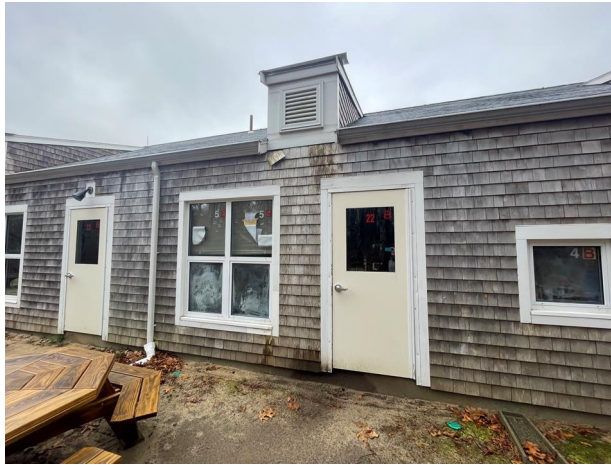
14. Water damage is evident at vent dormers.

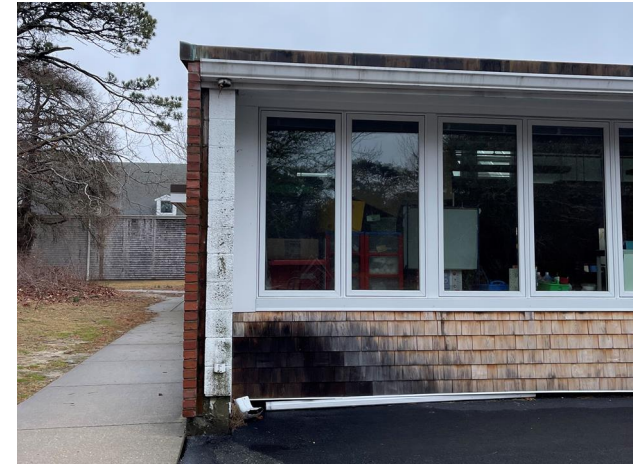
15. Downspout is damaged and water is creating stains on CMU & siding.

*Note: Downspouts terminating onto sidewalks and other hard surfaces do not channel stormwater to subsurface or basin retention areas creating a potential for slip hazards during icy conditions.*

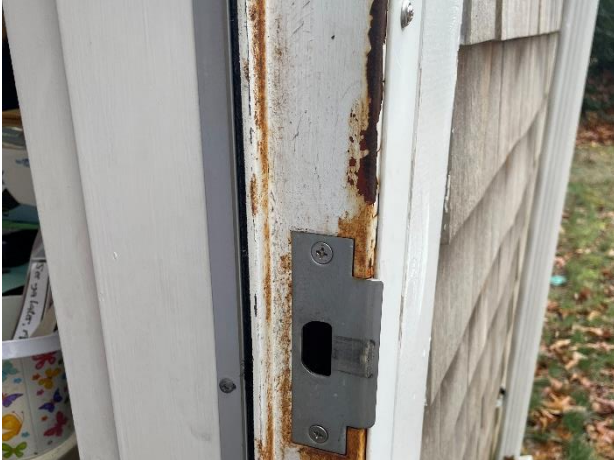
16. Door frames are rusted.

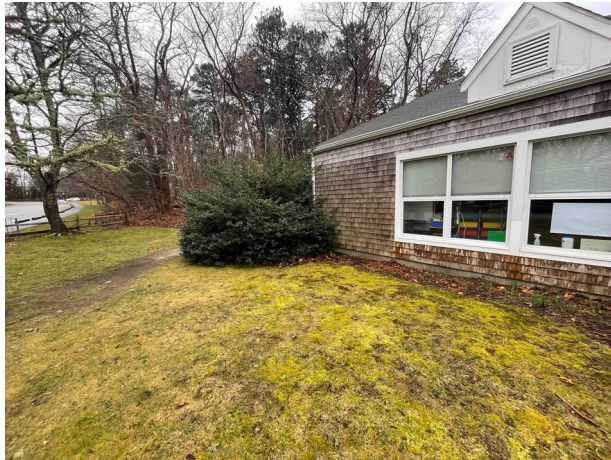
17. Wood trim is damaged.

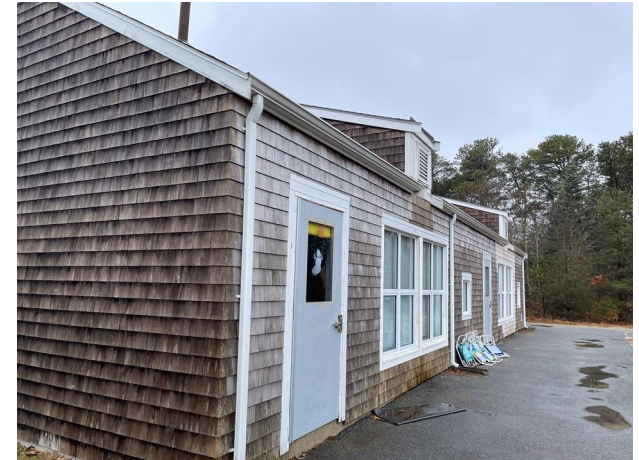
18. Hollow metal door has rust and oxidized paint. Wood fascia is peeling.

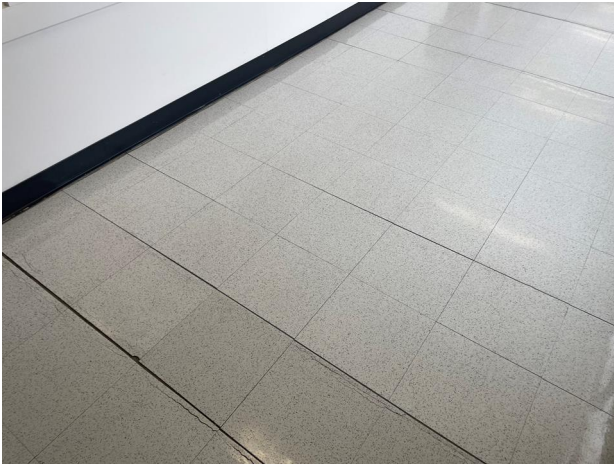
1. VCT floors are damaged.

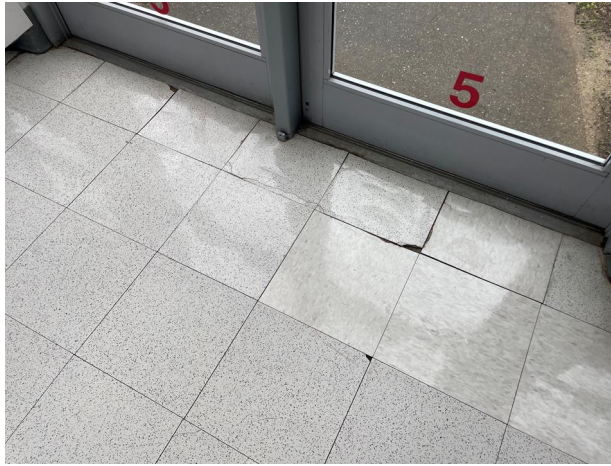
2. VCT floors are cracked and mismatched.

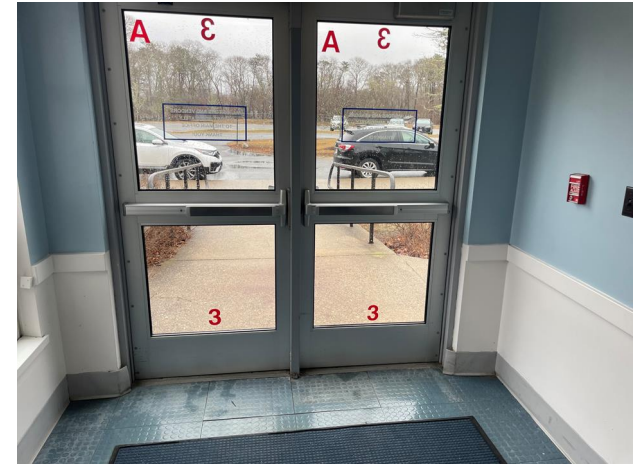
3. Rubber floors are worn.

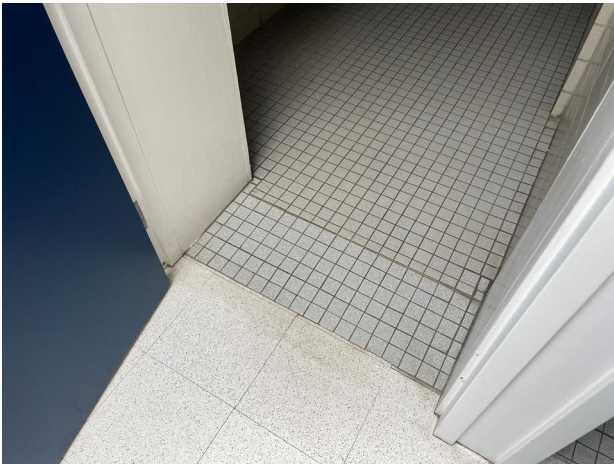
4. Ceramic Tile in Toilet Rooms is damaged.

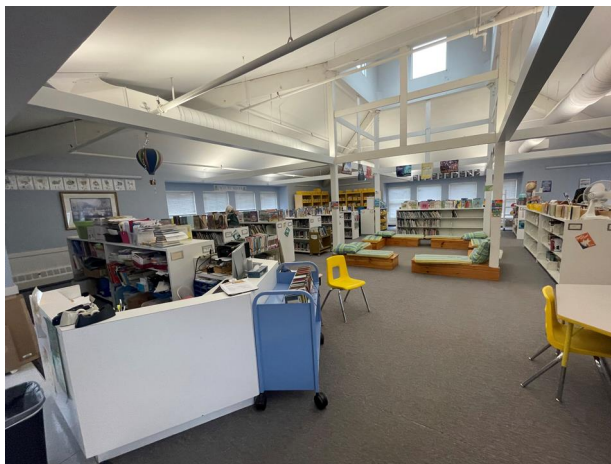
5. Library carpet has reached its anticipated end of useful life.

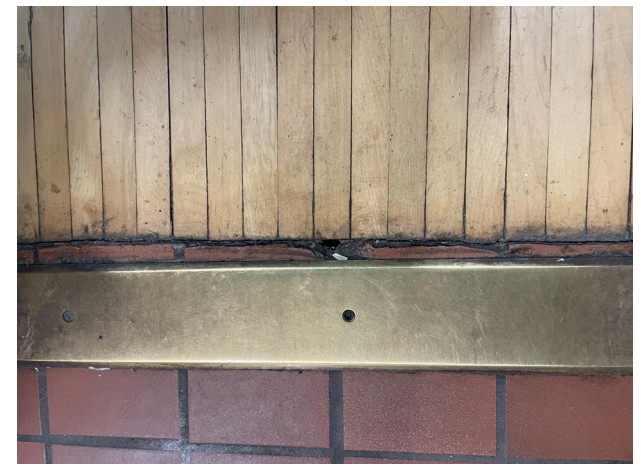
6. Quarry Tile and hardwood floor in Cafetorium are worn.

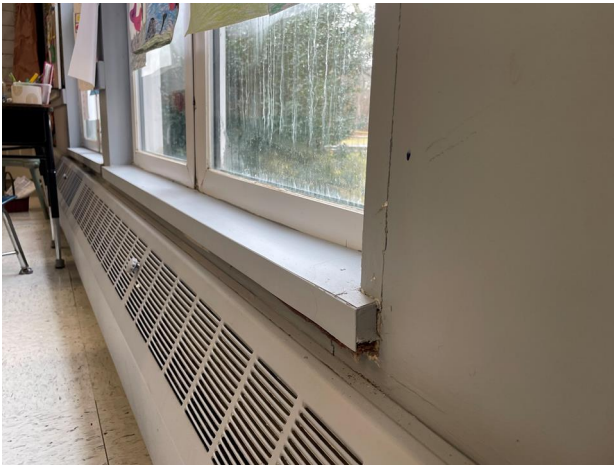
7. Windows have failed and sills water damage is evident.

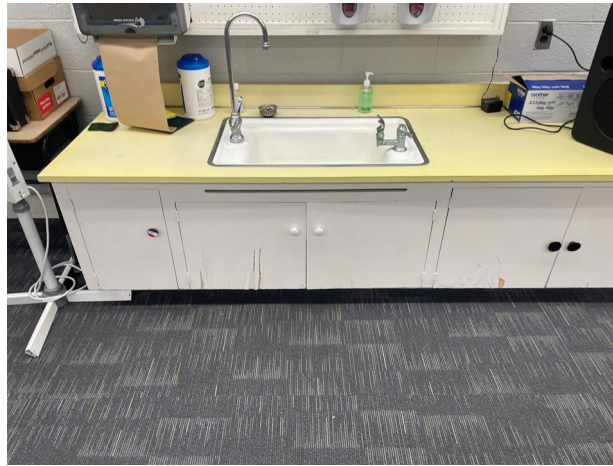
8. Classroom casework is damaged.

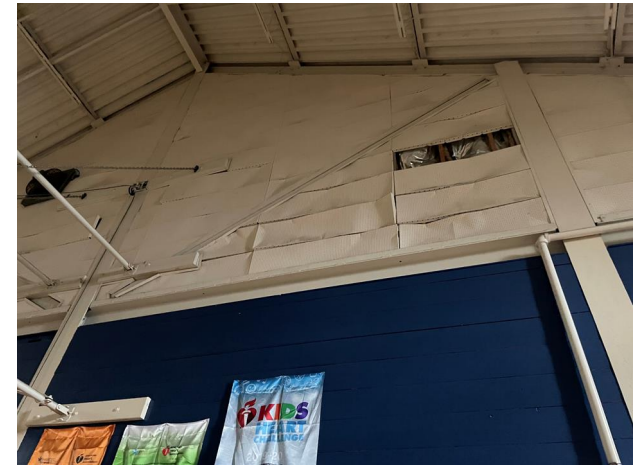
9. Metal Panels in Gym are damaged.

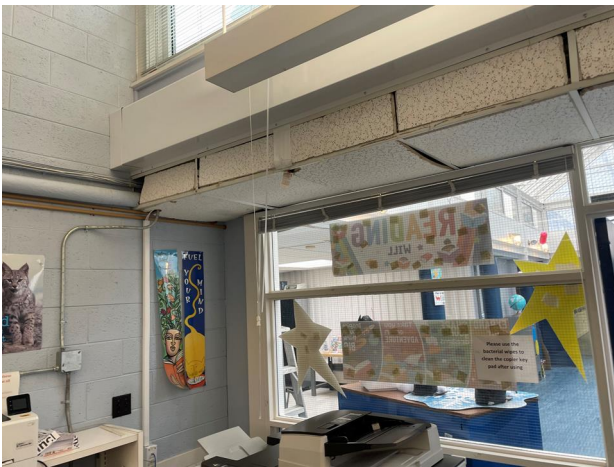
10. Acoustic Ceiling Tiles are damaged.

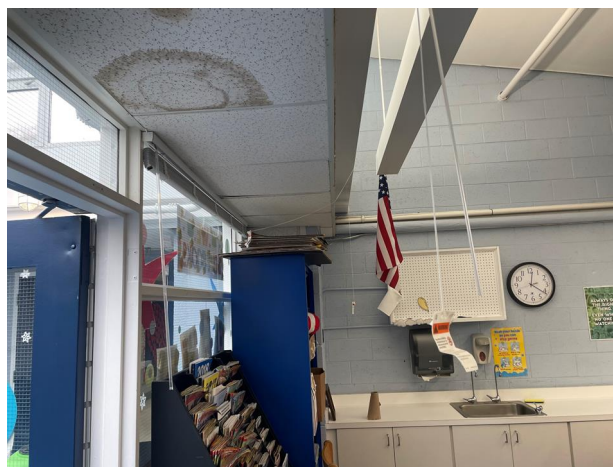
11. 2x4 Acoustic Ceiling Tiles are stained.

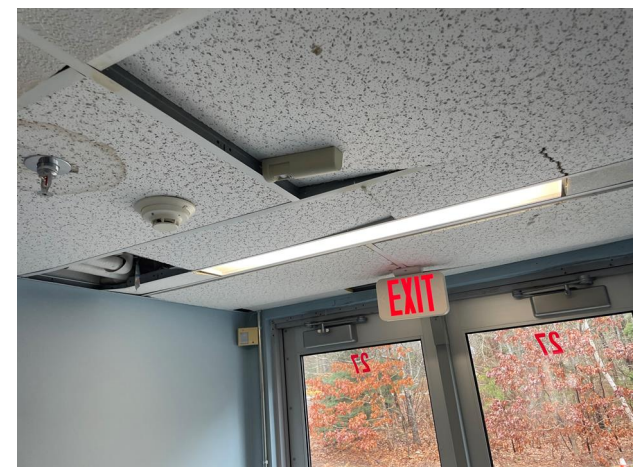
12. 2x4 Acoustic Ceiling Tiles are damaged.

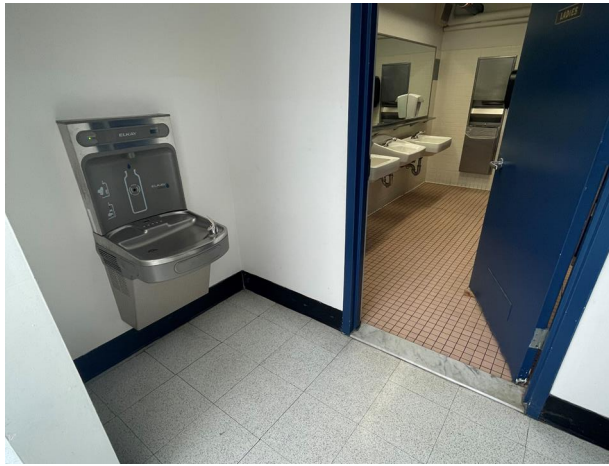
2. There is inadequate clearance at drinking fountains.

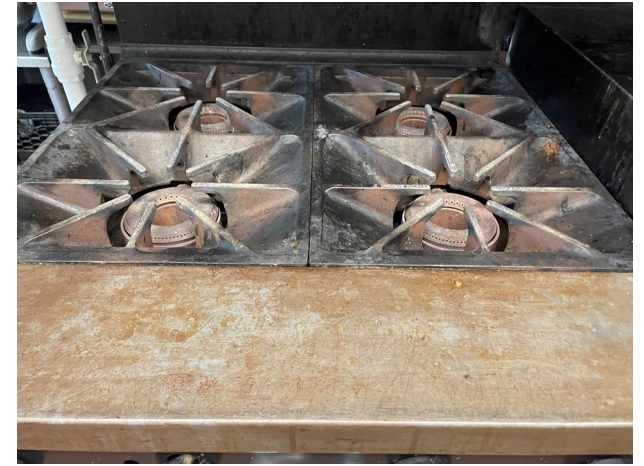
3. Kitchen equipment is outdated.

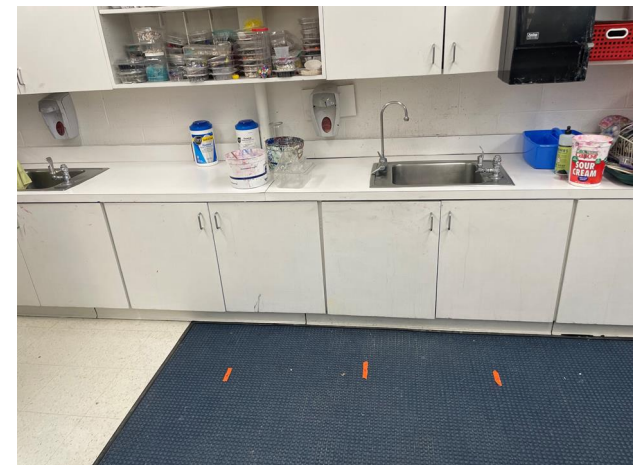
6. Sinks and drinking fountains are not accessible.

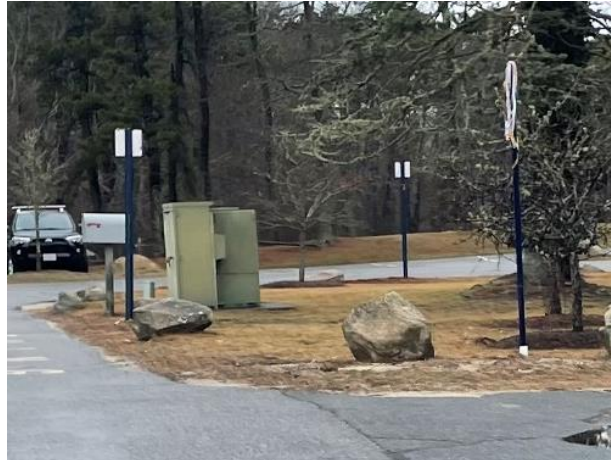
5. Site lighting is inadequate and transformer is unprotected.

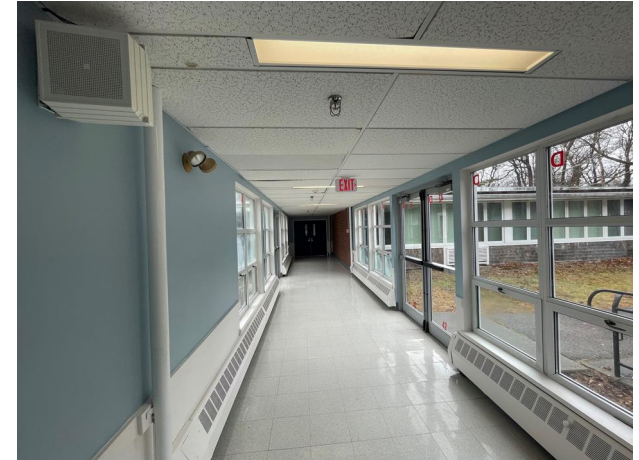
6. Fire alarm system is outdated.

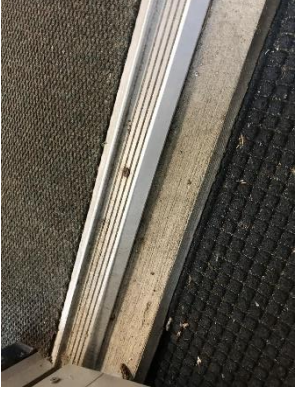
<p>4.</p>	<p><b>Main Entrance</b></p> <p>The threshold is &gt; 1/2" high.</p> <p>The intercom is mounted &gt;48" AFF to the highest operable part, @ 58".</p> <p>The doorbell is mounted &gt;48" AFF to the highest operable part, @ 60".</p>

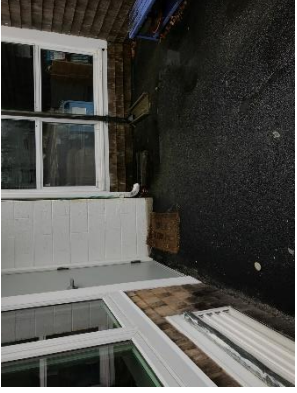
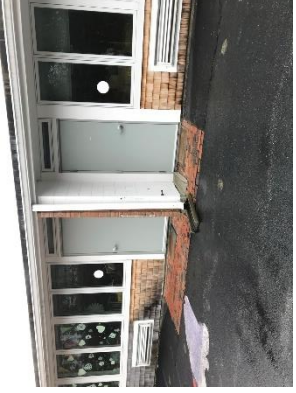
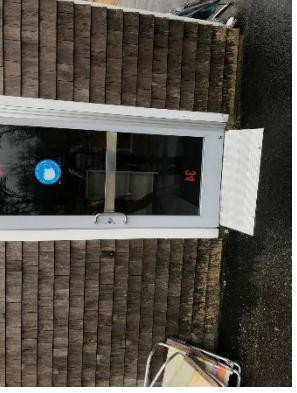
7.	<p><b>Egress Doors (Typical)</b></p> <p>Some egress doors lack a level landing, @ up to 27.7%.</p> <p><i>Observed at egress doors #9, egress door #10, egress door #27, egress door #34, classroom 8 egress door, most egress doors to the rear of the building, and art classroom egress door.</i></p> <p>Some egress doors are not accessible due to the step.</p> <p><i>Observed at most egress doors to the rear of the building, teacher's lounge egress door, art classroom egress door, gymnasium egress doors, egress door #5, egress door #27, and egress door #42.</i></p> <p>The maneuvering clearance is &lt;12" on the latch push side of the door.</p> <p><i>Observed at teacher's lounge egress door, and art classroom egress door.</i></p> <p>The glass door lacks the required minimum 10" of smooth surface along the bottom of the push side, @ 7" high.</p> <p><i>Observed at egress door #5, and egress door #34.</i></p>

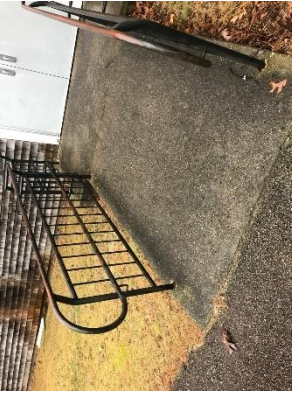
<p>11.</p>	<p><b>Exterior Ramp at Gymnasium's Egress Door</b> The ramp lacks level landings at the top and bottom of the ramp run. The ramp has slopes &gt;8.3%, @ 8.9%. The transition between the ramp and the bottom landing is abrupt. The handrails lack the required extensions at the bottom of the ramp.</p>

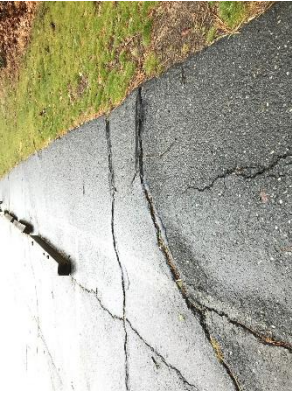
<p>12.</p>	<p><b>Walkways around the Building</b> Walkways have cross slopes &gt;2%, @ up to 3.9%, and abrupt changes in level due to material deterioration.</p>

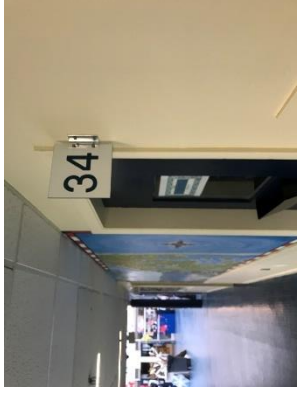
21.	<p><b>Interior Signage (Typical)</b></p> <p>All rooms lack the required tactile/Braille signage mounted on the latch side of the door.</p> <p>The headroom below the signs provides &lt;80" of vertical clearance, @ 74 1/2" AFF.</p>

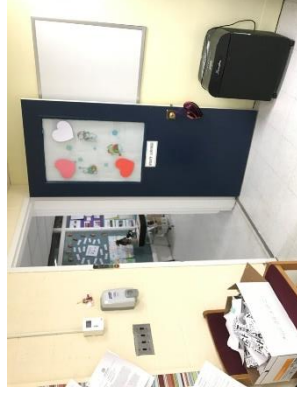
22.	<p><b>Door Hardware (Typical)</b></p> <p>Some of the door hardware require tight grasping, pinching, or twisting of the wrist to operate.</p> <p><i>Observed at both doors leading to the food service at the cafeteria, teachers' lounge, and work room.</i></p>

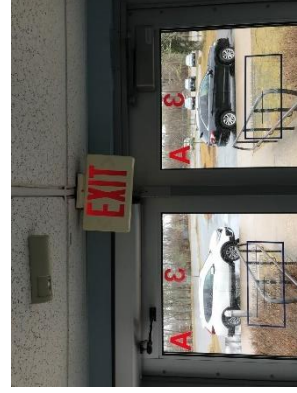
23.	<p><b>Exit Signs (Typical)</b></p> <p>The illuminated exit signs at all accessible means of egress are not identified with the International Symbol of Accessibility (ISA).</p>

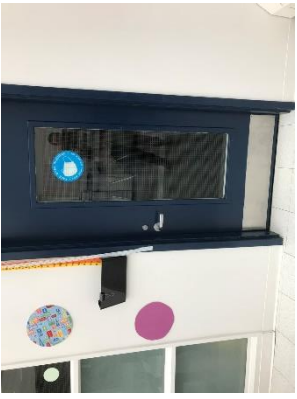
24.	<p><b>Recessed Doors (Typical)</b></p> <p>Several doors are recessed &gt;6" on the latch push-side and/or pull-side, @ up to 9". Note: These doors have both a latch and a closer.</p> <p><i>Observed at both doors leading to food service at the cafeteria, most classrooms along corridor 2, and most classrooms along corridor 3.</i></p>

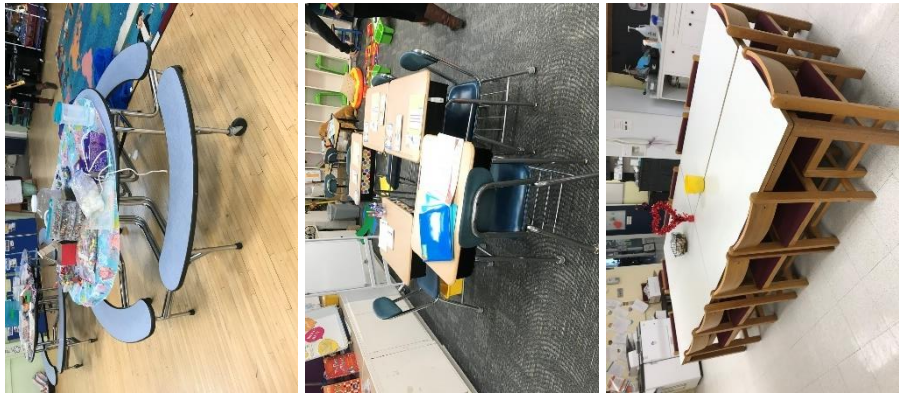
25.	<p><b>Tables and Desks (Typical)</b></p> <p>Some tables lack the required knee and toe clearances for a forward approach.</p> <p><i>Observed at the cafeteria.</i></p> <p>The knee/toe clearances at some desks and tables are &lt;30" wide, @ as little as 18".</p> <p>Some of the children's desks and tables lack the required 25" AFF minimum knee/toe clearance, @ as little as 23".</p> <p><i>Observed at most classrooms.</i></p> <p>Some of the desks and tables lack the required 27" AFF minimum knee/toe clearance, @ as little as 25".</p> <p><i>Observed at teachers' lounge.</i></p>

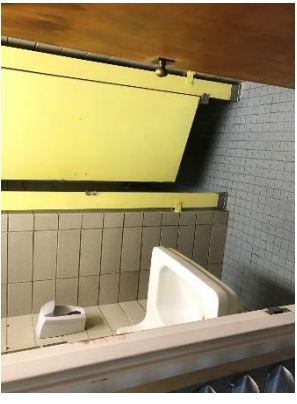
39.	<p><b>Staff Multi-User Toilet Room serving Kitchen</b></p> <p>The door provides &lt;32" of clear width, @ 28".</p> <p>The door hardware requires tight grasping, pinching, or twisting of the wrist to operate.</p> <p>The room lacks the required footprint and elements for an accessible toilet room.</p>

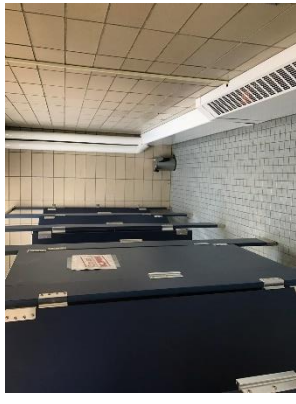
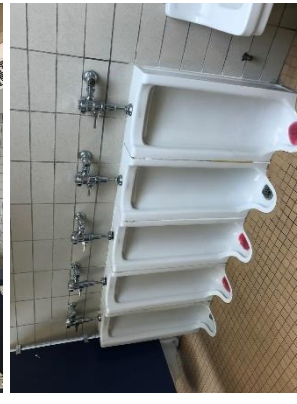
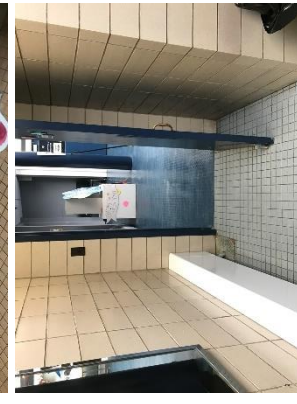
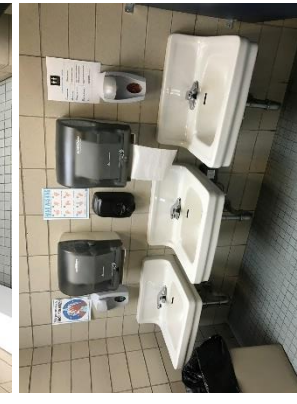
40.	<p><b>Girls' &amp; Boys' Toilet Rooms near Cafeteria</b></p> <p>The route to the stalls provides &lt;36" of clear width, @ 33 1/2" measured from the stall partition to the radiator.</p> <p><i>Observed at girls' toilet room.</i></p> <p>The urinal flush control is mounted &gt;44" AFF, @ 45".</p> <p>For a toilet room with six or more toilets/ urinals, there is no ambulatory stall provided.</p> <p><i>Observed at boys' toilet room.</i></p> <p>The door provides &lt;32" of clear width, @ 29".</p> <p>The maneuvering clearance is &lt;18" on the latch pull side of the door, @ as little as 13".</p> <p>The knee clearance at the sink is &lt;25" AFF, @ 19 1/2".</p> <p>The pipes underneath the sink are not insulated.</p> <p>The mirror is mounted &gt;31" AFF measured to the bottom of the reflective surface, @ up to 36 1/2".</p> <p>The room lacks an accessible stall.</p> <p>The room lacks visual alarm.</p> <p><i>Observed at girls' and boys' toilet rooms.</i></p> <p><i>Note: These toilet rooms appear to be utilized by students of all age groups, therefore KMA audited based on children's dimensional requirements. KMA has received guidance from the MAAB stating that these toilet rooms must meet either adult dimensions or the dimensions for the user group with the highest population using these facilities.</i></p>

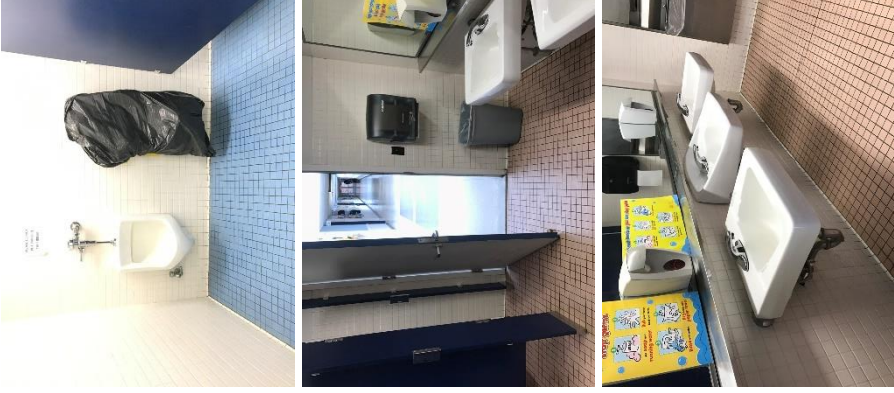
41.	<p><b>Girls' &amp; Boys' Toilet Rooms serving Corridors 2 &amp; 3</b></p> <p>The rim of the urinal is &gt;17" AFF, @ 18".  <i>Observed at boys' toilet room.</i></p> <p>The threshold is &gt; 1/2" high.</p> <p>The door lacks the required maneuvering clearance on the latch pull side due to the paper towel dispenser and to the wall.</p> <p>The knee clearance at the sink is &lt;25" AFF, @ 23".</p> <p>The pipes underneath the sink are not insulated.</p> <p>The mirror is &gt;31" AFF measured to the bottom of the reflective surface, @ 38".</p> <p>The paper towel dispenser protrudes &gt;4" into the circulation area, @ 9".</p> <p>There is no accessible stall provided.</p> <p>The room lacks visual alarm.</p> <p><i>Observed at girls' and boys' toilet rooms.</i></p> <p><i>Note: These toilet rooms appear to be utilized by students of all age groups, therefore KMA audited based on children's dimensional requirements. KMA has received guidance from the MAAB stating that these toilet rooms must meet either adult dimensions or the dimensions for the user group with the highest population using these facilities.</i></p>

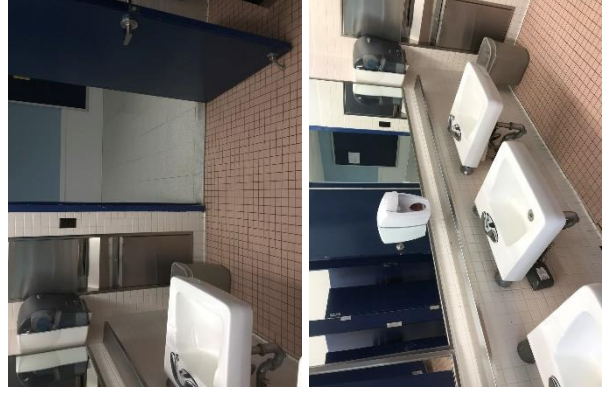
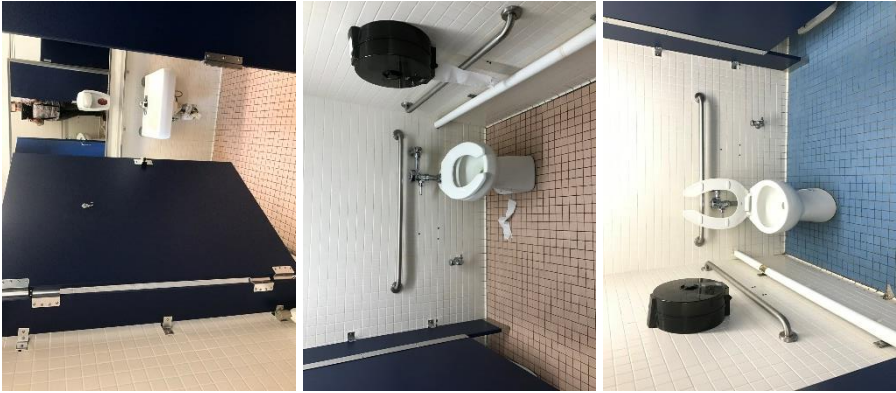
42.	<p><b>Girls' &amp; Boys' Multi-User Toilet Rooms near Gym</b></p> <p>The stall door is not self-closing.</p> <p>The toilet centerline is not 18" from the side wall, @ 18 1/2".</p> <p><i>Observed at girls' toilet room.</i></p> <p>The accessible stall is not 72"x60", @ 71"x60".</p> <p>The flush control is not located on the open side of the toilet.</p> <p><i>Observed at boys' toilet room.</i></p> <p>The threshold is &gt; 1/2" high.</p> <p>The maneuvering clearance is &lt; 18" on the latch pull side of the door, @ 12" measured from the door to the sink.</p> <p>The pipes underneath the sink are not insulated.</p>

<p>The knee clearance at the sink is &lt;25" AFF, @ 22".</p> <p>The mirror is &gt;31" AFF measured to the bottom of the reflective surface, @ 41".</p> <p>The stall door lacks a pull device on both sides of the door.</p> <p>The headroom at the stall door provides &lt;80" of vertical clearance, @ 72".</p> <p>The rear and side grab bars are not mounted 20"-25" AFF, @ 31" measured to the top of the gripping surface.</p> <p>The side grab bar extends &lt;54" from the rear wall, @ 49".</p> <p>The toilet paper dispenser is mounted &lt;12" above the side grab bar.</p> <p>The pipe along the side wall is obstructing the toilet clearance.</p> <p><i>Observed at girls' and boys' toilet rooms.</i></p> <p><i>Note: These toilet rooms appear to be utilized by students of all age groups, therefore KMA audited based on children's dimensional requirements. KMA has received guidance from the MAAB stating that these toilet rooms must meet either adult dimensions or the dimensions for the user group with the highest population using these facilities.</i></p>

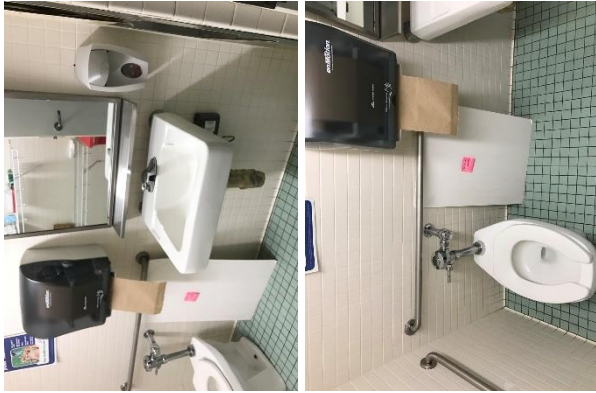
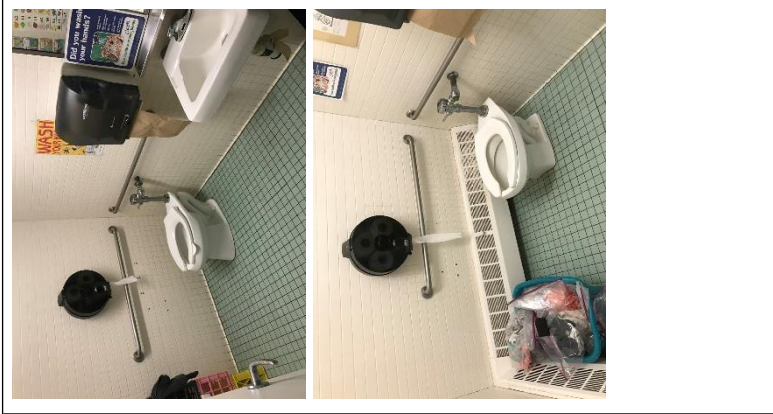
<p>43.</p>	<p><b>Single-User Toilet Rooms in Classrooms</b></p> <p>The knee clearance at the sink is &lt;25" AFF, @ 22".</p> <p>The mirror is &gt;31" AFF measured to the bottom of the reflective surface, @ 38".</p> <p>The radiator obstructs the toilet clearance.</p> <p>The side grab bar extends &lt;54" from the rear wall.</p> <p><i>Observed at kindergarten 3.</i></p> <p>The sink is &gt;30" AFF, @ 32" measured to the rim.</p> <p>The clearance around the toilet is not 42" measured perpendicular from the rim of the toilet, to the shelf, @ 32".</p> <p><i>Observed at kindergarten 1 and kindergarten 2.</i></p> <p>The threshold is &gt; 1/2" high.</p> <p>The maneuvering clearance is &lt;18" on the latch pull side of the door, @ as little as 9".</p> <p>The pipes underneath the sink are not insulated.</p>

<p>The flush control is not located on the open side of the toilet.</p> <p>The centerline of the toilet is not 11"-15" from the side wall, @ 17 1/2" - 19".</p> <p>The clearance around the toilet is &lt;60", @ as little as 58" measured from the side wall to the sink.</p> <p>The paper towel dispenser protrudes into the circulation area.</p> <p>The rear and side grab bars are not mounted 20"-25" AFF, @ 31" measured to the top of the gripping surface.</p> <p>The toilet paper dispenser is mounted &lt;12" above the side grab bar.</p> <p>The room lacks visual alarm.</p> <p><i>Observed at kindergarten 1, 2, and 3.</i></p> <p><i>Note: These toilet rooms appear to be utilized by kindergarten students, therefore KMA audited based on kindergartener dimensional requirements.</i></p>
