# TOWN OF ORLEANS FIRE STATION FEASIBILITY STUDY

August 11th, 2021

# FIRE STATION FEASIBILITY STUDY

A structural inspection of the Orleans Fire Station located at 58 Eldredge Park Way, Orleans, MA 02653 was conducted on June 4, 2021. The visual inspection (no test) was performed to evaluate the overall condition of the existing building as part of the feasibility study for the Fire Station.

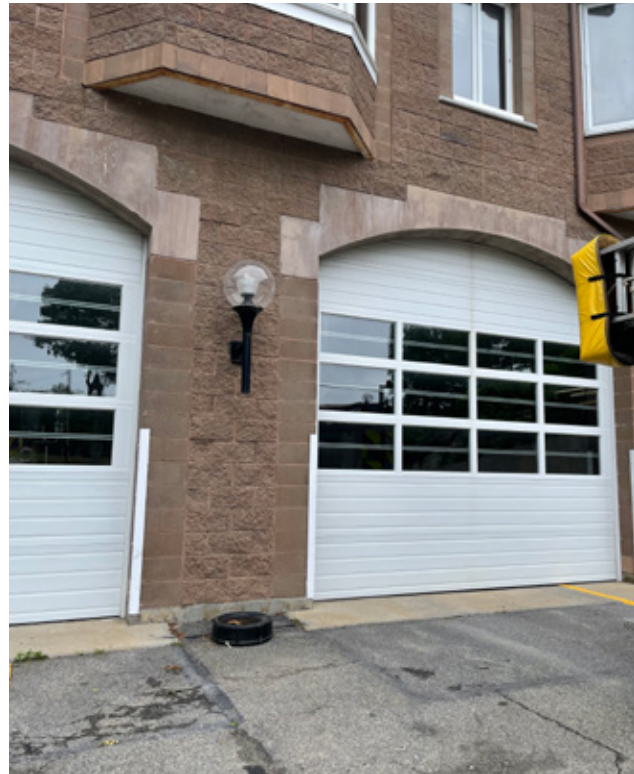
The aprons in place at the existing station are made of asphalt. Today this material would NOT be used for the reasons above and more. Asphalt settles, cracks, and moves radically with temperature changes. It is slippery when wet and builds ice easily. It is a more dangerous material to first responders for this reason, and much more abusive to the Town’s trucks and property leading to long-term expensive truck repair or replacement. Further, it does NOT last as long as concrete, which can be designed specifically for these areas. The current aprons are outdated, failing, cracked, not draining properly, and are a general safety hazard and nuisance to the fire department. Repairing them would require extensive reworking and we suggest this would be a poor use of tax dollars.

Today’s fire stations have “light broom finished” concrete aprons that are longer than the trucks that use them for safe maneuverability. They are structurally reinforced, align with the apparatus bay interior, and designed for proper drainage to eliminate rain, snow, and ice buildup. The goal is a non-slip, safe surface to protect the health and welfare of those who are responding to emergencies. In some cases we design them with in-slab radiant heat that melts ice and snow and allows emergency vehicles to dispatch safely any time of day or night regardless of New England winter conditions.

**It is recommended that concrete aprons be incorporated into any future design thinking**

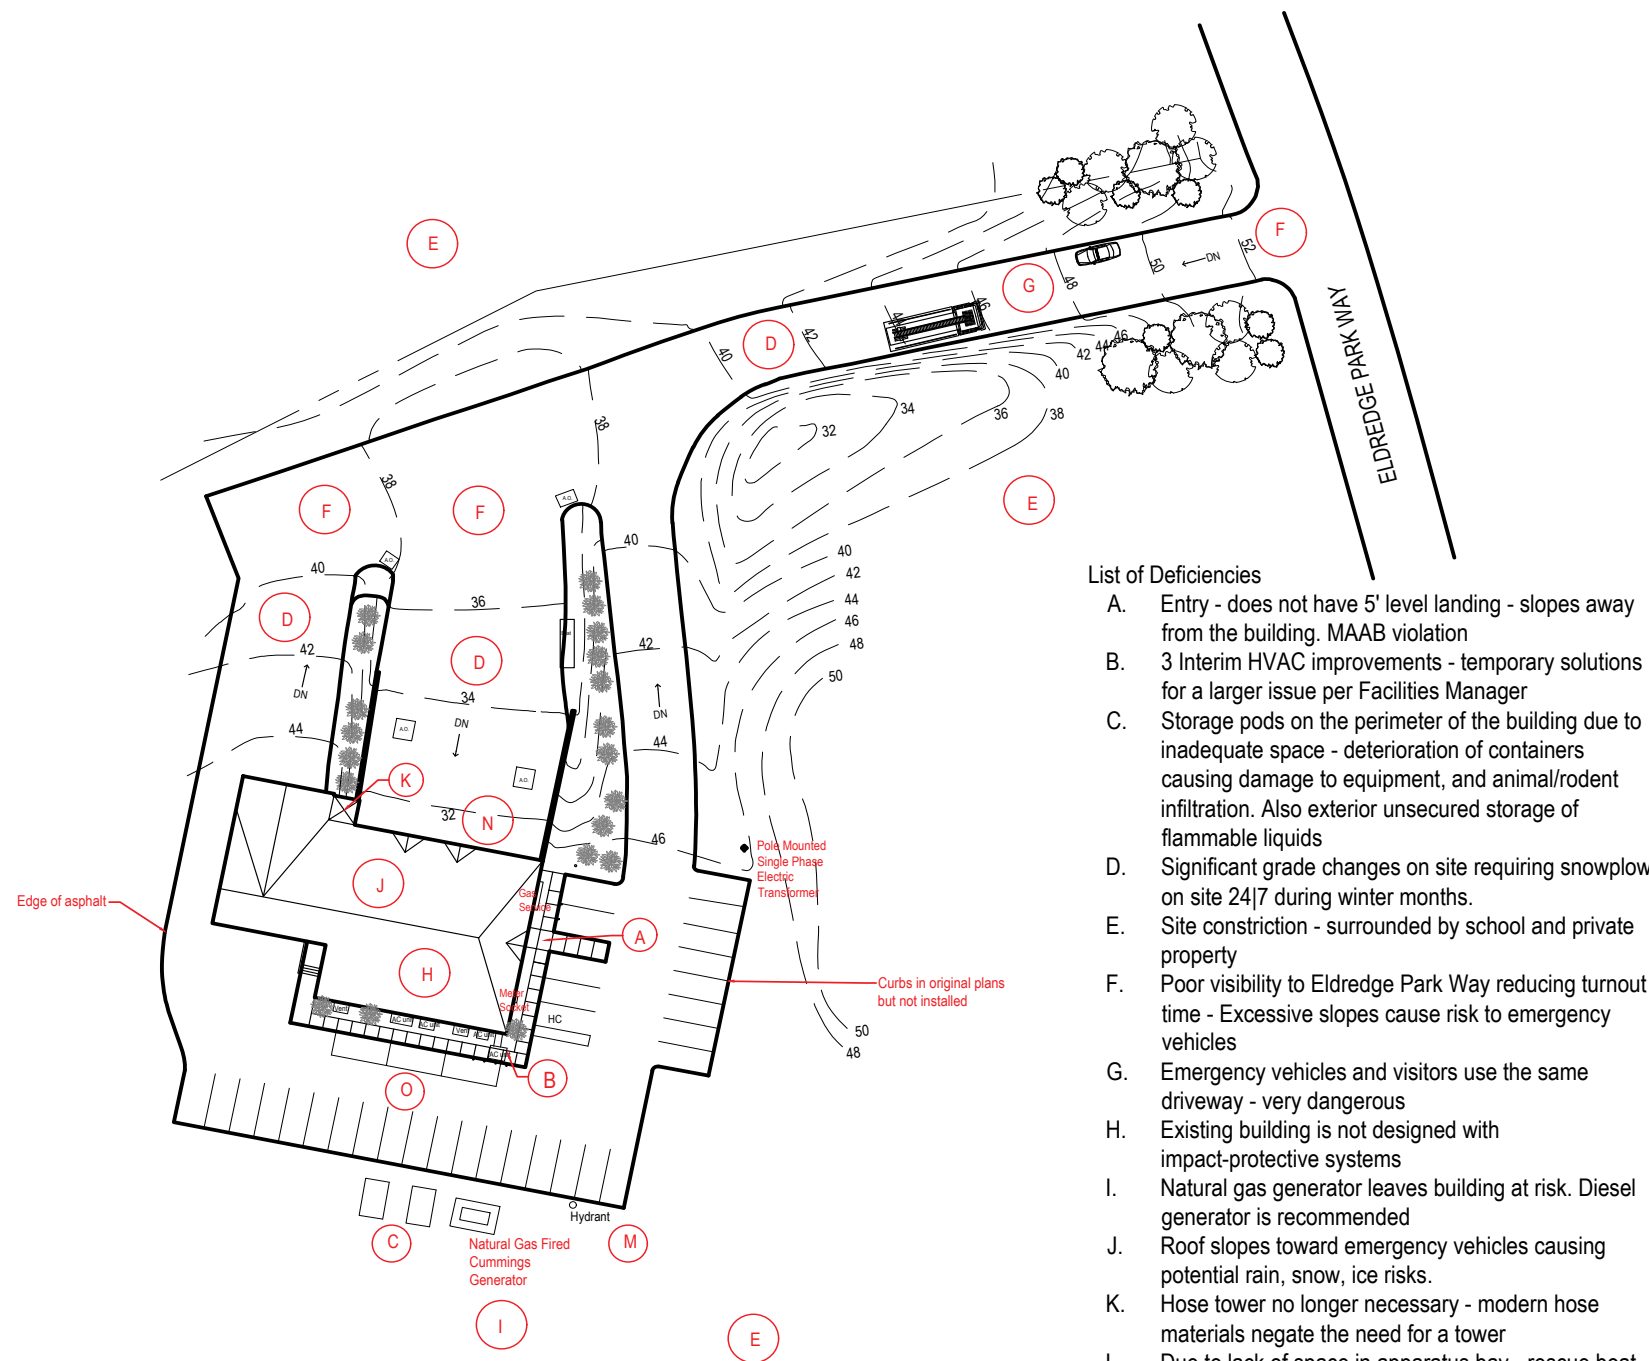
Ex Site 1a

- A. Entry - does not have 5' level landing - slopes away from the building. MAAB violation
- B. 3 Interim HVAC improvements - temporary solutions for a larger issue per Facilities Manager

- C. Storage pods on the perimeter of the building due to inadequate space - deterioration of containers causing damage to equipment, and animal/rodent infiltration. Also exterior unsecured storage of flammable liquids

- F. Poor visibility to Eldredge Park Way reducing turnout time - Excessive slopes cause risk to emergency vehicles
- G. Emergency vehicles and visitors use the same driveway - very dangerous

- H. Existing building is not designed with impact-protective systems
- I. Natural gas generator leaves building at risk. Diesel generator is recommended

- L. Due to lack of space in apparatus bay - rescue boat stored outside
- M. When hydrant is used for training it causes low pressure at the Orleans Elementary School

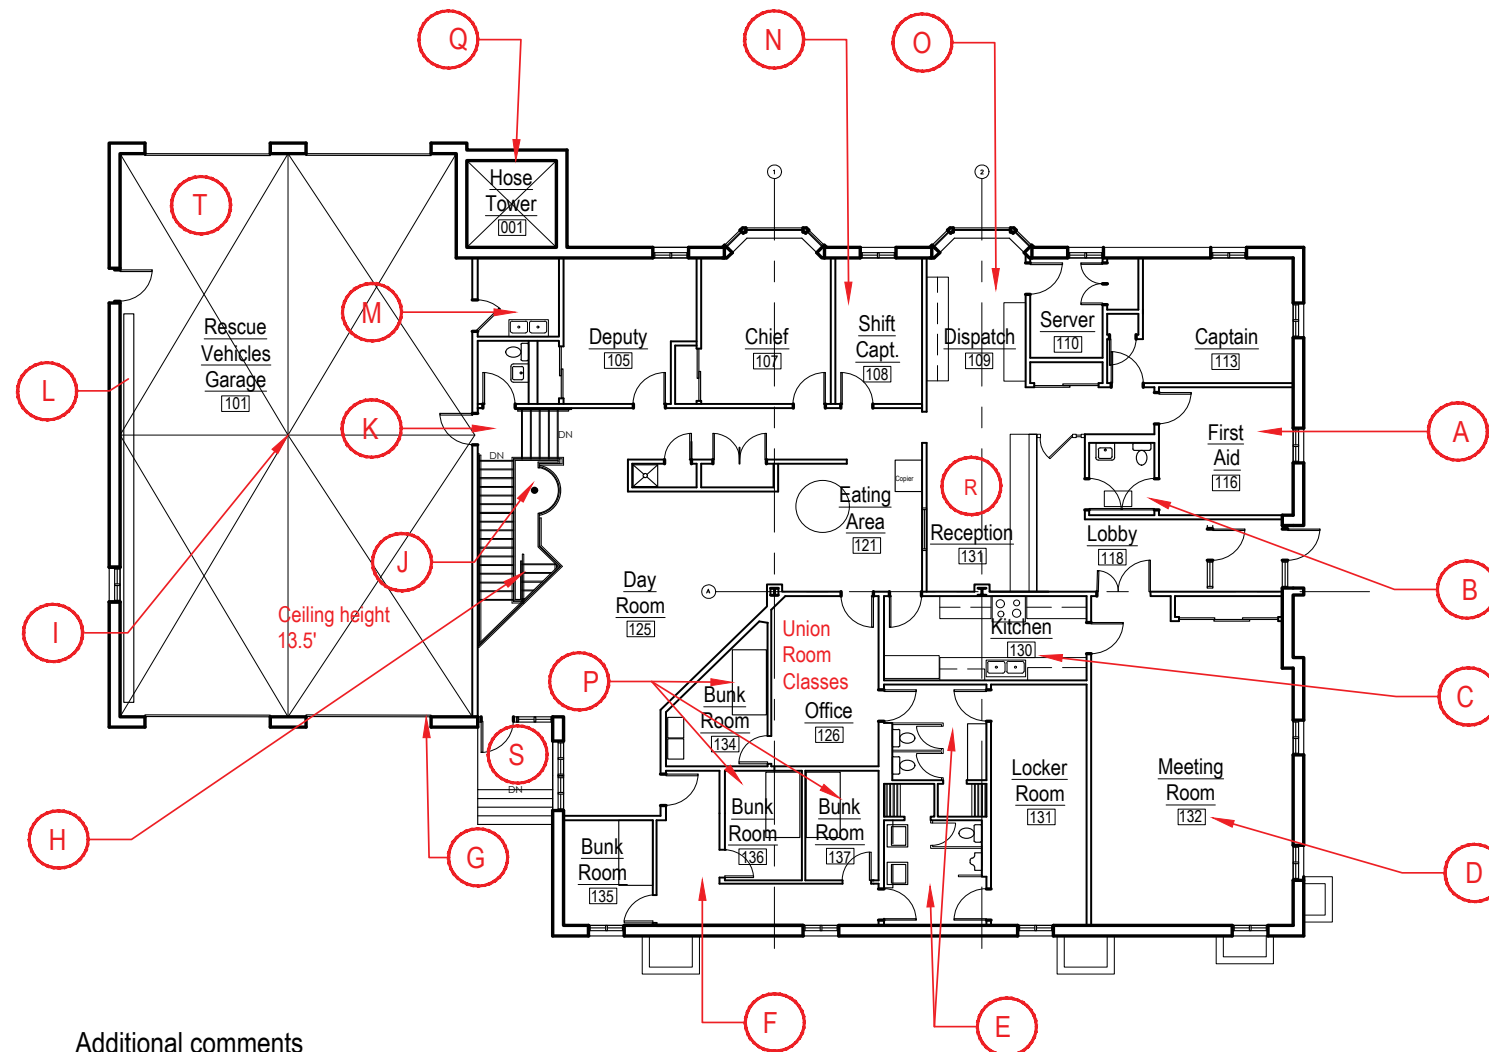
- B. Public restroom (MAAB Violation) - Unsecured location and privacy issues (odor, etc)
- C. Kitchen - Current facility has been outgrown, is outdated and inadequate for personnel. Not MAAB compliant

- D. Training/Meeting Room - Not large enough to accommodate 30+ station personnel, and to function as backup Emergency Operations Center. Temporary HVAC repair takes up space.

- F. Laundry facilities - No domestic laundry available leading to potential carcinogen transfer.
- G. First floor apparatus door height/Ceiling height - Inadequate for apparatus. Door height at lowest point is currently 10', ceiling height is 13.5' Contemporary standards require 14'-0" doors

- L. Turnout gear on apparatus floor - does not conform to NFPA standards
- M. EMS Medical Supply - Space inadequate  
Two bay sink blocks door swing
- N. Shift capt. office - Used for sleeping but was not designed for this. Poorly located

- O. Dispatch area - No longer used therefore inactive space
- P. Bunk rooms in violation of building codes. No natural light or ventilation. Too small as built.

- Q. Hose tower no longer used
- R. Reception desk not MAAB compliant
- S. No separation of the dayroom from the exterior - door not tight and cold air infiltrates

- T. Vehicles must be driven out of the back of the upper apparatus bay - can not back up the hill during minimal snow and ice (even with plowing and sanding)

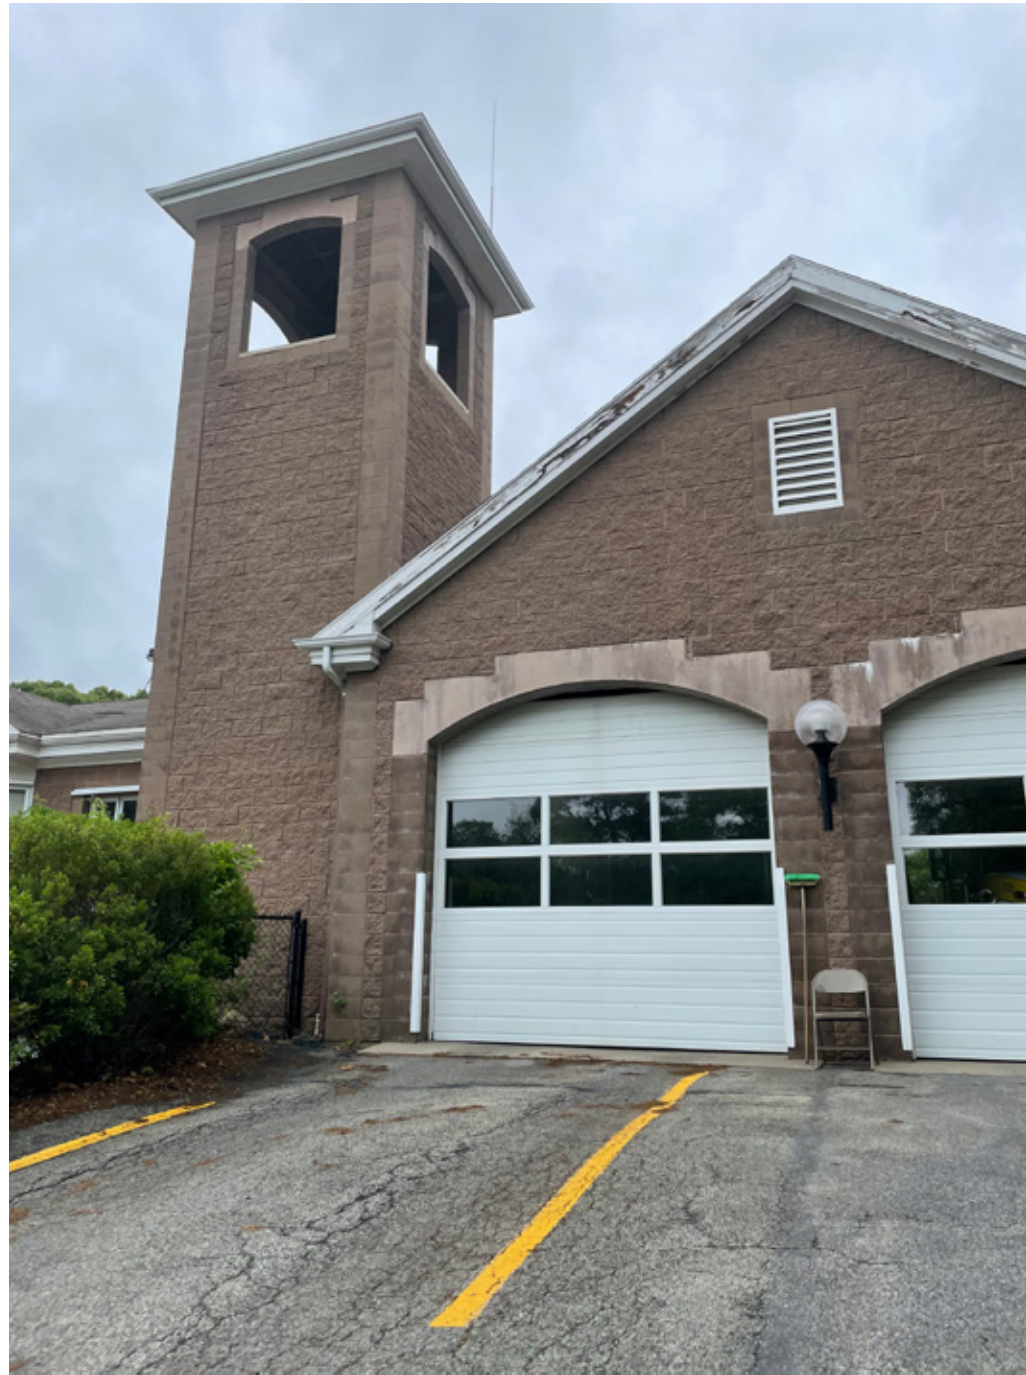
Main Entry to building is not clear, and access has non-compliant slope

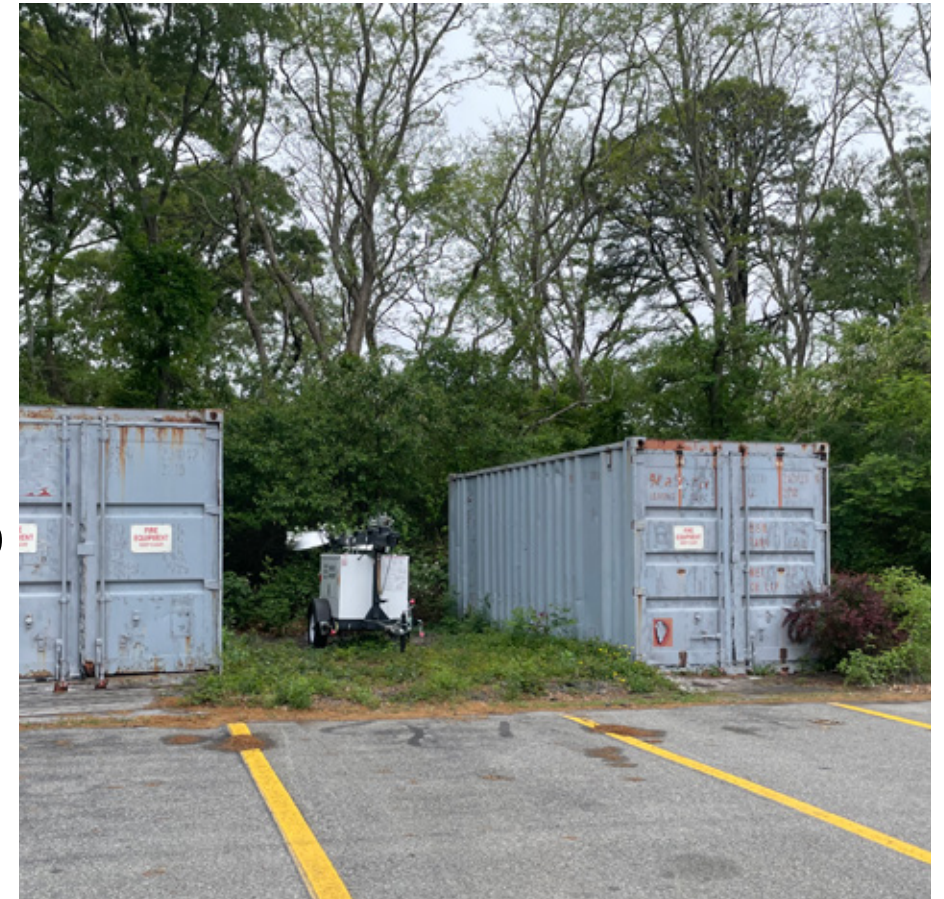
Apparatus bays lack a concrete apron, and asphalt is in poor condition. Precast arch shaped lintels limit effective overall height of doors which limits apparatus selection

Storage pods at perimeter of site due to lack of storage space and do not provide adequate protection from the elements

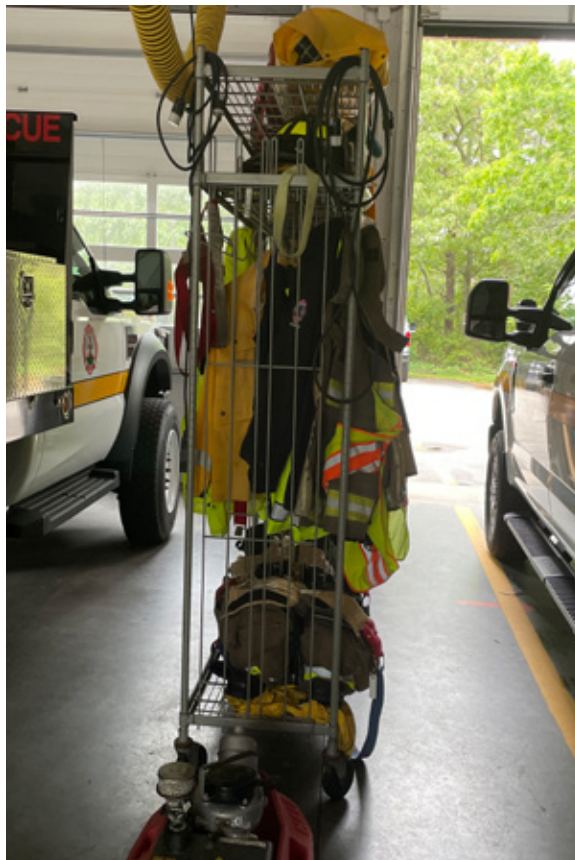
Apparatus bays are too small for current fire-rescue vehicles

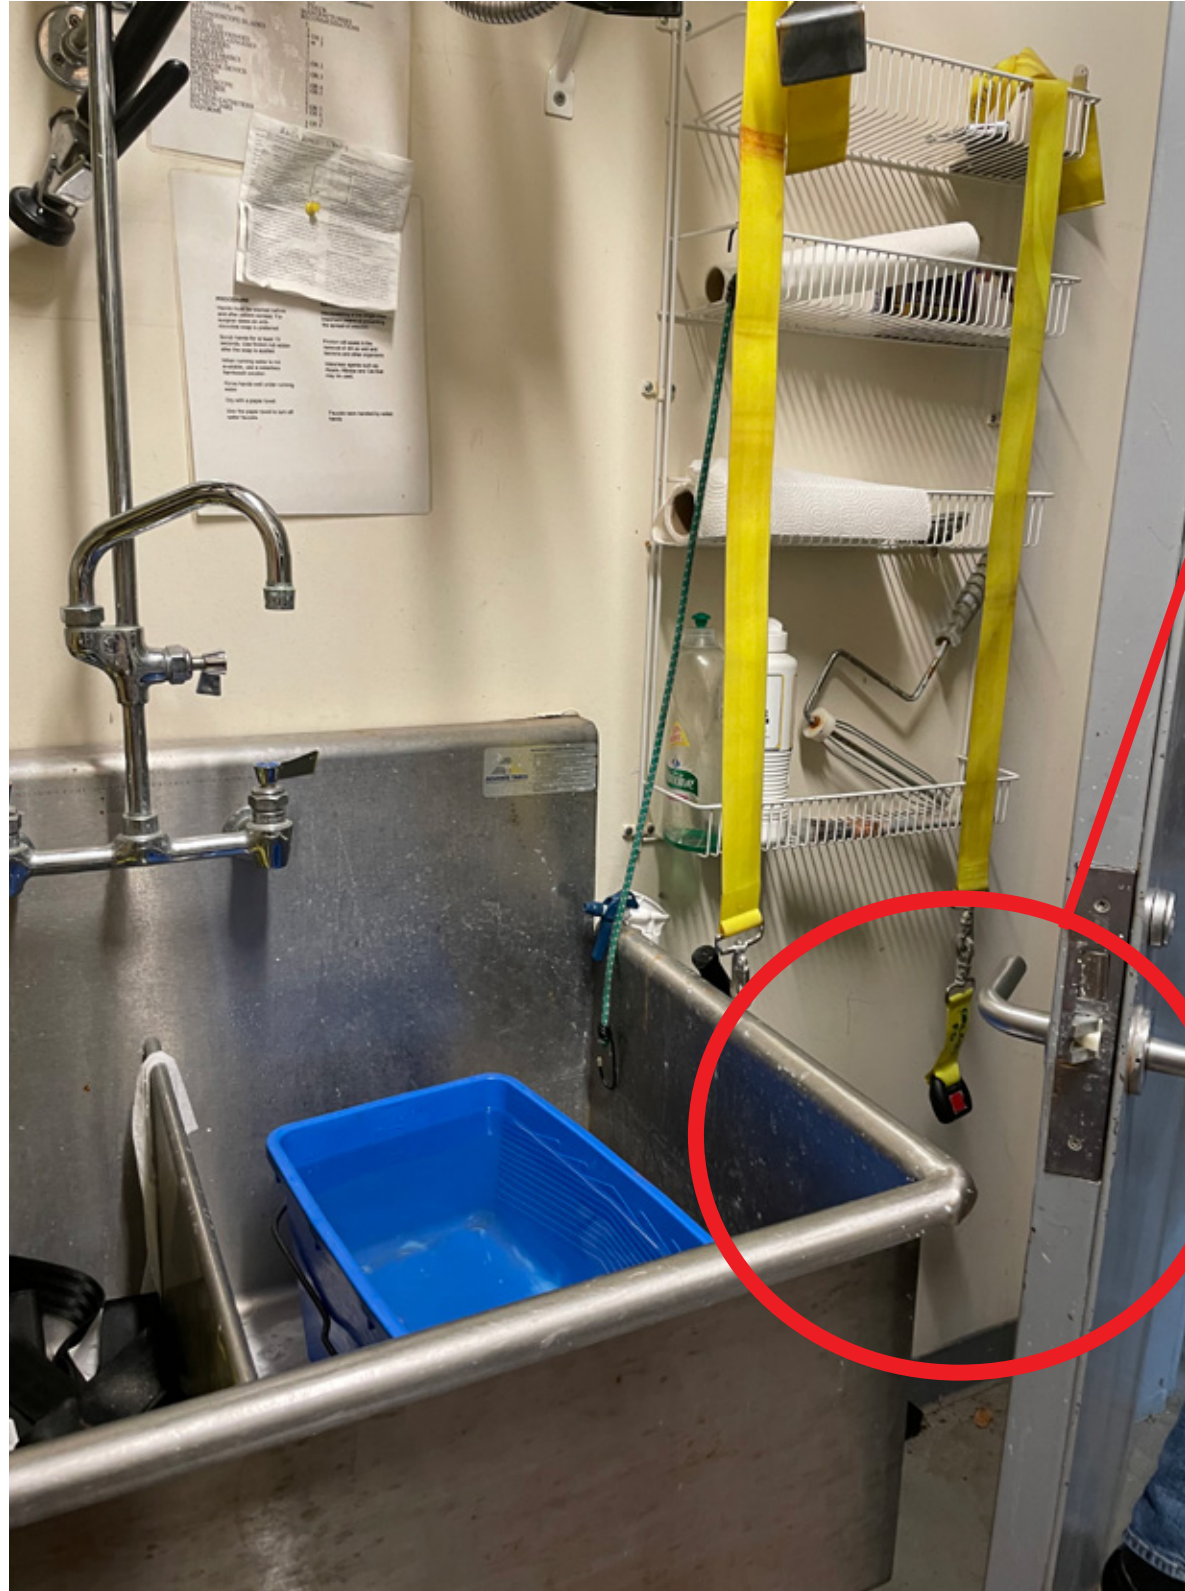
EMS Supply Room was retrofitted with a sink. Because of crowded conditions door can not fully open.

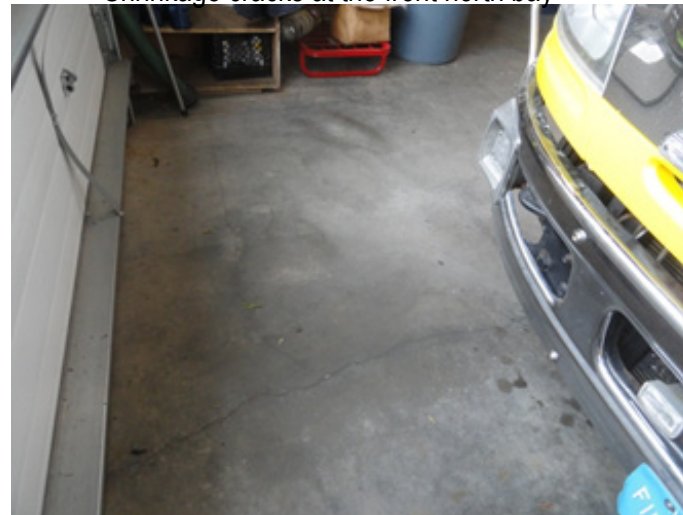
- b. The exposed floor concrete slab is in satisfactory condition with a few cracks observed mainly at the first row of the vehicle bays from the entrance. The cracks appear to be shrinkage cracks with no visible differential observed.

Photo #11 Basement Apparatus Room slab  
Shrinkage cracks at the front middle bay

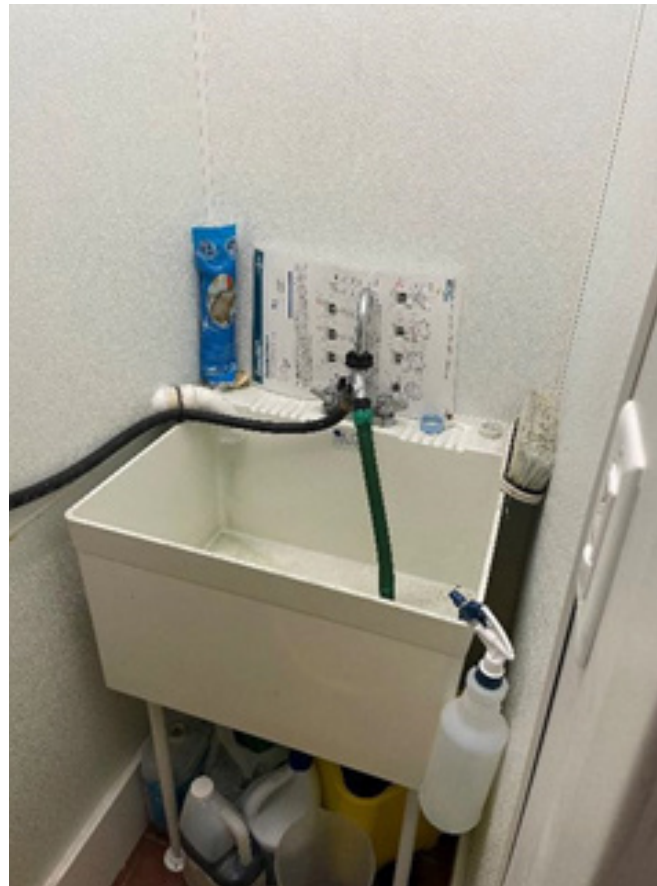
Janitor Sink

4. Janitor's Sink: The janitor's sink is a laundry tub style with two lever faucets. The sink is in good condition but space is tight inside the room with number of chemicals and cleaning supplies. The sink is provided with a cleaning chemical dispensing unit mounted on the wall. There is no testable backflow preventer installed between the unit and the water supply in order to protect the water supply from contamination. It is recommended to install a testable backflow preventer.

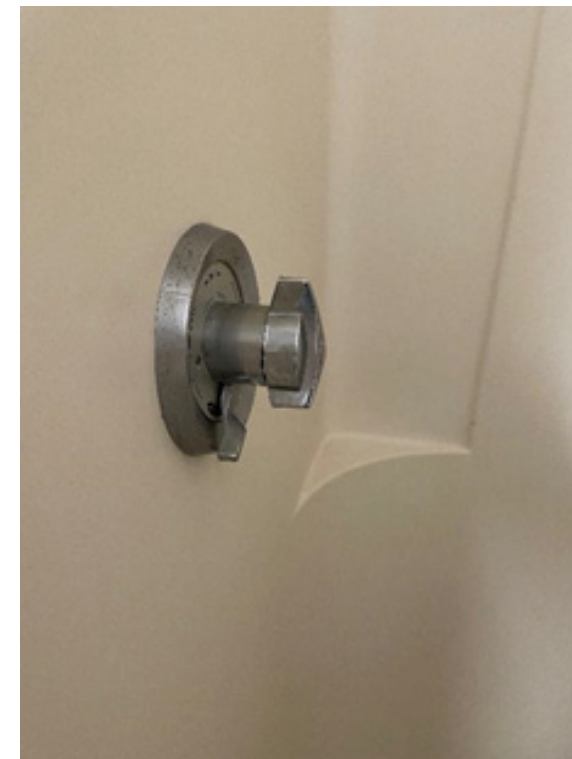
Existing Shower Valve

5. Showers: The two showers in the building are fiberglass units with integral thermostatic mixing valves. The showers appear to be in poor condition and it is recommended that these be replaced.

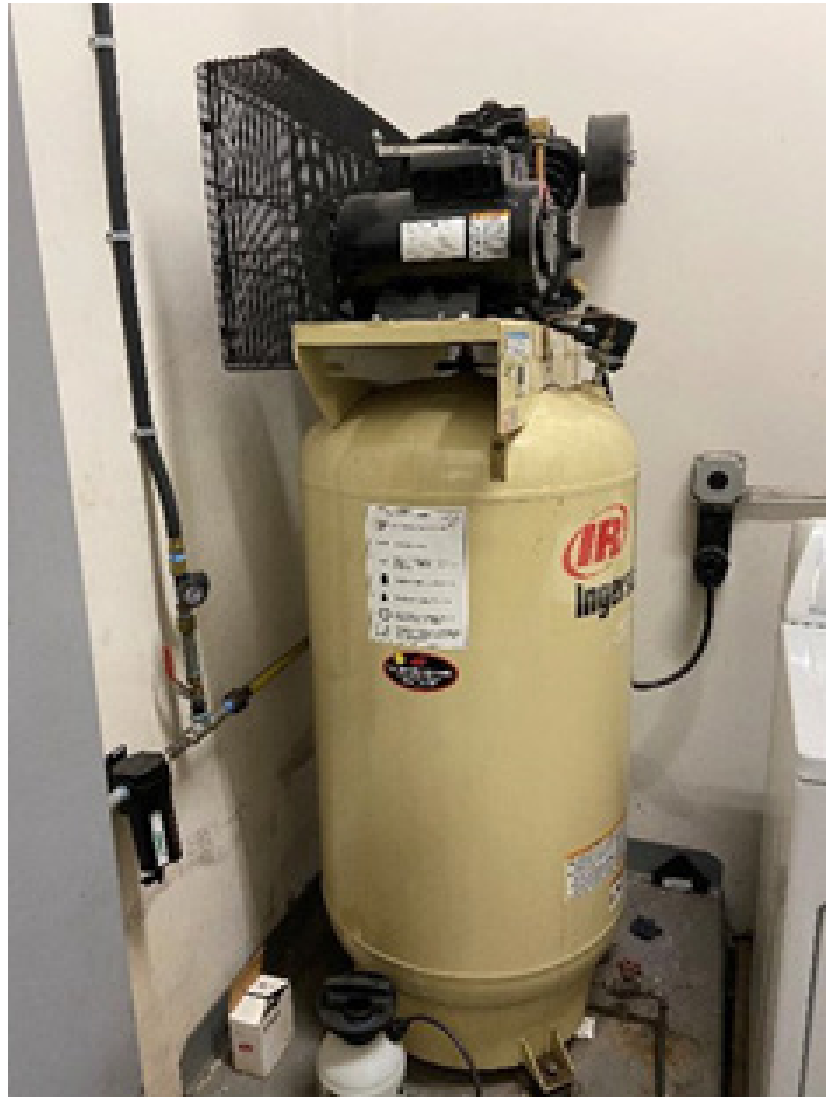
Air Compressor

6. Air Compressor: An air compressor is provided for compressed air throughout the facility. The air compressor appears to be in good condition but there are no acoustical barriers between the compressor and washer/dryer room

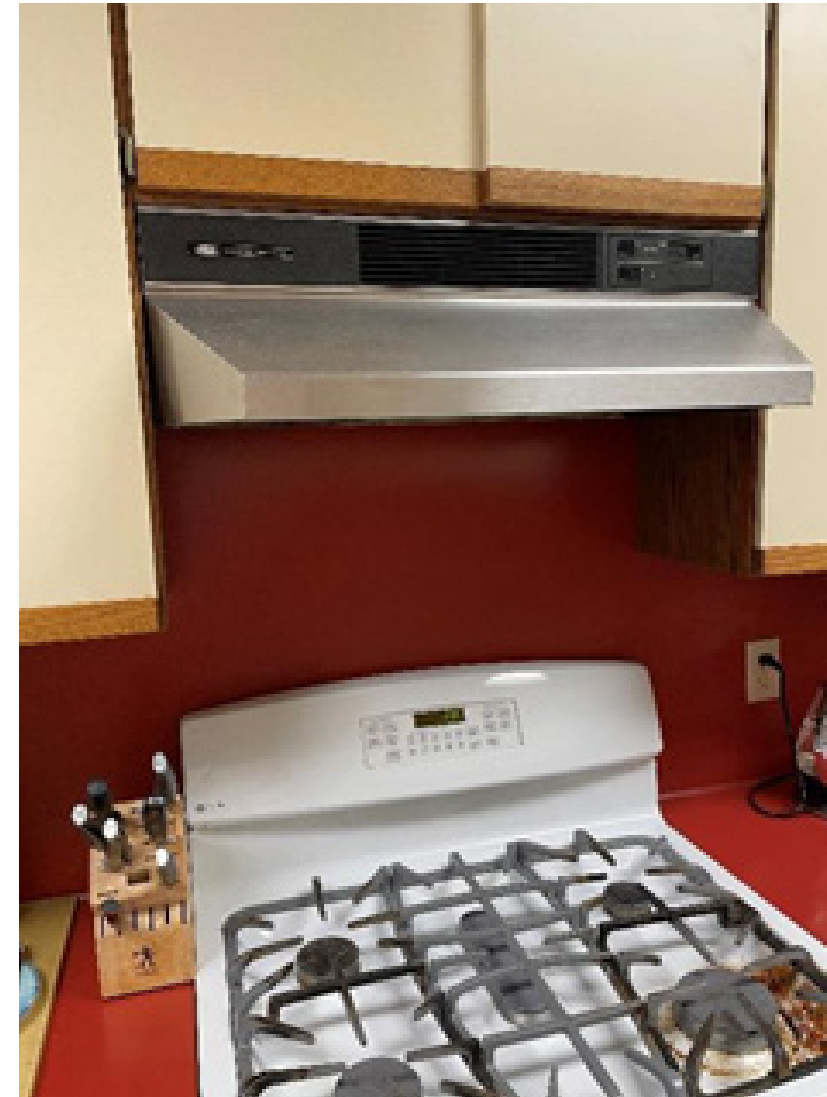
Kitchen Oven and Cooktop

7. Kitchen: The Kitchen is provided with a residential oven and exhaust hood. These appliances are both significantly outdated and not sufficient for a modern day fire station. It is recommended that these be removed and updated with commercial appliances and proper exhaust to meet MAAB requirements

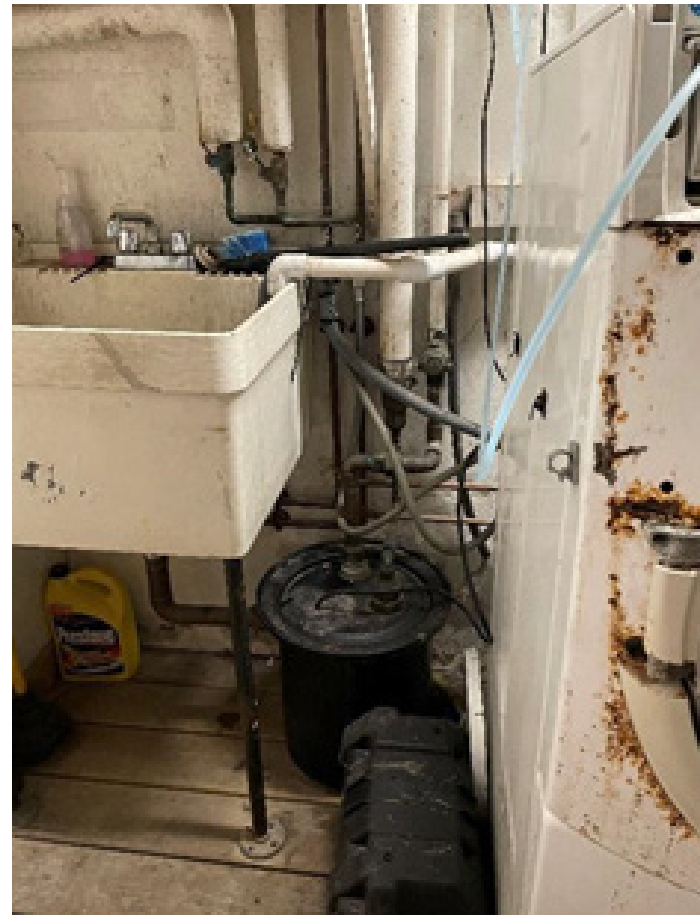
Ejector Pump for Laundry Tub

9. Extractor and Washing Machine Waste: The waste from the extractor and washing machine in the Apparatus Bay drain into a laundry tub sink. The waste from the sink is then pumped up via an ejector pump and taps into the gravity waste. It was brought to CES' attention that the sink routinely overflows onto the floor when the extractor and washing machine are running. This issue is likely caused by an undersized ejector pump which cannot handle the amount of water flow.

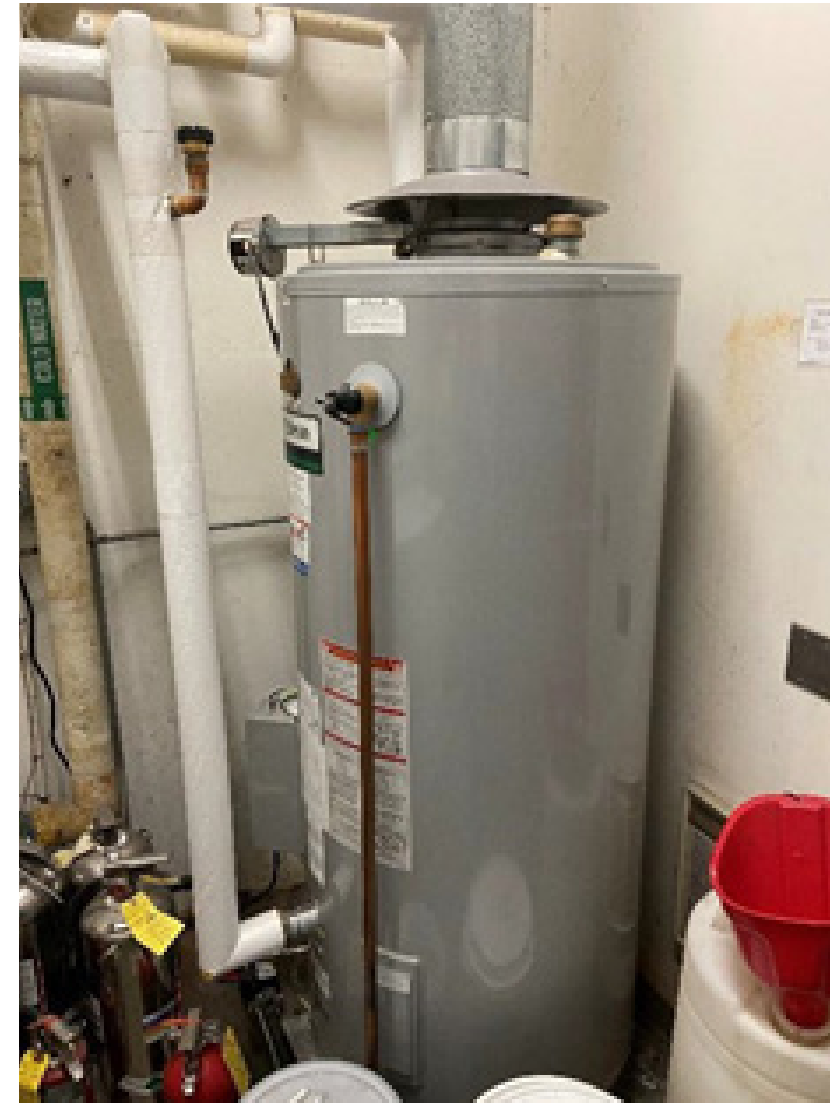
Gas Fired Water Heater

1. Hot Water Heater: The existing building is currently provided with hot water through the use of (1) 100 gallon gas-fired hot water heater. The water heater is in good condition.

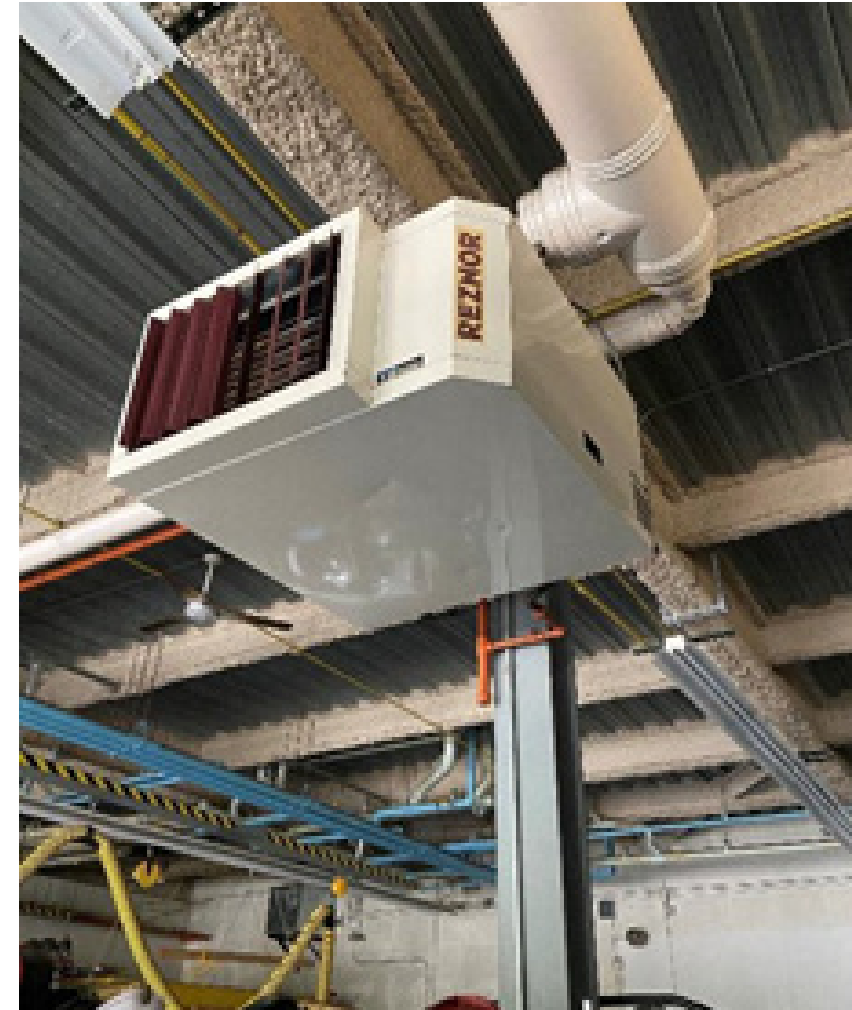
Gas Fired Unit Furnace

2. Gas-Fired Unit Heaters: The apparatus bays are provided with gas-fired unit heaters. These units appear to be relatively new and are in good condition.

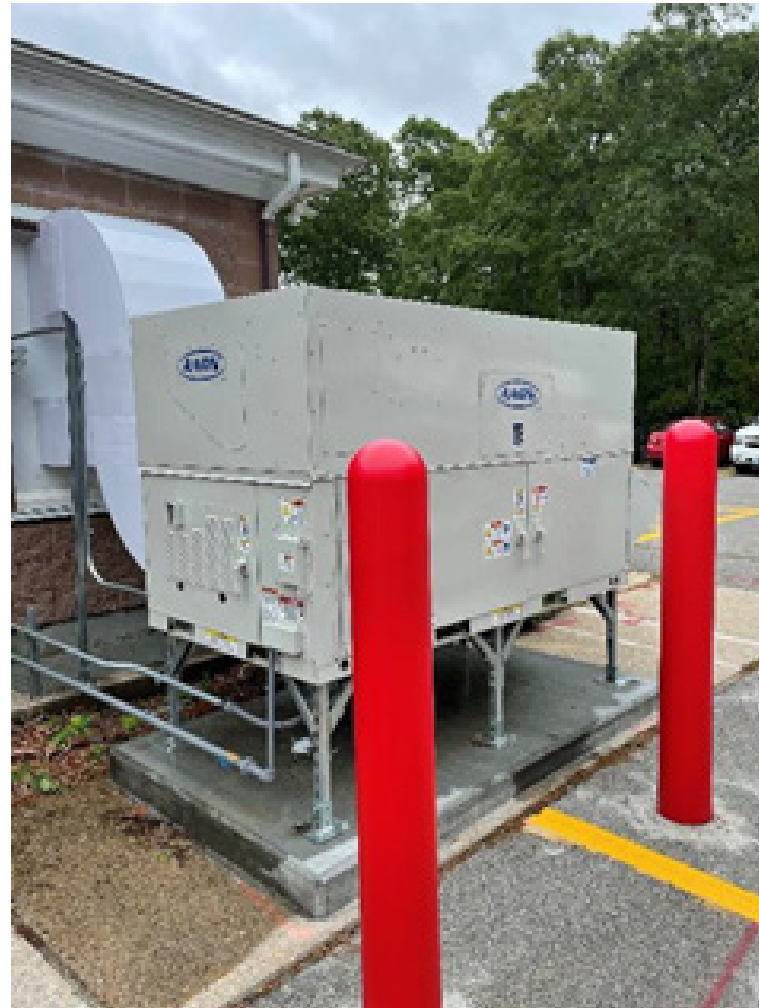
Outdoor Energy Recovery Ventilator (ERV)

1. Energy Recovery Ventilator: Ventilation is provided to the building via an energy recovery ventilator (ERV) mounted outside on the ground and ducted into the building attic space. The outdoor air is ducted into the return mains of the furnace units and the exhaust air is ducted directly to the spaces. The ERV is new and is in good condition, however, the unit is located in order to minimize the amount of structural penetrations. The unit's ductwork enters the building in the conference room, protruding into the space and taking up floor area.

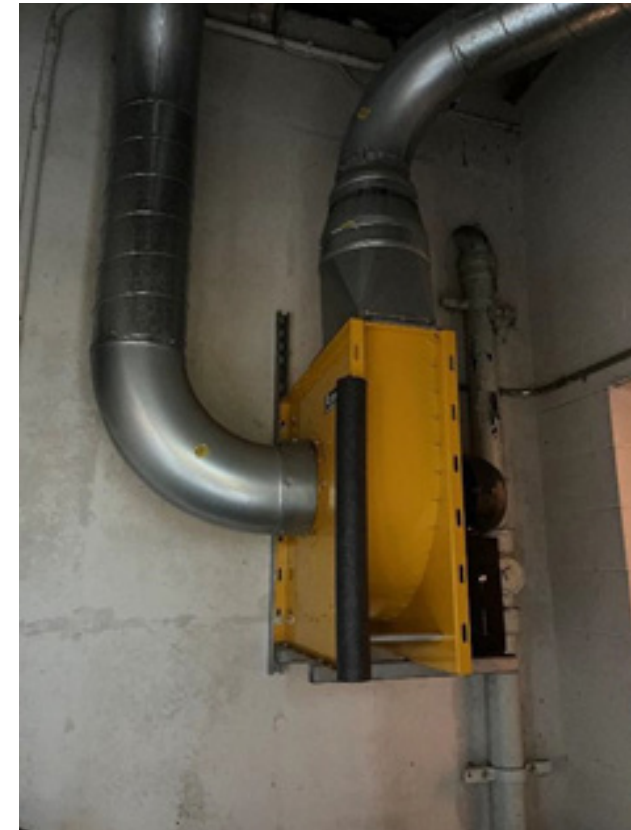
Plymovent Exhaust Fan

2. Plymovent System: A Plymovent vehicle exhaust extraction system is utilized to capture and release vehicle exhaust outdoors. The exhaust extraction system consists of hose reel assemblies with pneumatic grabbers and a central exhaust fan. This equipment is in good condition. The hose grabbers locations are not designed for vehicles to enter the apparatus bay in reverse. It was brought to CES' attention that this is a common issue during the winter months when vehicles have to back into the apparatus bay. The fumes from vehicles in the bay that aren't able to be connected to the Plymovent system can reach dangerous and toxic levels to individuals.

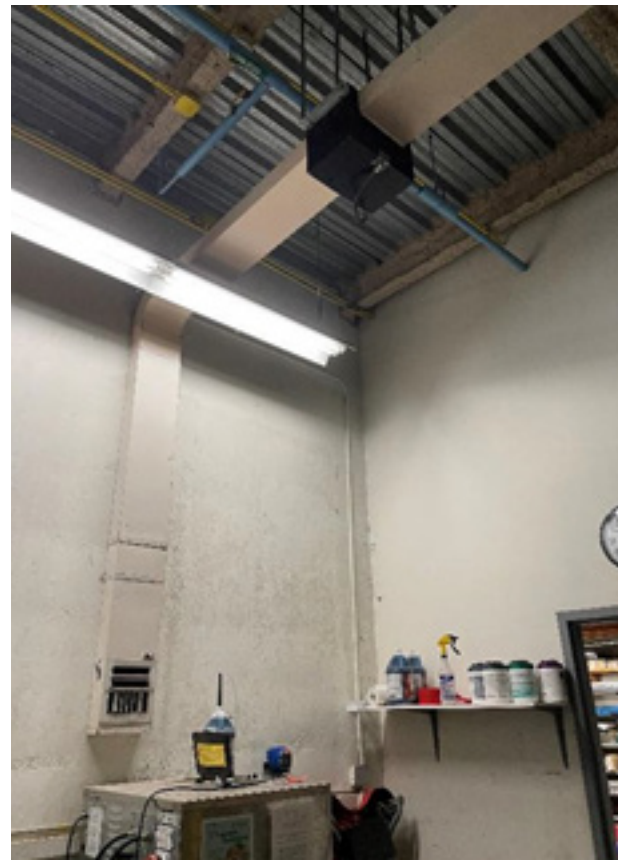
Washing Machine Area Exhaust Fan

3. Laundry Area Exhaust: The Gear Laundry area is provided with exhaust ductwork for the dryer and makeup air. This room does not have any general space exhaust which is recommended for the gear that is currently being stored in this room. The adjacent extractor/washing machine space is provided with an exhaust fan and grille mounted on the wall behind the equipment. CES did not verify the amount of airflow from this fan because of the location of the fan and the need for a flow hood.

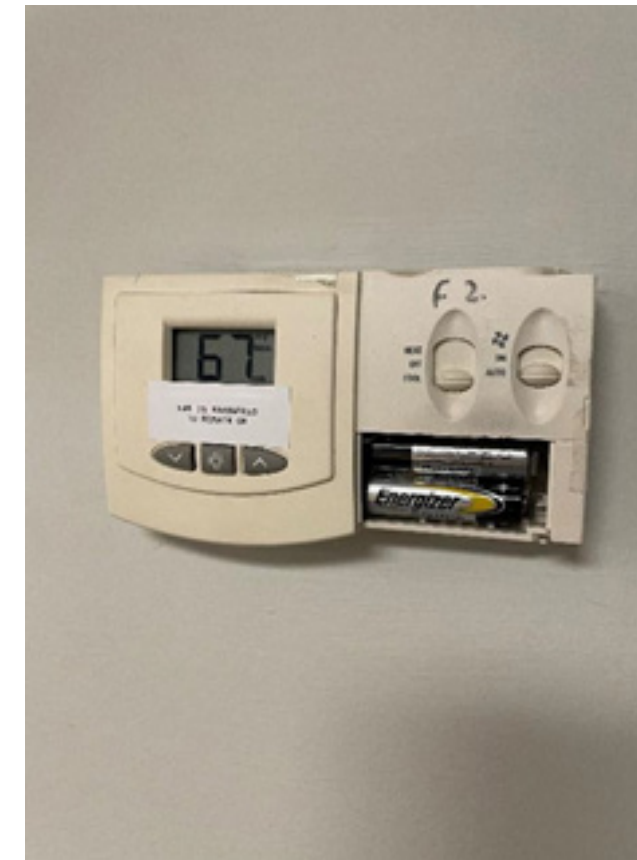
Existing Thermostat

1. Each furnace is provided with local thermostats in the space. There is currently no centralized building management system at the facility. Thermostats do not appear to have energy saving controls. It is recommended that these be replaced with programmable thermostats at a minimum. The ideal solution is to bring in a building management system (BMS) for the overall building for better control and energy efficiency.

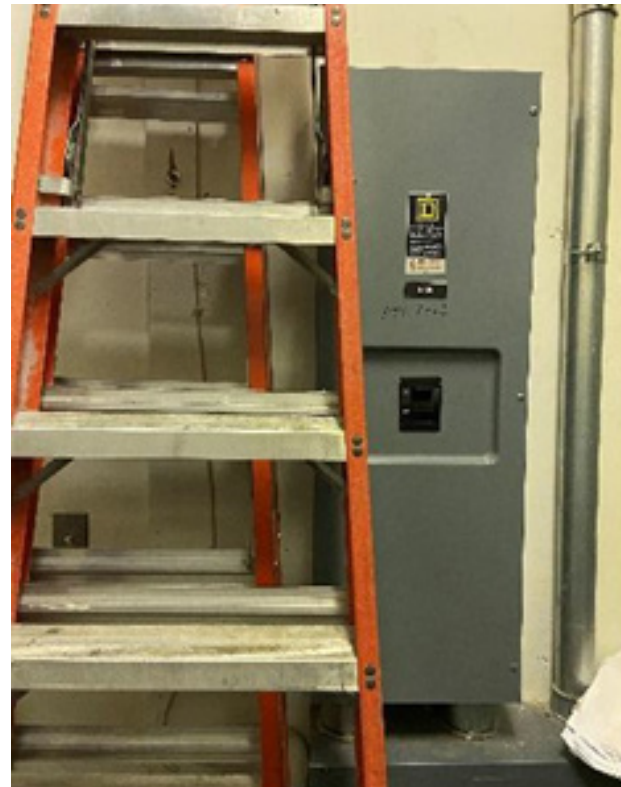
Electrical Service Equipment

1. Electrical Service: The existing electrical service is a 400 amp, 240/120volt, 1-phase, 3-wire service that consists of a main disconnect switch and distribution panelboards. The main disconnect switch is manufactured by Square D. The distribution panelboard is manufactured by Siemens/I-T-E. This equipment is in good condition. If the building is renovated or expanded, the current service size would not be adequate. It is recommended that a 3-phase service with higher amperage be brought to the building. Single phase power is not adequate for the electrical needs of a modern day fire station.

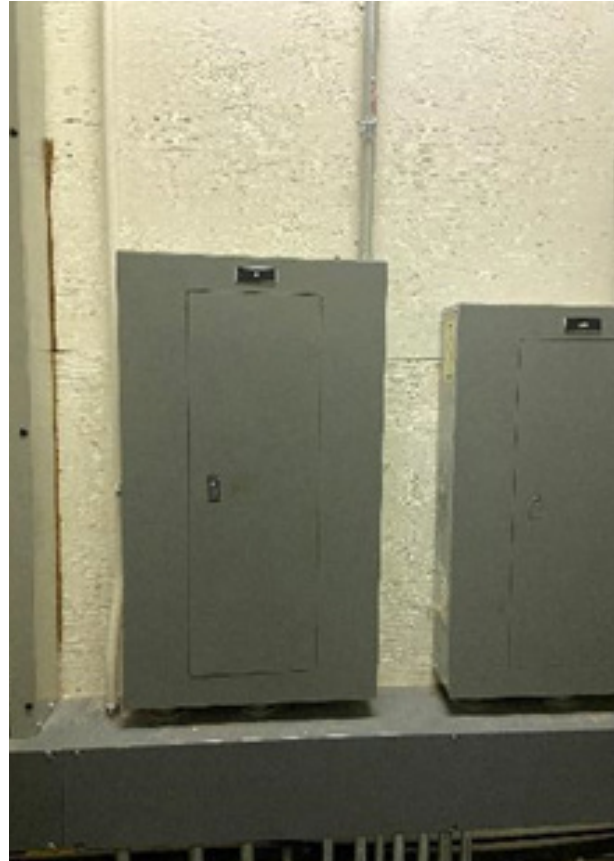
Older Electrical Panels

3. Panelboards: There are a number of branch circuit panelboards in the Main Electrical Room. These panelboards are original to the building and manufactured by Square D. There are missing blank-off plates in one panel. These original panelboards are in fair condition and have very limited spare capacity. There are also newer panelboards that were installed with the generator. These panels are manufactured by Siemens/I-T-E and are in good condition.

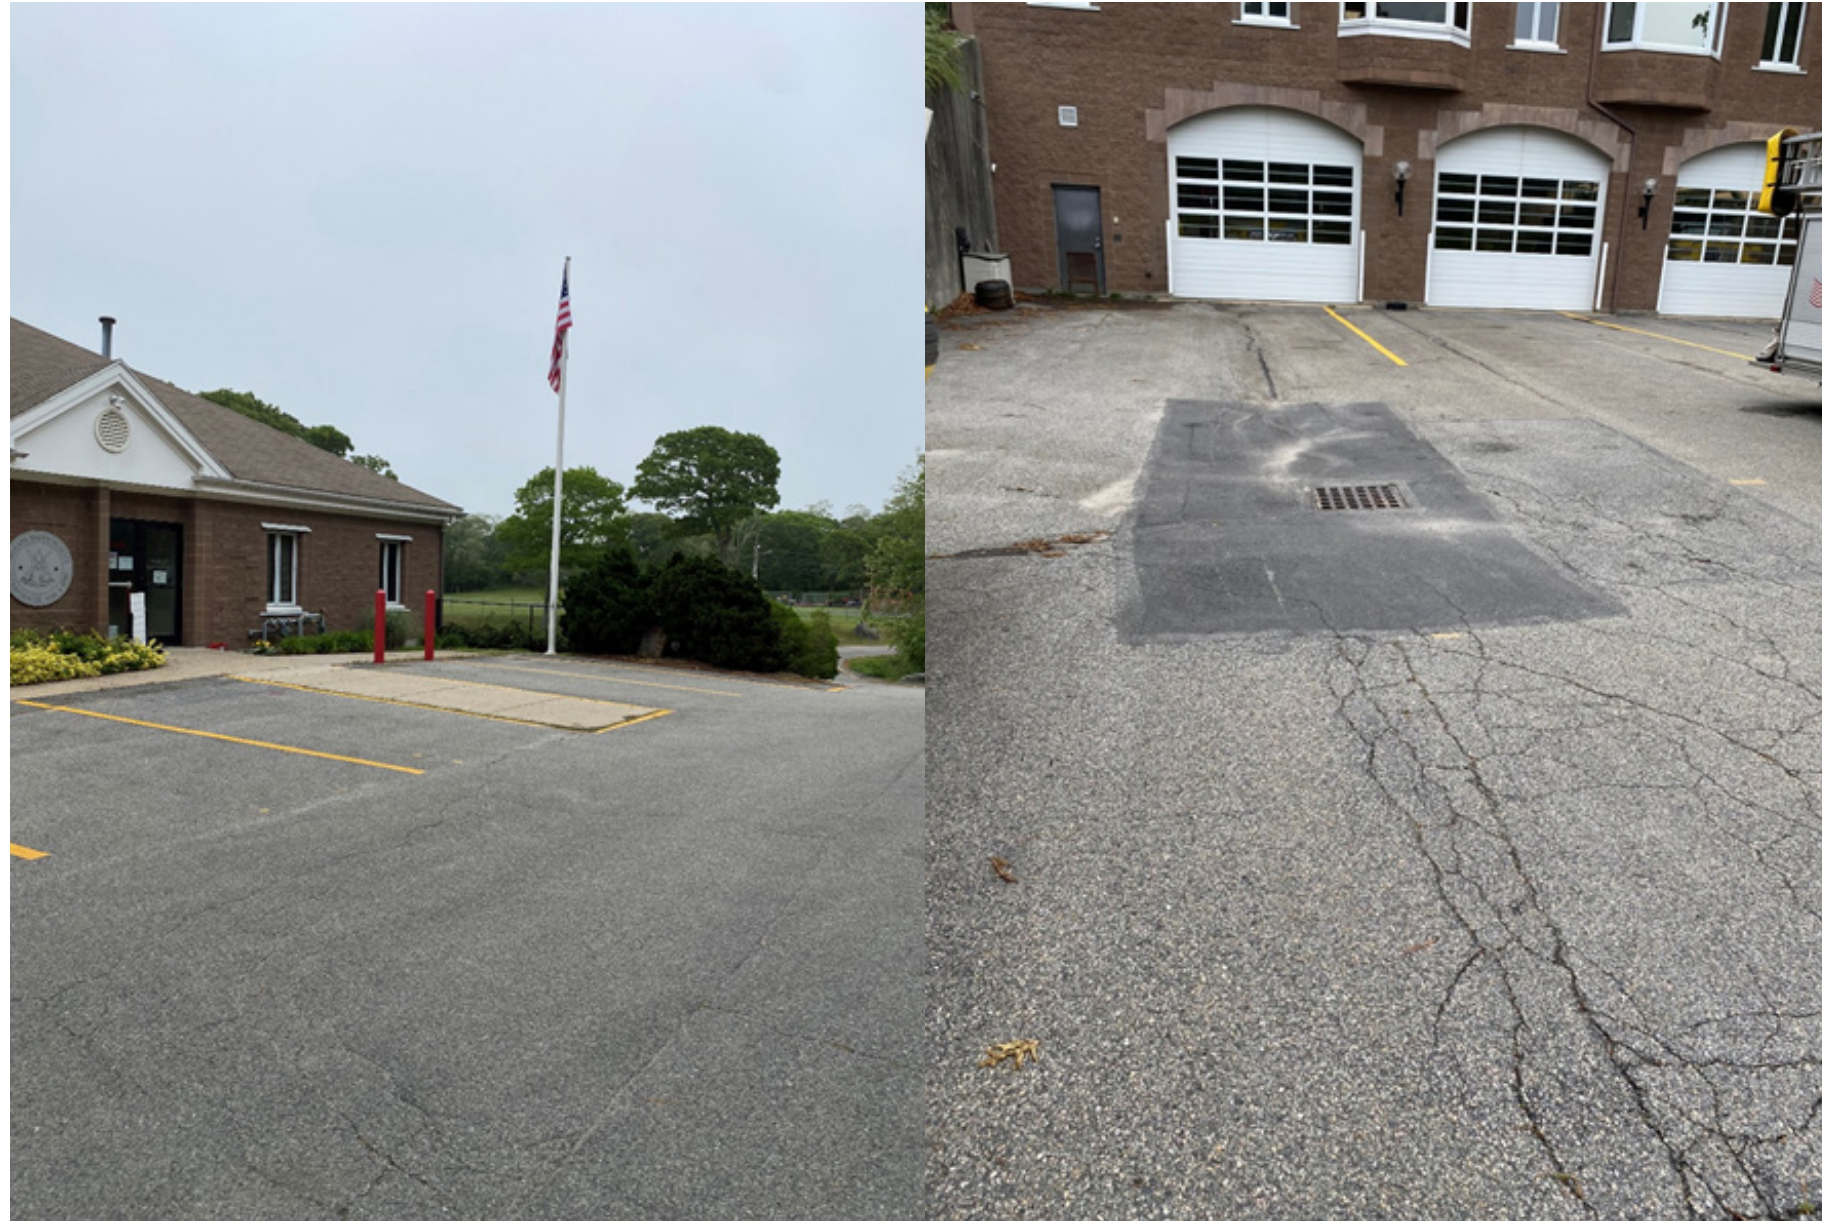
Figure 6: Existing asphalt conditions - Public entrance (left); Lower Apparatus Bays (right). Varying levels of pavement deterioration.
