Cedar Pond
Adaptive Management Monitoring Program:
Annual Technical Report
January 2021 to December 2021

FINAL REPORT

April 2022

Town of Orleans

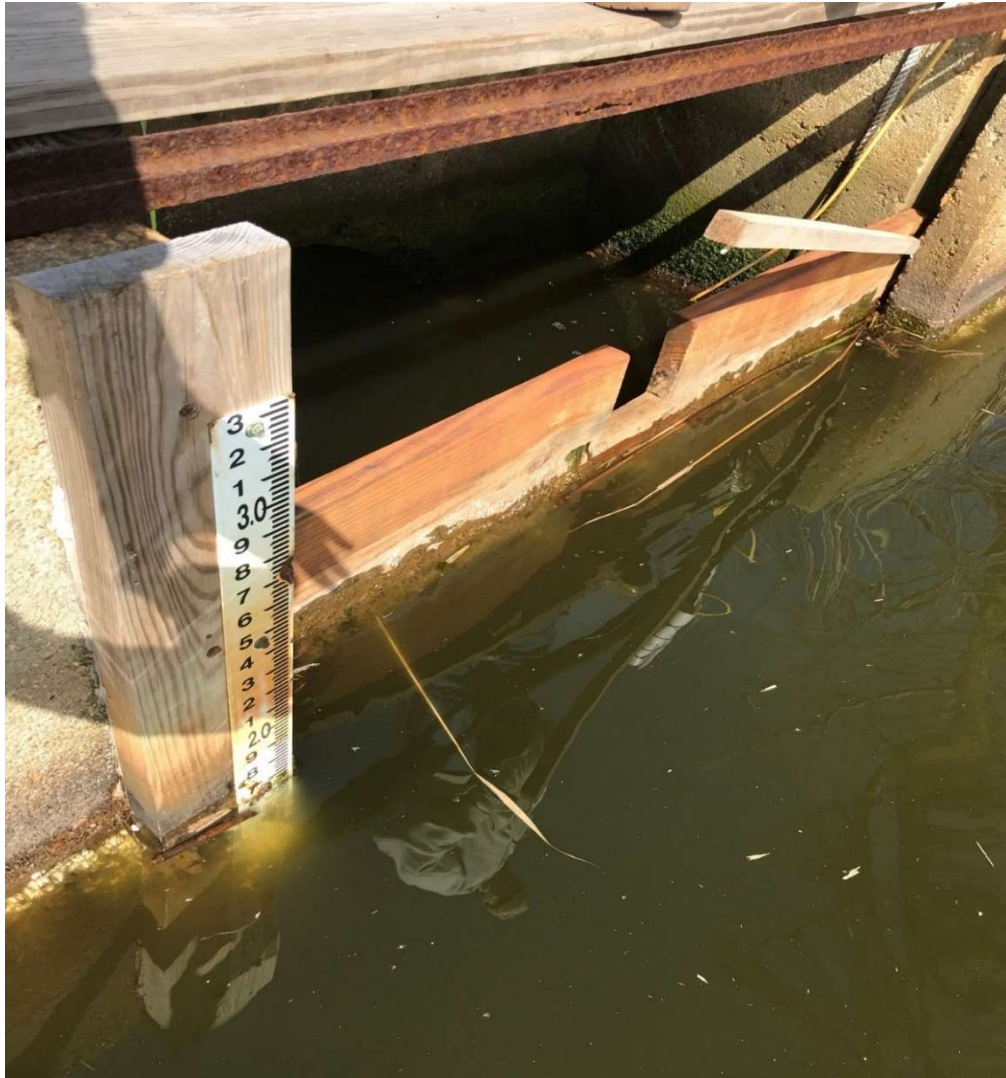
Figure III-1. Notched Board at Cedar Pond Outlet. After reviewing 2018 water levels at the outlet, Town, MassDMF, and CSP/SMAST staff agreed that the boards at the outlet could have a notch in the upper board to facilitate fish passage while also trying to limit the volume of high tides reaching Cedar Pond. Subsequent water level monitoring in 2019 showed this decreased salinity in the pond, but once it was added, salinity levels increased at the same rate as in 2018. 2020 monitoring suggested that the elevation of the bottom of the notch could be increased while also attaining similar frequency of water levels meeting the Fishway Plan goals. Notch elevations are adjusted according to Fishway Plan goals for 6 inches of water over the notch bottom in the spring for spawning herring immigration (March 15 to June 30) and 2 inches of water over the notch bottom in mid/late summer to allow young of the year emigration (July 1 to November 15). No herring have been observed during more than 81 visits from 2018 through 2021.

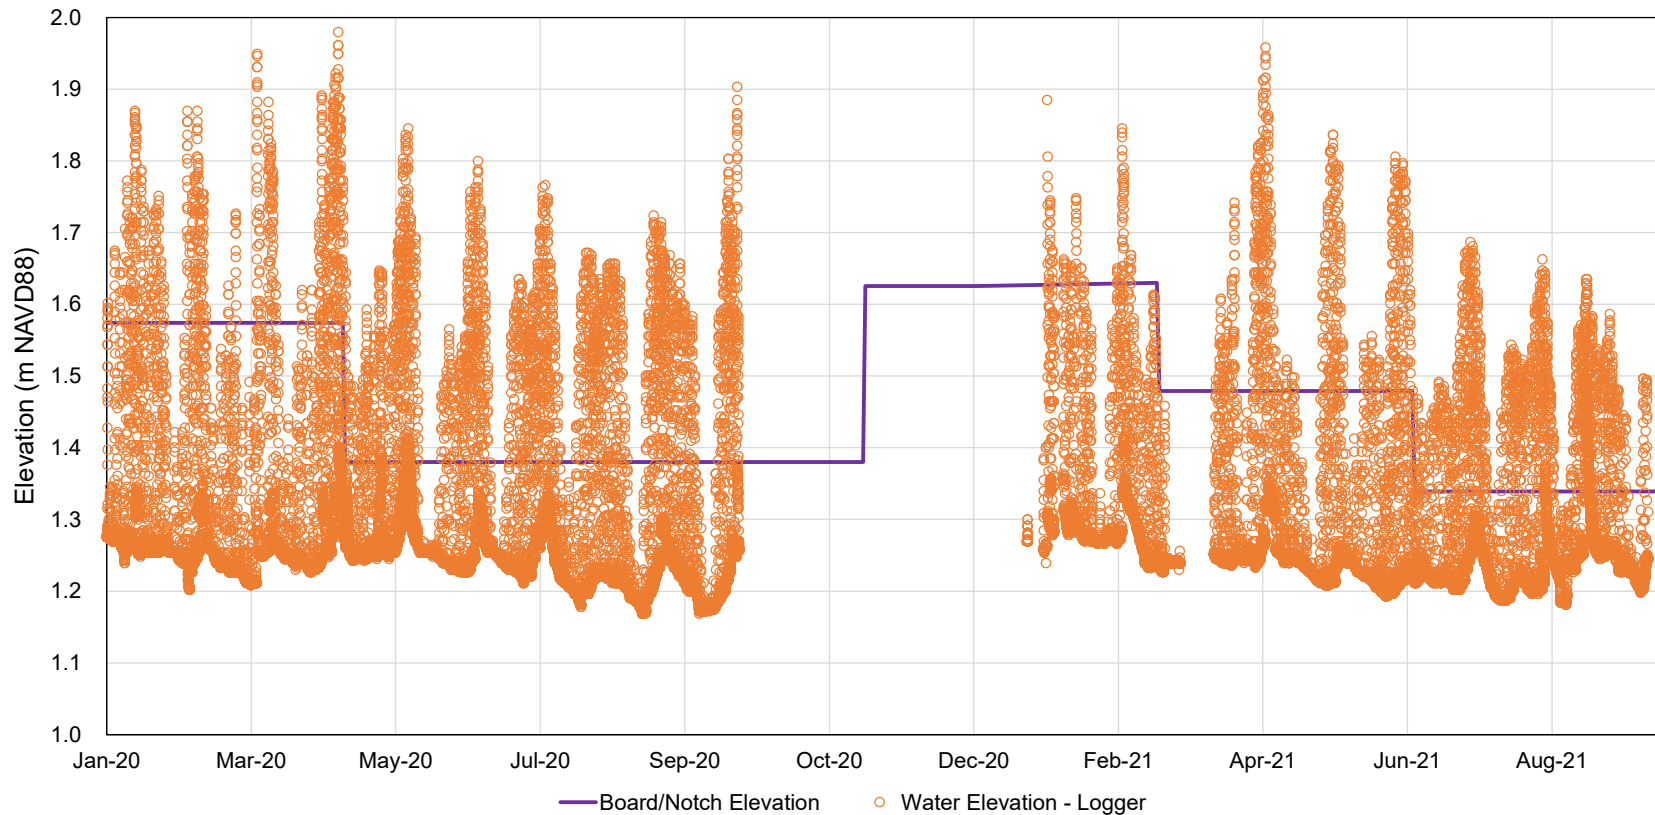
Figure III-2. Cedar Pond 2020-2021 Water Levels and Outlet Board Heights. CSP/SMASST staff installed an autonomous recording device programmed to record water levels every 10-15 minutes at the pond outlet on May 23, 2019 and the device has recorded through October 5, 2021 with occasional record gaps due to battery failures. As specified in the Fishway Plan, a notched board was added at the outlet around March 15 (3/17 in 2021) and maintained until July 1 with the goal of 6 inches of water above the bottom of the notch. On July 1, the notch elevation was adjusted with the goal of 2 inches of water above the bottom of the notch. Review of the water level records showed that in 2021, 3% of readings between 3/17 and 7/1 were 6 inches above the bottom of the notch. This is slightly lower than the 5% of readings in the same period in 2020. Water level readings between 7/1/21 and 10/5/21 were 2 inches above the bottom of the notch in 11% of the readings, which is slightly more frequent than in 2020 when 7% of the readings during this period had 2 inches or more. These two board adjustments are implemented to allow spawning herring to enter the pond and juvenile herring (spawn of the year) to leave the pond, respectively. No fish entering or exiting Cedar Pond have been noted during more than 80 visits to the outlet during 2018, 2019, 2020 and 2021 by CSP/SMASST and Town staff.

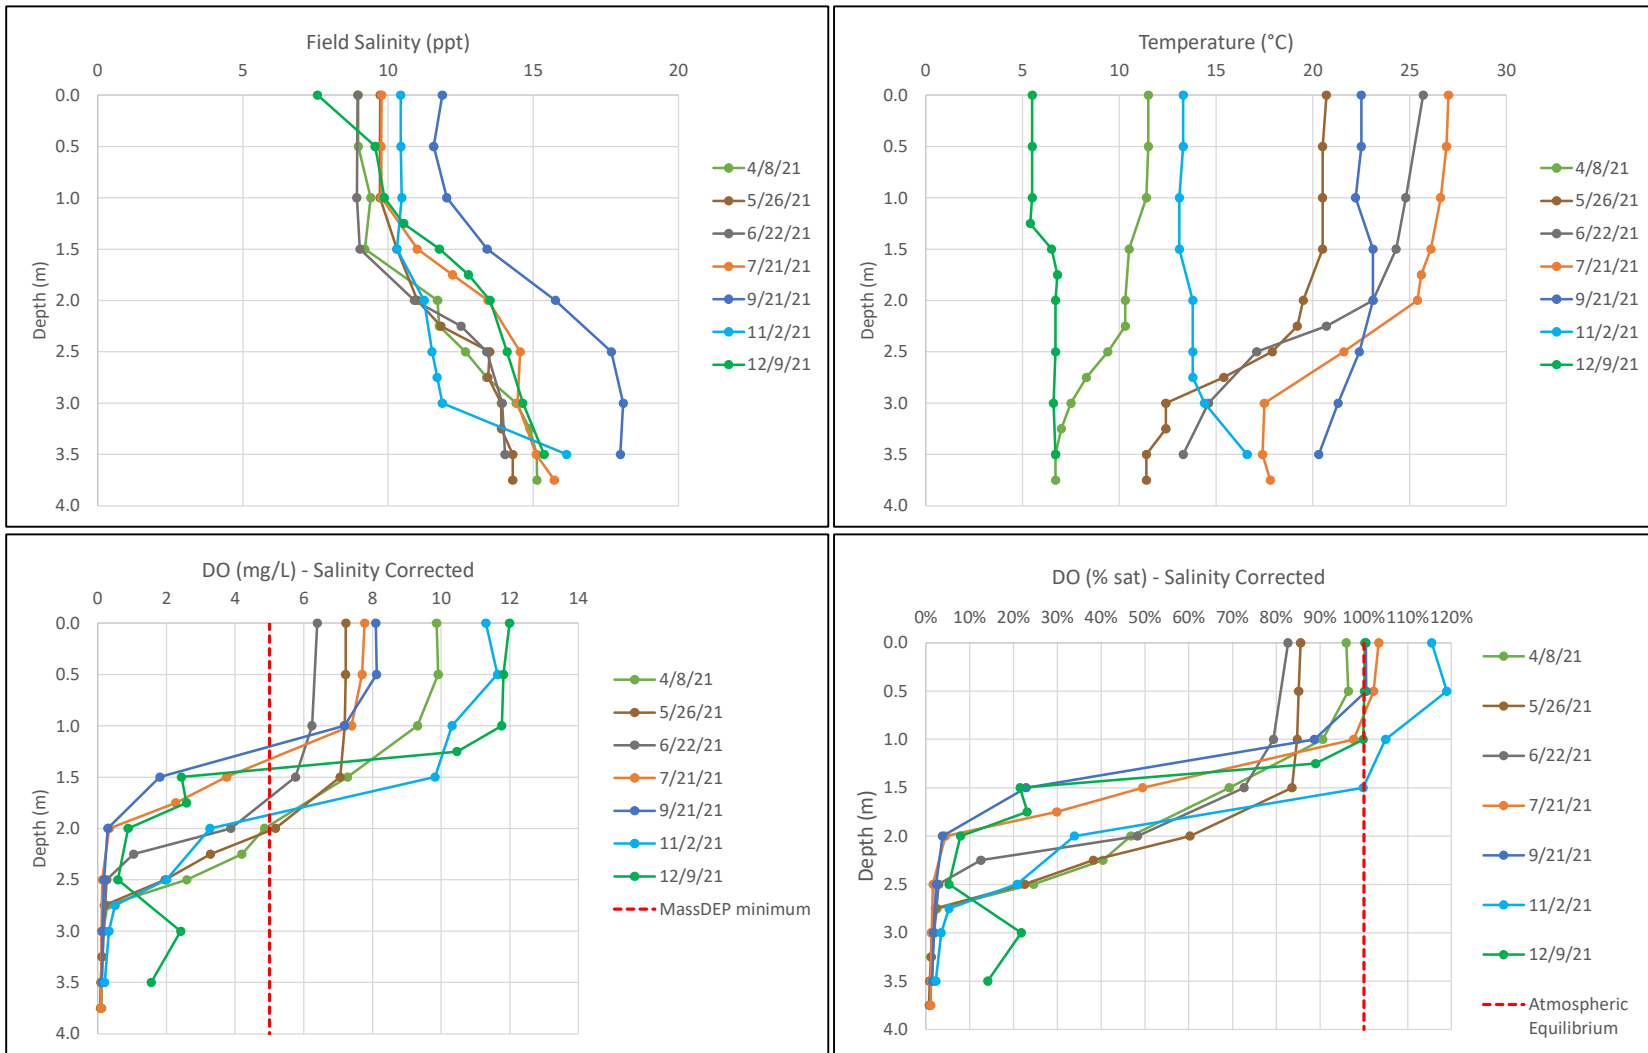
Figure III-3. Cedar Pond 2021 Salinity, Dissolved Oxygen, and Temperature Profiles. 2021 temperature profiles generally showed relatively isothermic conditions throughout the water column except for the May, June, and July profiles, which showed strong stratification deeper than 2 m depth. In contrast, salinity profiles showed isohaline concentrations to 1 m or 1.5 m depth. DO readings were generally consistent with this salinity stratification with similar, acceptable concentrations in the upper, well-mixed, lower salinity layer and hypoxic or anoxic concentrations in the higher salinity, deeper layer. Shallow 2021 DO readings were improved over 2018, 2019, and 2020 levels; none of the readings in the upper 1 m were less than the MassDEP minimum threshold for the first time in the four years of monitoring. Saturation levels showed, however, that sediment oxygen demand was impacting the shallowest waters in May and June and phytoplankton in early November created DO concentrations in excess of atmospheric equilibrium.

Salinity levels were similar from April through July, but the September 2021 shallow salinity was 11.9 ppt, while the September 2020 salinity was 15.8 ppt. Salinity in the subsequent 2021 profiles remained lower than 2020 (*e.g.*, 0.5 m salinity on December 9 was 9.6 ppt). However, none of the 2021 salinity profile readings were within the 1 to 4 ppt Cedar Pond Management Plan target range.

Salinity stratification seemed to be the key for the minimum depth of anoxia. Salinity concentrations shallower than 1 or 1.5 m depth (depending on the individual profile) were similar, which indicates well-mixed conditions. Well-mixed conditions mean regular atmospheric contact within this layer to replenish any diminished DO. Waters deeper than 2 m do not mix substantially into the upper layer because of the salinity difference and the sediment oxygen demand and organic matter decay in the water column consumes most of the deep DO creating anoxic conditions. The 2021 salinity pattern was similar to previous years. Although the individual profiles show strong salinity stratification, review of DO % saturation levels in the profiles show that waters in the well mixed shallow layer are often less than 100%, which shows that oxygen uptake in the deep waters was impacting the entire Cedar Pond water column even with the salinity stratification (see **Figure III-3**). This decreased % saturation throughout the water column is something that has been relatively consistent across all four years (**Figure III-4**).

Collectively, the 2021 profiles suggest that water column salinity differences mostly isolated portions of the water column at 1.5 m and deeper and this isolation led to hypoxia and anoxia in these deeper waters. If temperature alone controlled water column layering, low DO would be limited to depths 2.25 to 2.75 m and deeper. Lower salinity conditions in the upper 1 m led to acceptable DO concentrations (*i.e.*, were greater than the MassDEP minimum) in these shallow waters in all 2021 DO profiles for the first time in the four years of monitoring. DO conditions in the deeper water continue to experience anoxia and this anoxia regularly lowers DO concentrations in the upper water column as well.

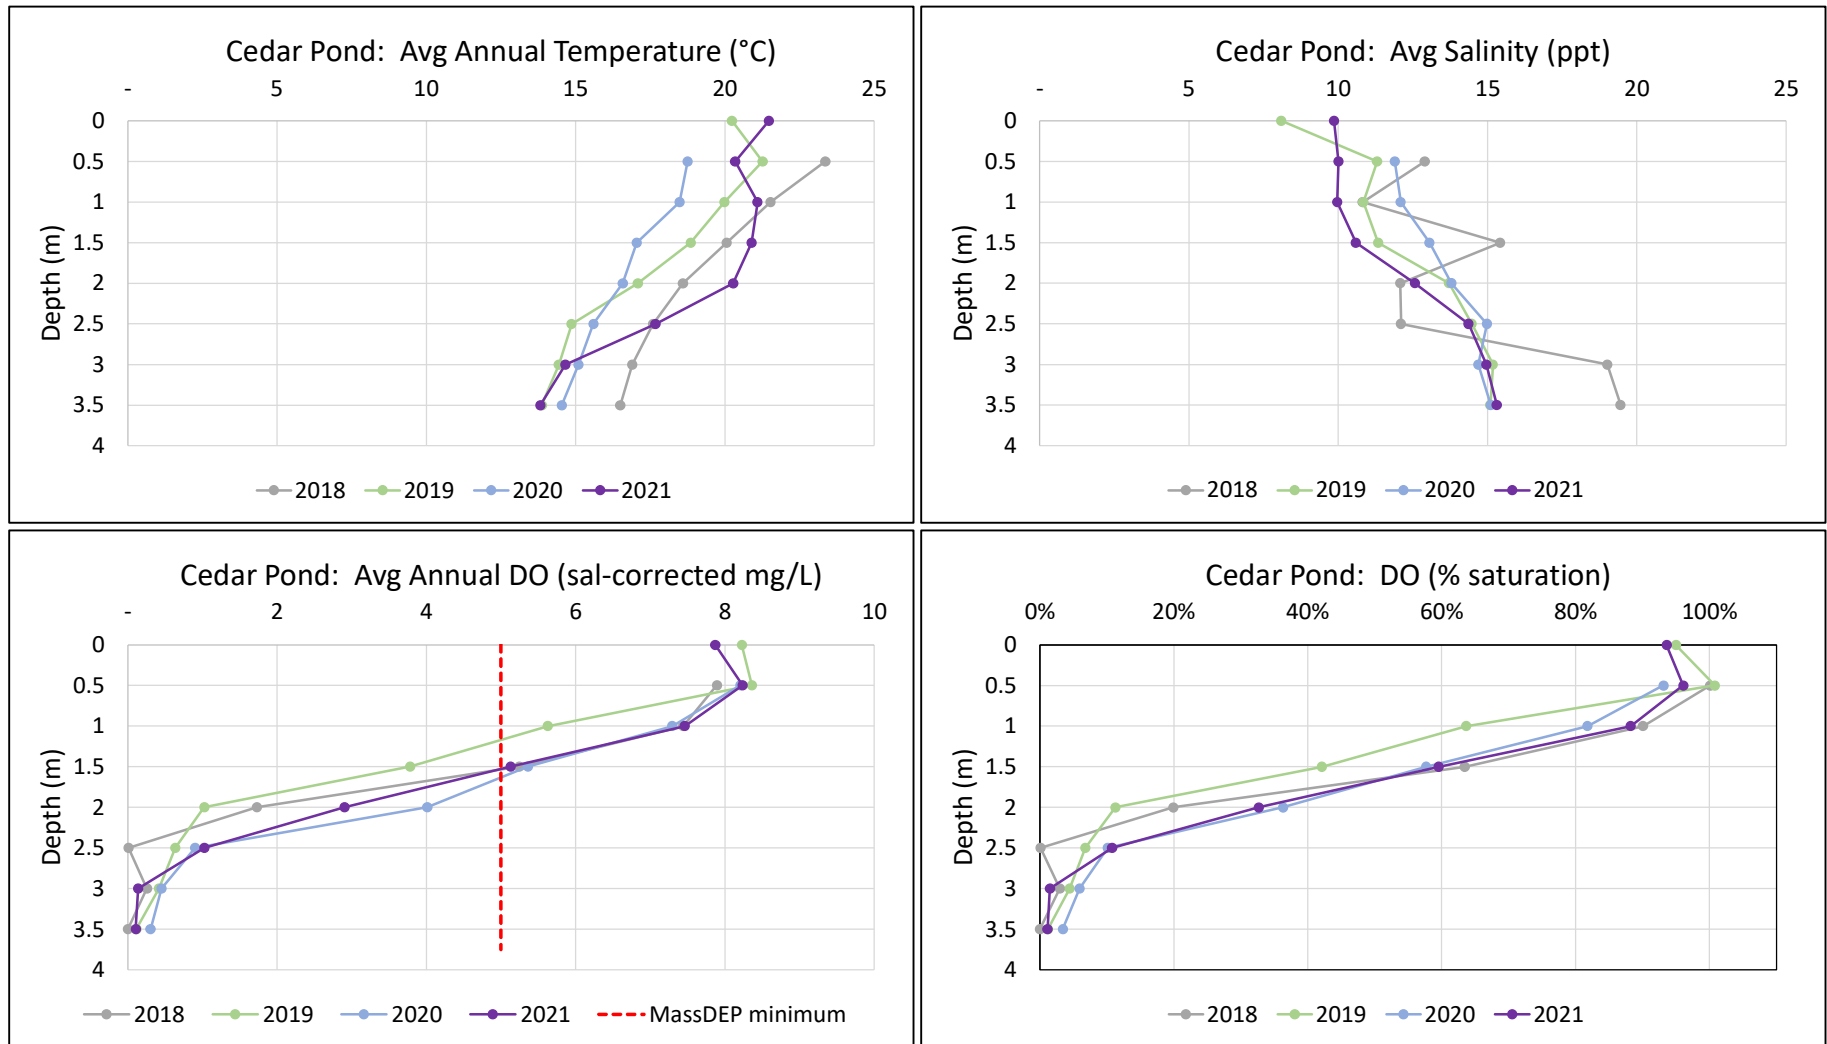
Figure III-4. Average 2018, 2019, 2020, and 2021 Water Column Temperature, Salinity, Dissolved Oxygen, and DO % Saturation (April to October). Comparison of water column profile data showed that 2019, 2020, and 2021 generally had similar conditions in the deep portions of the water column (≥ 2.5 m) with lower deep temperatures and salinity than 2018. Shallow 2021 waters were warmer than 2020, but generally had lower salinity, and slightly higher DO concentrations. Average 2021 DO concentrations from the surface to 1.5 m were above the MassDEP 5 mg/L minimum and average salinities in these waters were the lowest among the four years. DO % saturation levels generally show that average sediment oxygen demand impacts the whole water column with average saturation at all depths below 100% (*i.e.*, atmospheric equilibrium). Overall, 2021 slightly increased the improved shallow DO concentrations achieved in 2020, but waters deeper than 1.5 m continued to be impaired and higher in salinity.

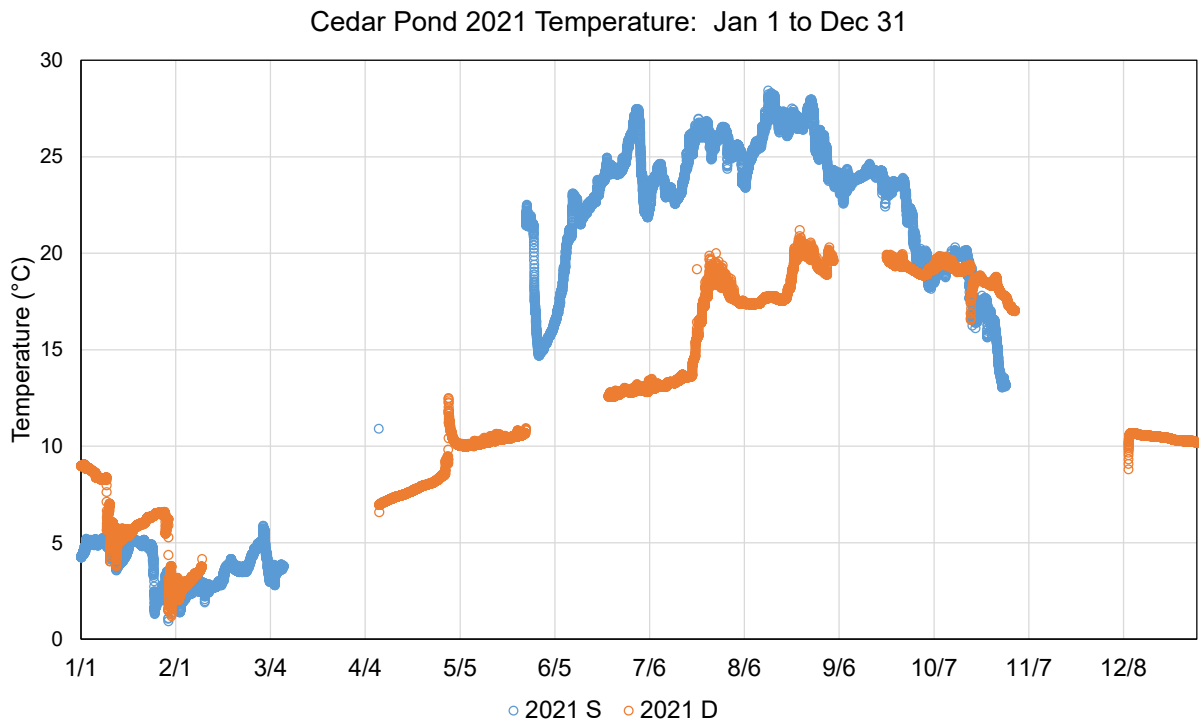
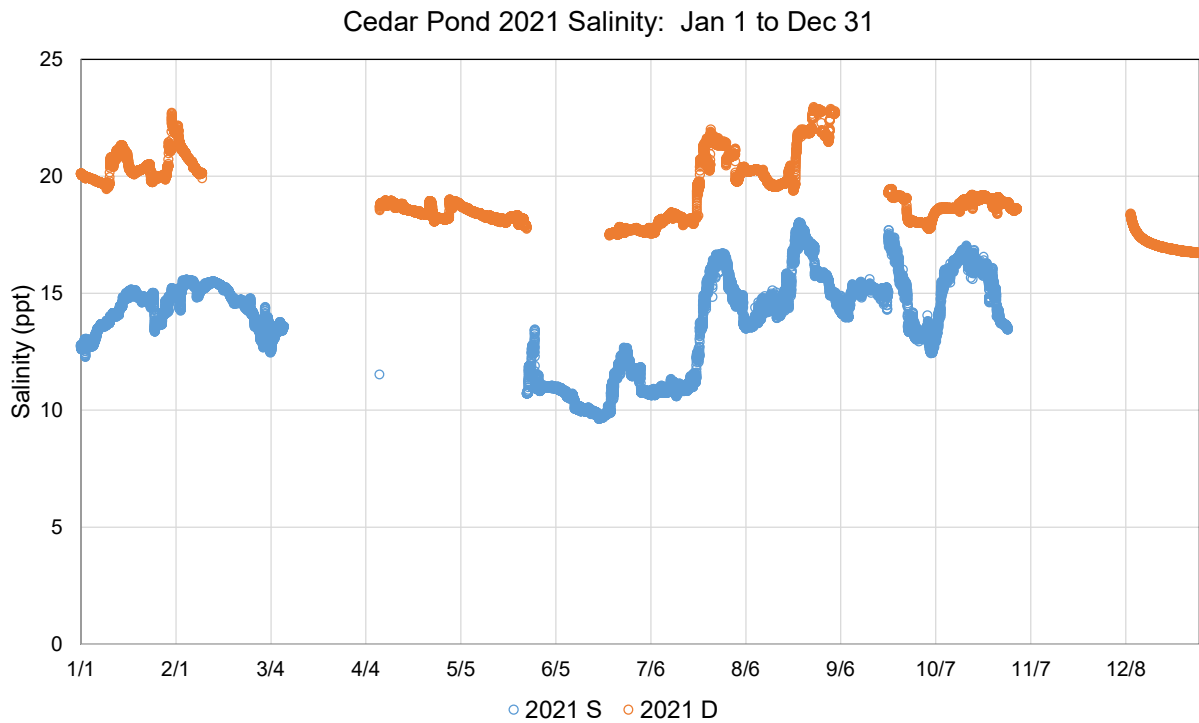
Salinity differences were sufficiently different in all 2021 continuous readings to prevent mixing between the 1.2 m and 3.6 m depths throughout the year. Average summer 2021 salinities were comparable to 2020 with slightly lower surface salinity in June/July 2021, but slightly higher surface salinity in August/September 2021. Average shallow and deep summer salinity levels in 2021 generally approximated those in both 2019 and 2020, while all three years were notably lower than in 2018. Salinity levels are a complex mix of current and previous months tidal and watershed groundwater inputs. Groundwater levels in June, July, and August 2021 were below average and notably less than during 2020 (**Figure III-6**). At the same time, higher tidal elevations occurred more often in July to September 2021 (see **Figure III-2**). Lower groundwater inputs and greater tidal inputs would tend to increase salinity levels, which was notable in late summer averages (see **Table III-2**).

Figure III-5. Cedar Pond 2021 Continuous Temperature and Salinity Readings. Continuous recorders located in the main basin at averages depths of 1.2 m and 3.6 m recorded temperature and salinity readings every 15 minutes. Gaps in the record were caused by recorder failure. Shallow and deep temperatures were sufficiently different during June, July, August and most of September to prevent mixing of the water column between the two depths. Similar differences occurred in January and late October, but deep temperatures were warmer than shallow temperatures during these periods. Salinity differences were sufficiently different in all 2021 readings to prevent mixing between the upper and lower water column.

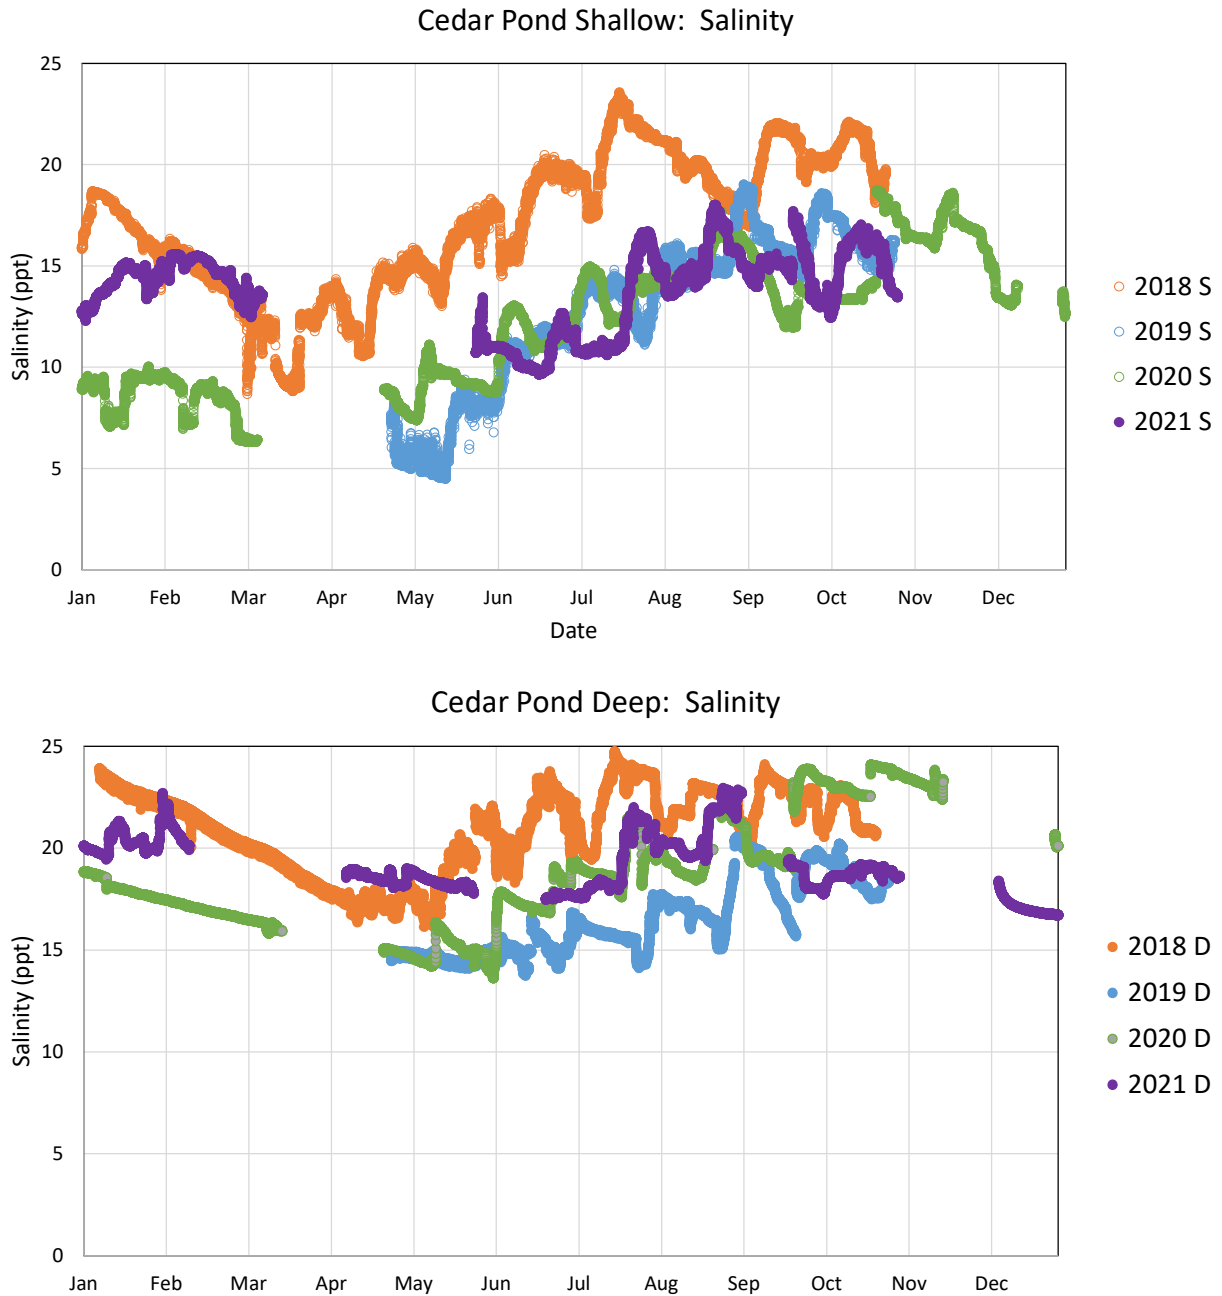
Review of salinity readings in 2018, 2019, 2020, and 2021 show that the lowering of the boards regularly causes both shallow and deep water salinities to increase throughout the summer and review of the rate increases show that they are similar every year (**Figure III-8**). In June to August 2021, shallow salinity levels increased at a statistically significant rate of 0.08 ppt per day. This rate is within the same range of salinity increases measured in 2018 and 2020: 0.06 to 0.09 ppt per day.³⁵ This increasing rate occurs each year during the period when board elevations are lowered to allow fish passage: March 15 to November 15. The consistency of this annual salinity increase shows that once boards are lowered, higher salinity tidal inputs have a larger impact on water column salinity levels than can be offset by fresh groundwater inputs. Having lower tidal inputs, especially during the summer is the key to achieving the lower salinity goals specified in the Cedar Pond Management Plan for achieving water quality improvements.

Figure III-8. Continuous Shallow and Deep Salinity at Cedar Pond (2018 – 2021). Salinity readings show that the lowering of the boards during the summer regularly causes both shallow and deep salinity to increase. Shallow salinity levels in all four years increased at approximately the same rate (0.06 to 0.09 ppt per day) between April/May and August once the inlet boards are lowered. Deep salinity readings generally follow a similar pattern, though the rate of change is lower. Since the rate of change is similar in all four years, the early summer starting salinity is a key factor determining salinity throughout the summer and shows that lowering board elevations essentially resets the pond to higher salinity levels every summer. This finding suggests that boards should be kept at a relatively high elevation between November 15 and the installation of the notch in March 15 in order to sustain lower salinity readings throughout the summer. It also suggests that alternative board configurations should be explored in order to attain the lower salinity levels recommended to improve water quality and establish a herring run.

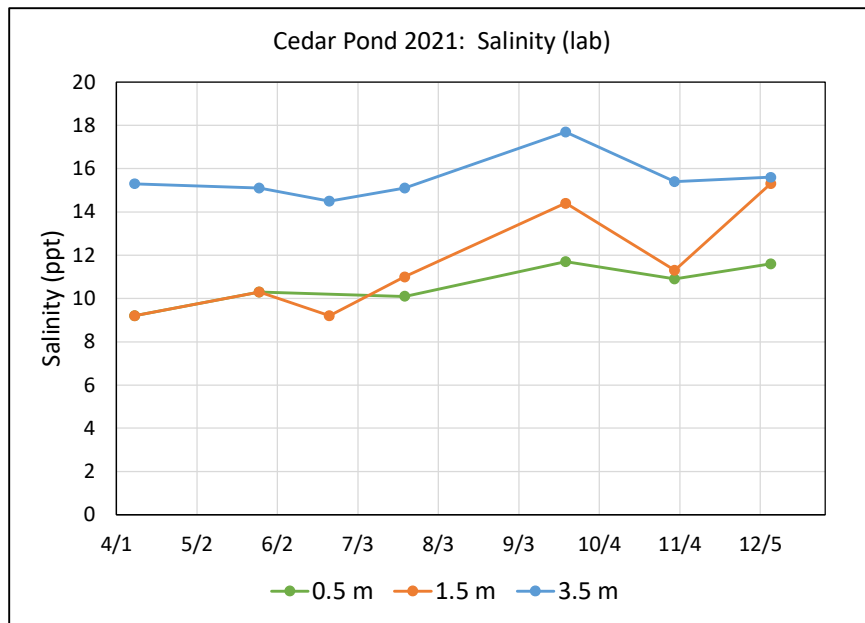
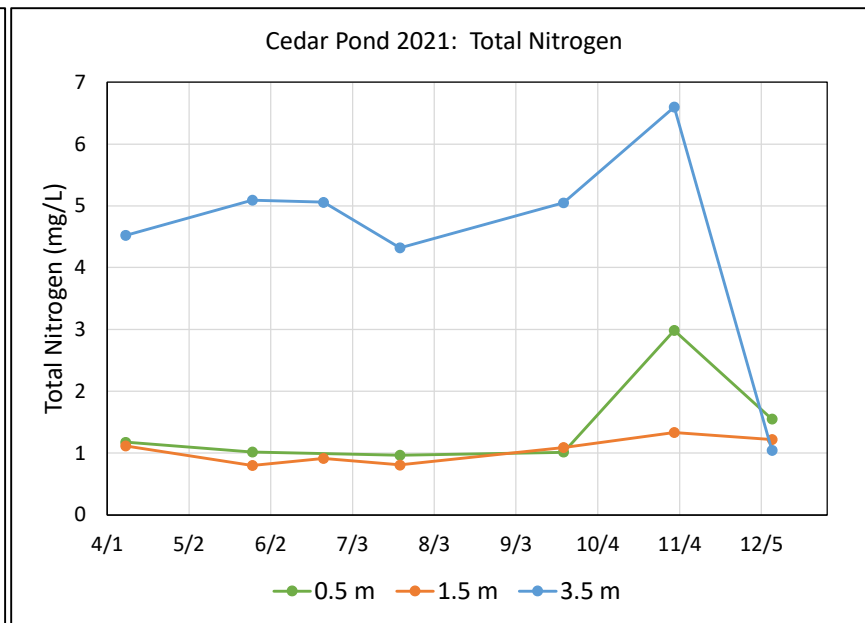
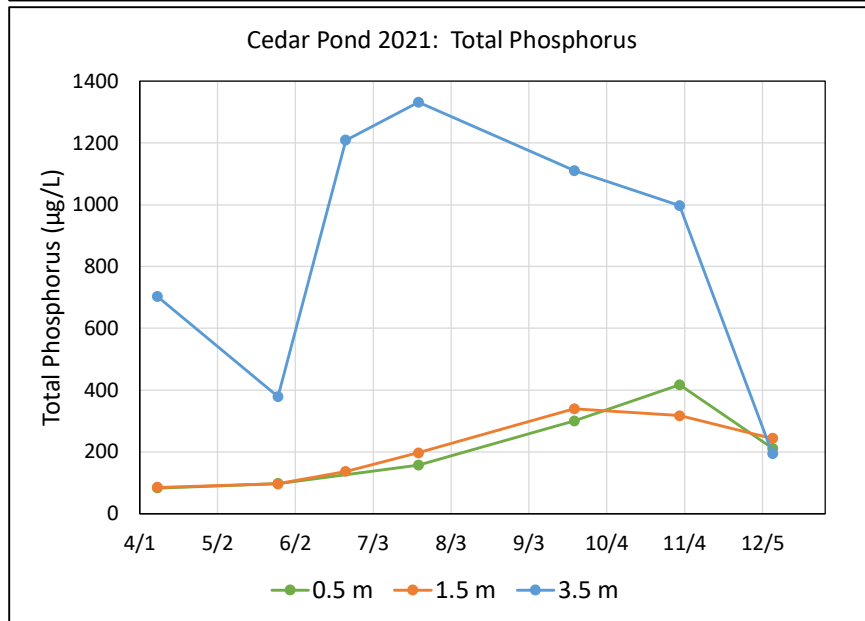
Figure III-9. Cedar Pond 2021 Water Column Salinity, TP, and TN. Shallow and deep 2021 salinity readings did not increase like previous years (to >20 ppt), although continuous readings did show an increase. TN concentrations at 0.5 m and 1.5 m were relatively consistent (~1 mg/L), while 3.5 m was significantly higher with an average of 4.8 mg/L. TP concentrations at 0.5 m and 1.5 m increased through at least September, while 3.5 m TP averaged >5X higher. Significantly higher deep TP and TN concentrations ($p < 0.05$; T test) were likely due to strong salinity stratification and uninterrupted deep anoxia. N:P ratios were not significantly different at all depths averaging 19, 16, and 14 at 0.5 m, 1.5 m, and 3.5 m, respectively. N:P ratios in individual profiles were phosphorus sensitive in April (*i.e.*, ~30), decreased to co-nitrogen and phosphorus sensitivity in May and June, and were then nitrogen sensitive (<16) throughout the rest of 2021 samples.

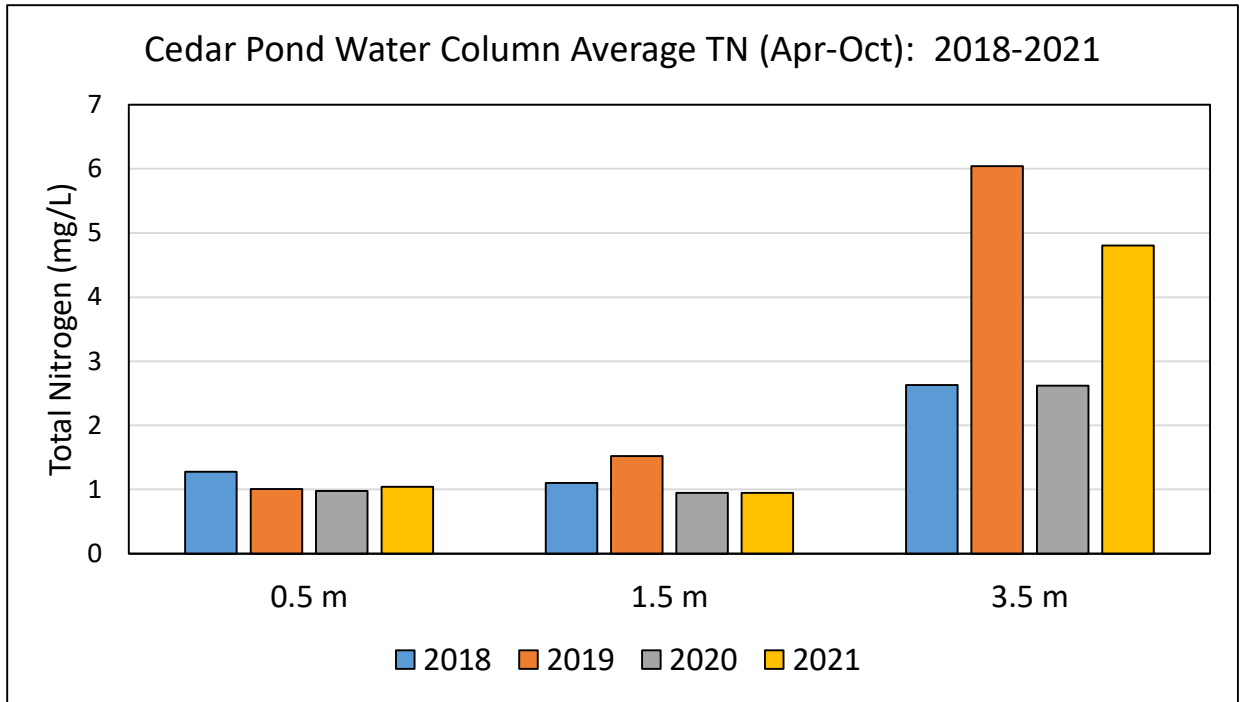
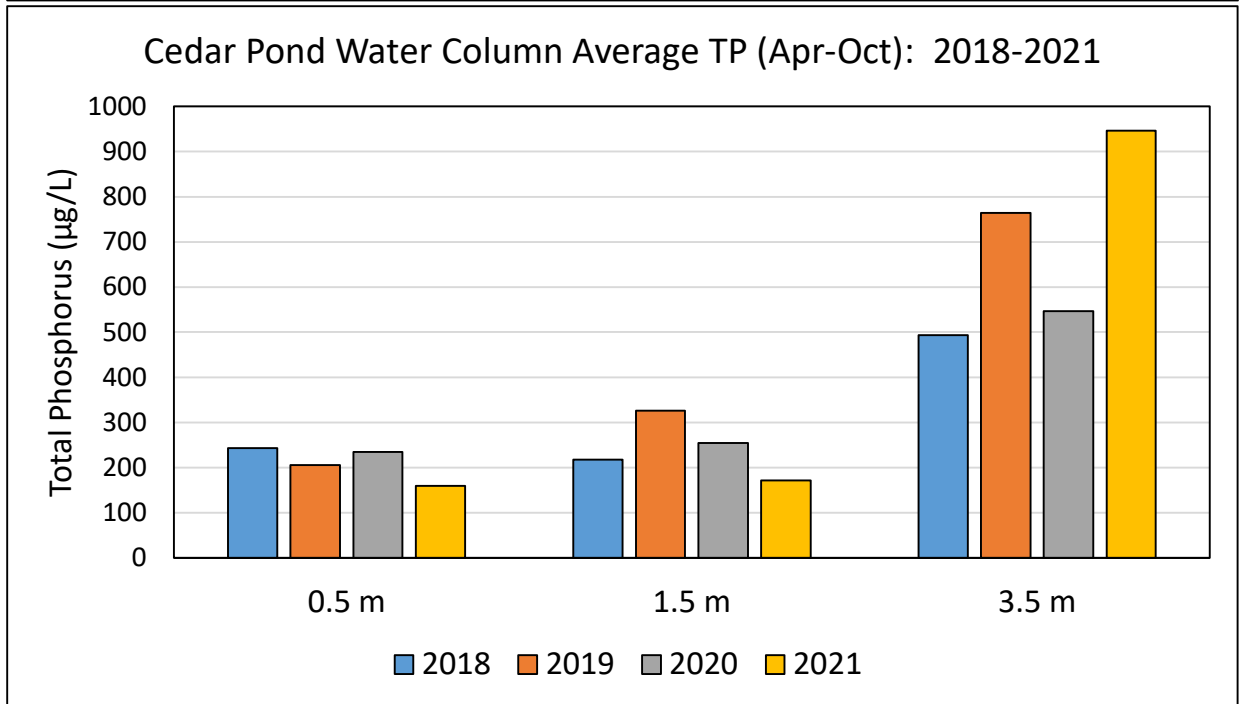
Figure III-10. Cedar Pond Average Water Column TN and TP (April-October): 2018-2021. Average TN concentrations at 0.5 m have been relatively consistent since 2019 (~1 mg/L), while average 1.5 m TN concentrations have been consistent since 2020 (~0.9 mg/L). Average 0.5 m and 1.5 m 2021 TP concentrations decreased significantly compared to 2020 (-32% and -33%, respectively). Deep 3.5 m TN and TP increased notably compared to 2020, likely due to stronger salinity stratification and resulting more consistent anoxia.

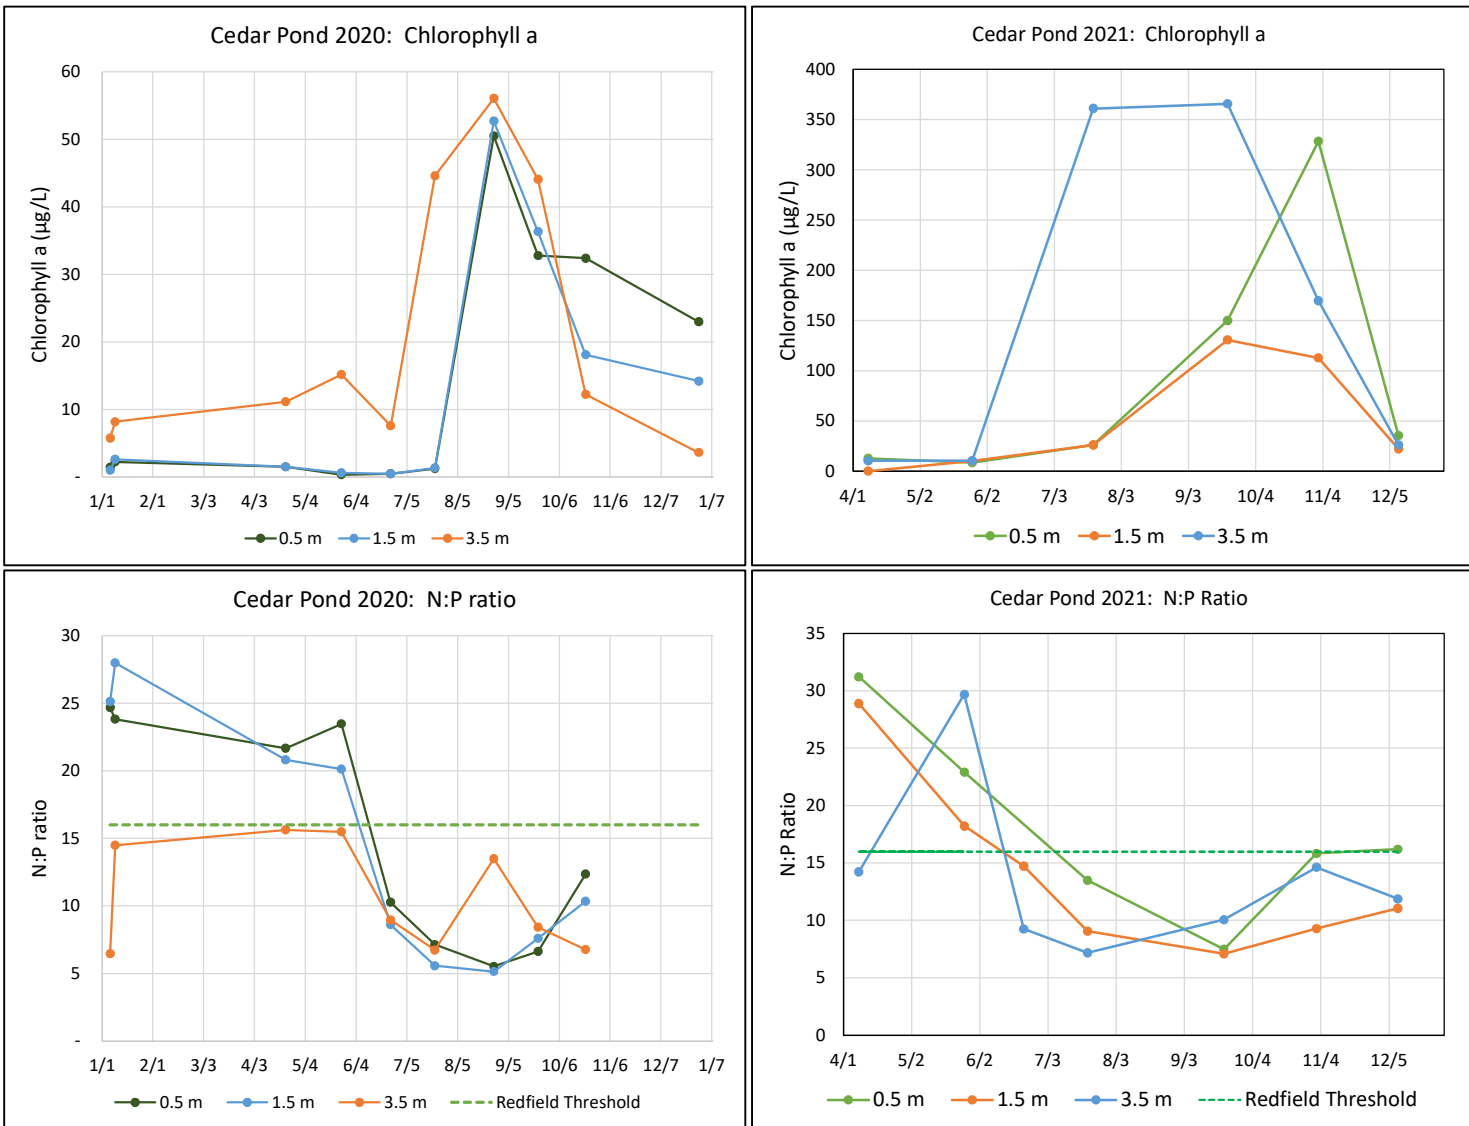
Figure III-11. Cedar Pond 2020 and 2021 Water Column Chlorophyll and N:P ratios. 2021 chlorophyll a concentrations were notably higher throughout the water column than 2020. Increases in chlorophyll a concentrations during the summer in both years corresponded to the increase in salinity (*i.e.*, the lowering of the boards at the outlet) and greater sensitivity to nitrogen. N:P ratio had similar profiles in 2020 and 2021, although 2021 ratios during the summer were slightly higher. N:P ratios during the summer in both years show that nitrogen availability determines water quality and ecosystem conditions.

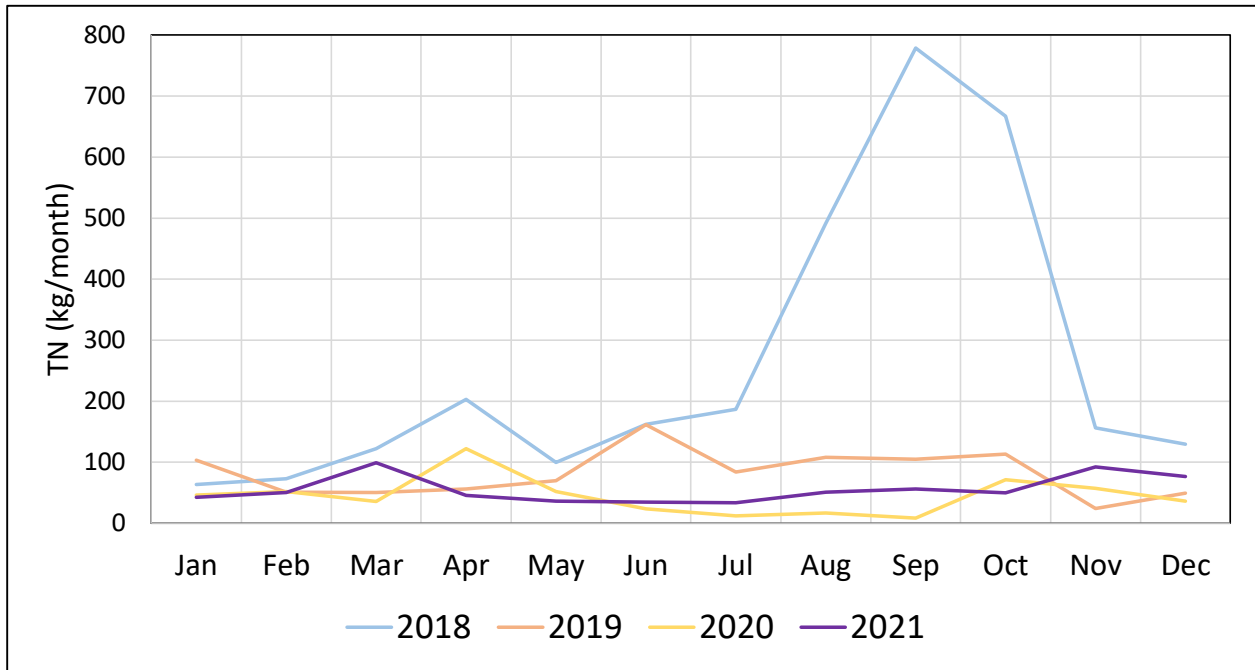
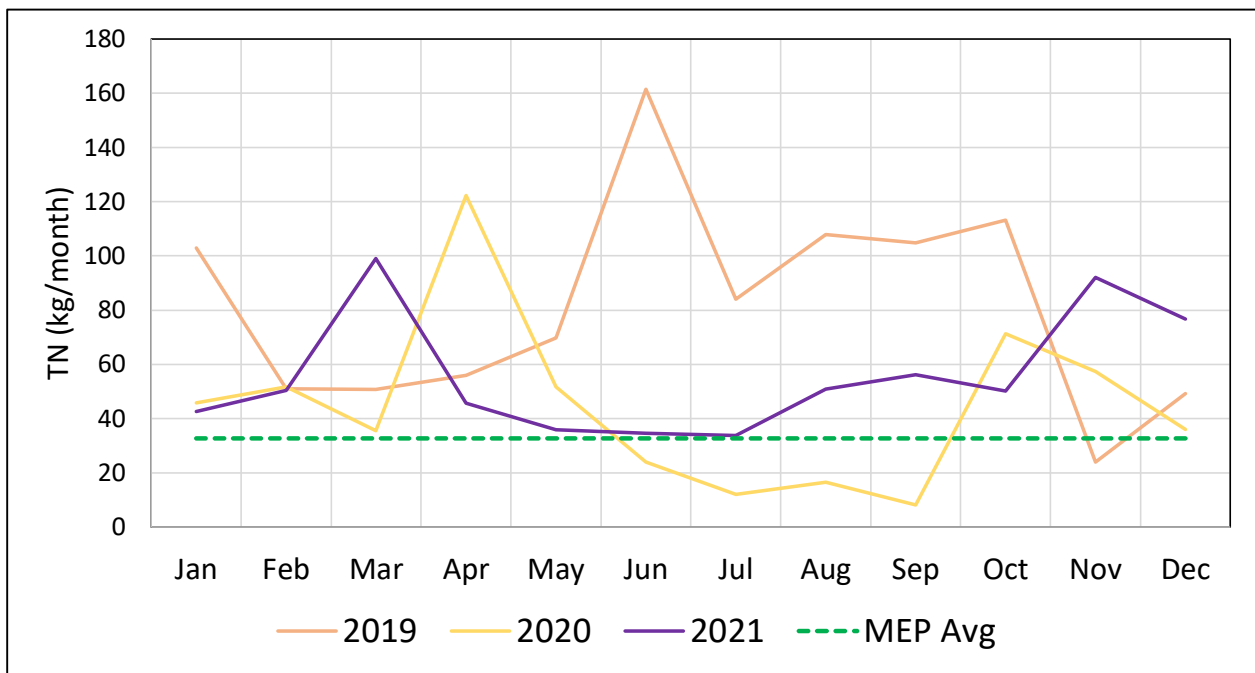
Figure III-14. Average Monthly Total Nitrogen Outflow through Cedar Pond outlet (2018-2021). Average monthly TN outflow in 2021 was not significantly different from 2020, but both years were significantly less ($p < 0.05$, T test) than 2019, which in turn was significantly less than 2018. The lack of significant difference between 2020 and 2021 even with the exceptionally high September 2021 outflow shows that the on-going water quality improvements in Cedar Pond are robust even with slightly increased outflow. TN export in May, June, and July 2021 approximated export measured in 2002/03 for the MEP assessment of Rock Harbor.

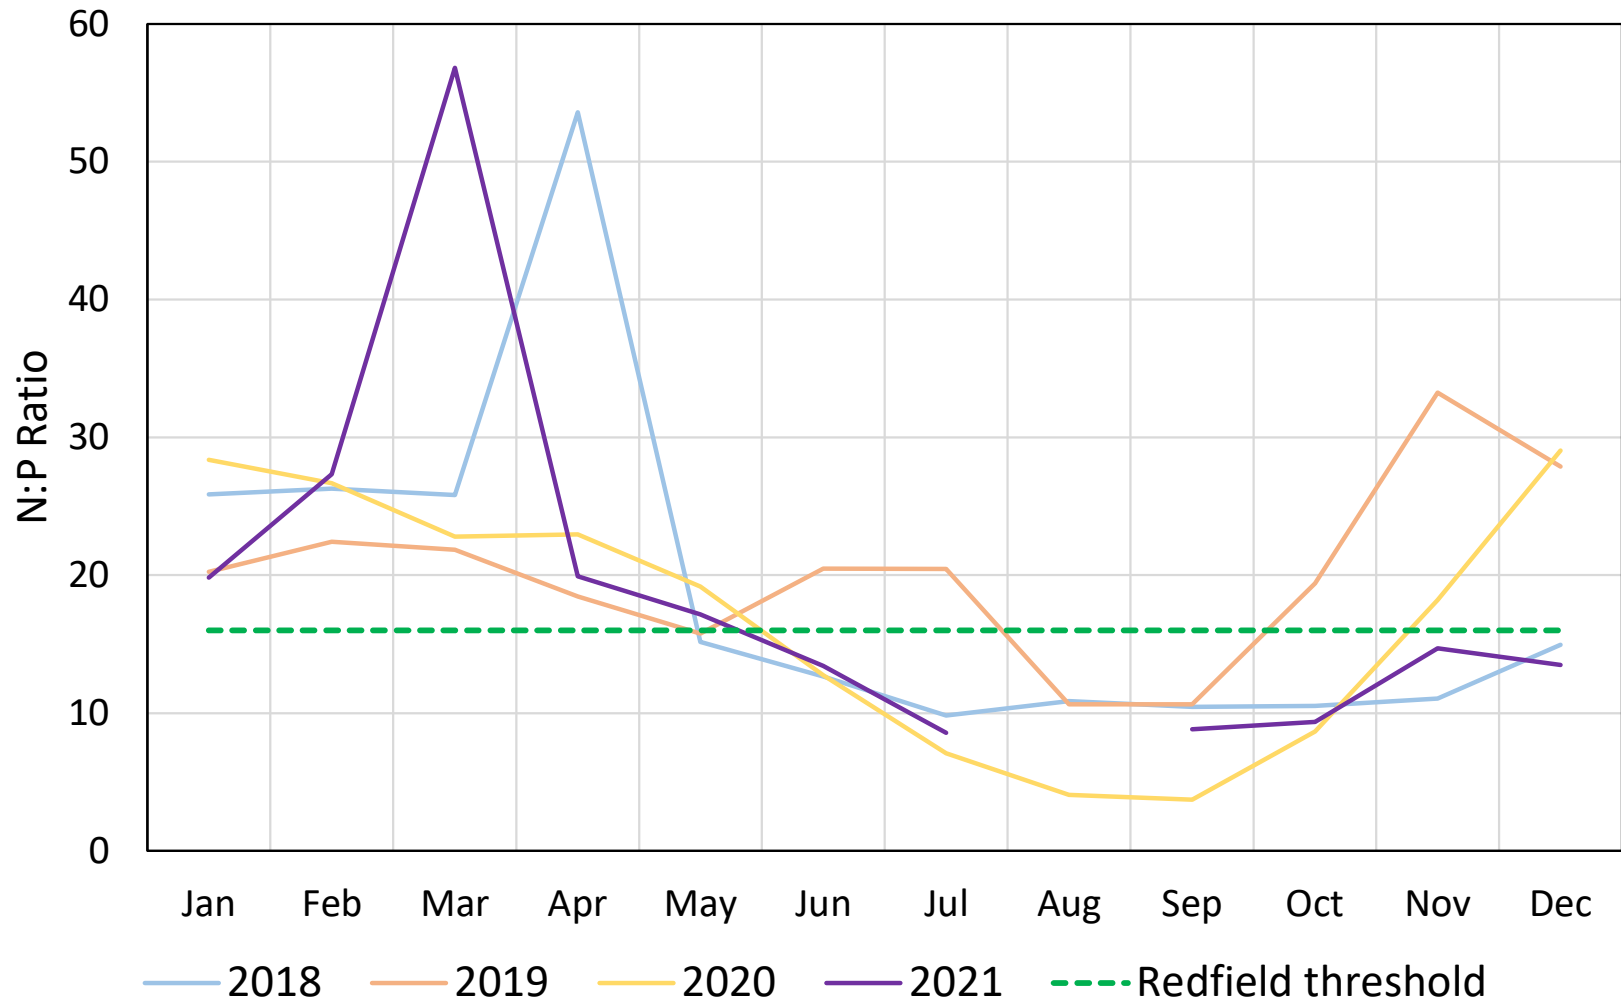
Figure III-15. Average N:P ratios in Cedar Pond Creek (2018-2021). Comparison of TN and TP concentrations showed that the nutrient controlling water quality conditions in near surface pond water and the downstream creek changed throughout the year. N:P ratios typically showed that both N and P determined water quality conditions in January through April (*i.e.*, N:P ratios above 16, but less than 32). Spikes in ratios in March in 2021 and April in 2018 show that occasionally phosphorus was the controlling nutrient, but nitrogen was consistently the key nutrient during summer months.
