Orleans Town-Wide Preliminary Stormwater Assessment

Town of Orleans, MA

Town of Orleans: Preliminary Town-Wide Stormwater Assessment

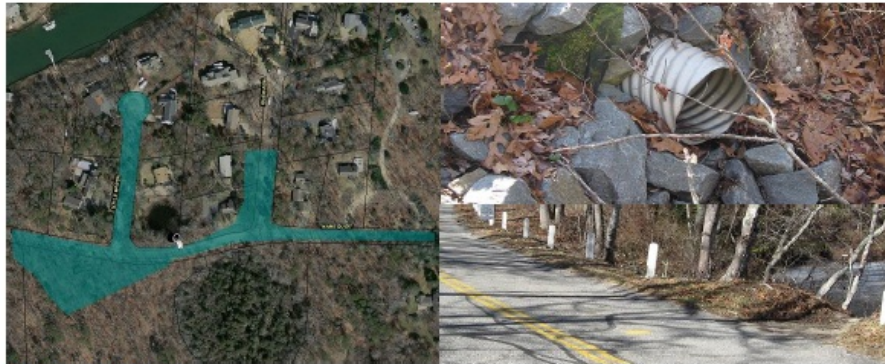
Seasonal residential with average 1/2 acre lots. Majority of runoff from Namequit Road and some from Little Marsh lane.

Abandoned outfall or old culvert observed near 69-OUT-1

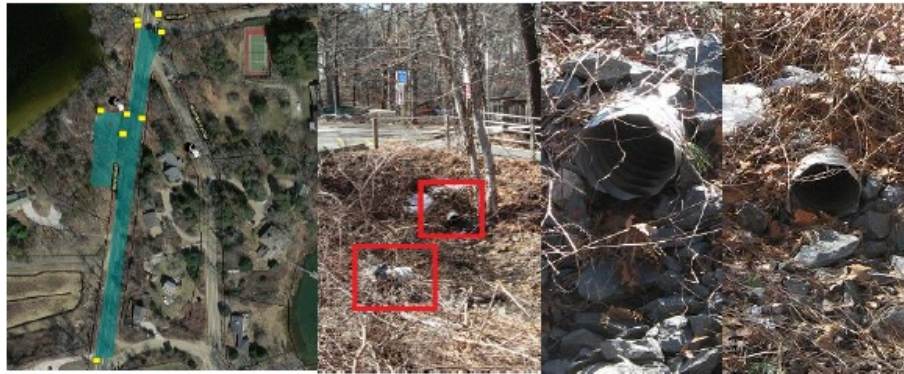
Includes runoff from Monument Road and Dickenson Conservation Area paved parking lot.

2 Outfalls were found and both drain into the same discharge area. Unable to determine which structures lead to each outfall.

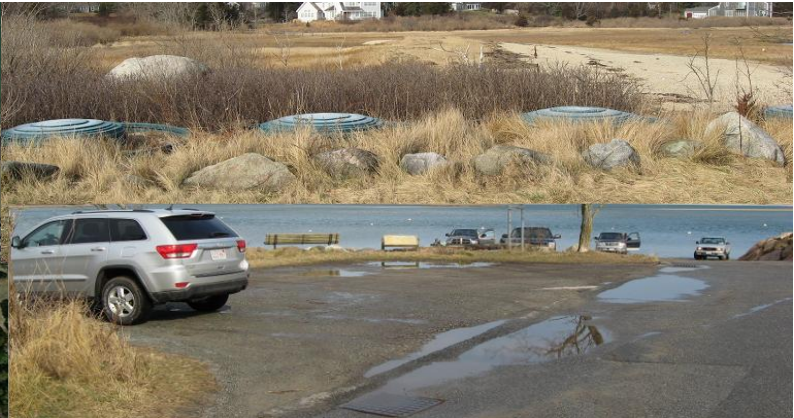
Outfall was not located. Stormdrain structures in parking area were observed to be flooded likely due to high tide. Four Storm-Treat Systems have been installed and it is assumed that the outfall has existing mitigation.

Storm-Treat systems are currently installed. It is recommended that the Town continue to perform routine maintenance on the structures.

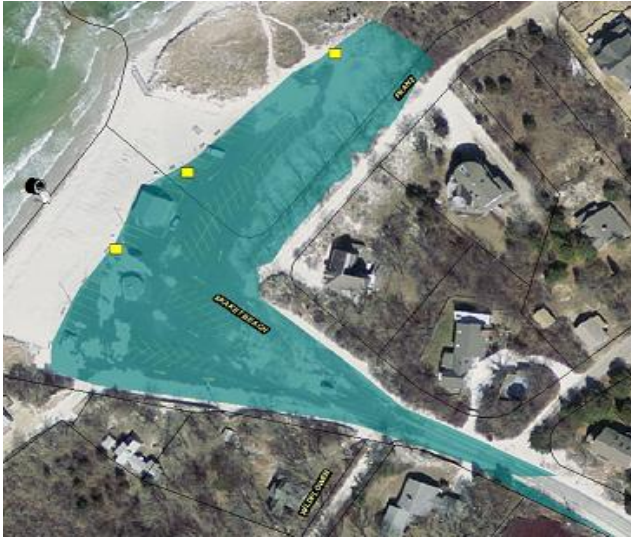
Paved road & parking area. Stormwater improvements performed in 2013 including installation of new leaching catch basins, leaching pits, and new septic system and leach field for bath house. Overflow pipe replaces old outfall onto beach.

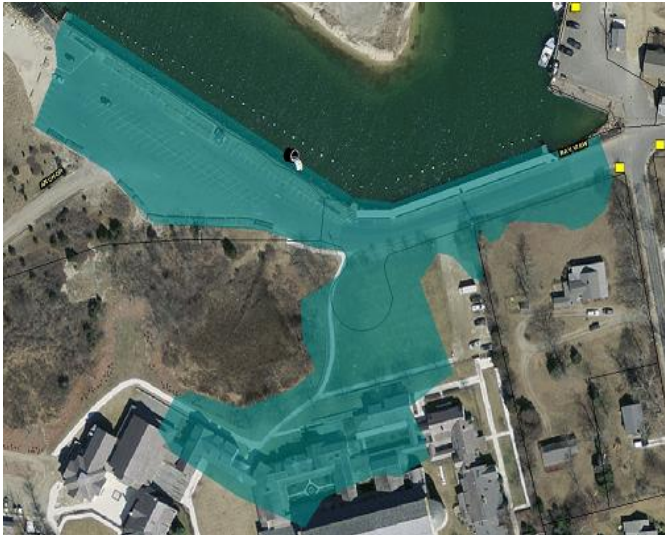
Actual outfall location was not observed. Assumed outfall located at drain manholes. No catch basins were observed and it was assumed that the parking area was included in the drainage area.

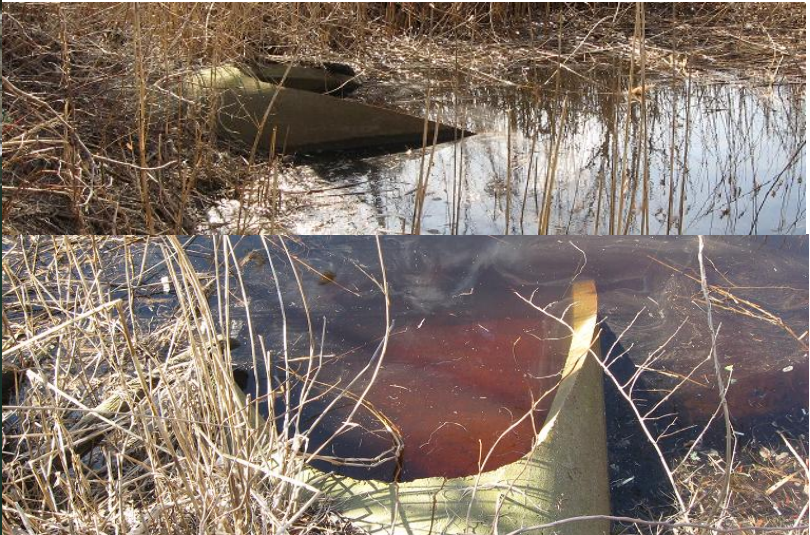
Discharge water observed to have surface oils and a redish tint.

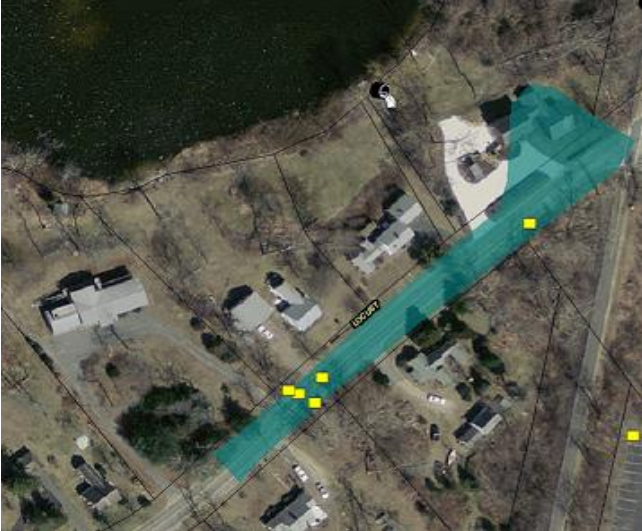
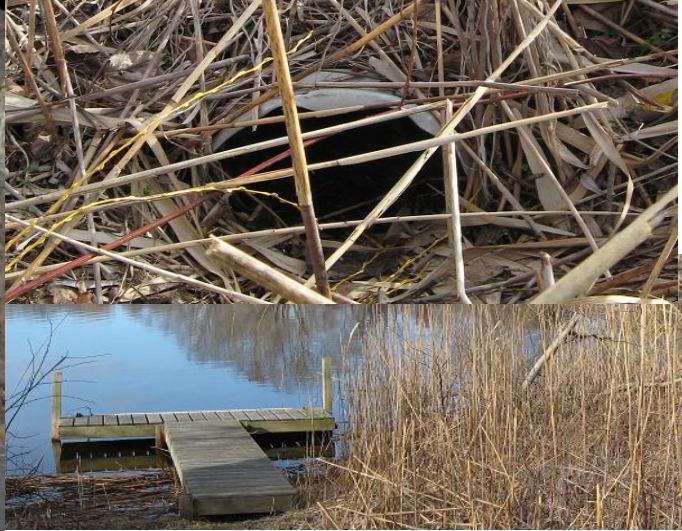
Unclear what stormdrains lead to outfall. Recommend Town to investigate.

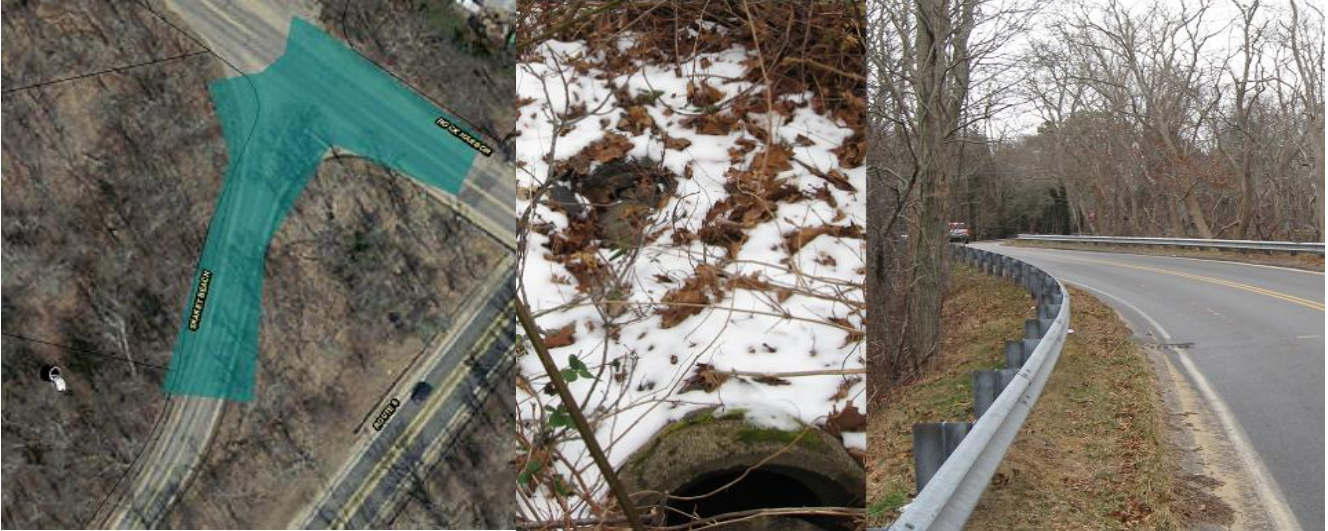
Observed multiple gaps in the concrete outfall pipe. Outfall pipe was partially submerged under dirt and brush.

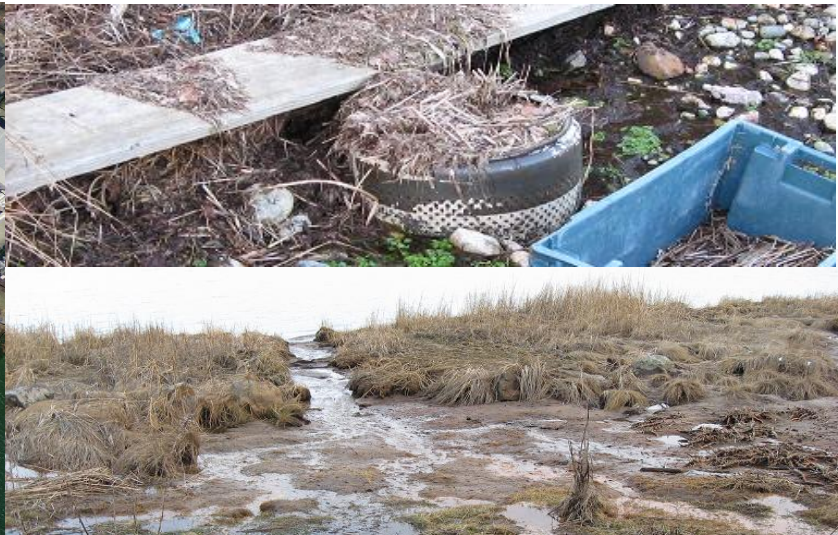
Water was observed flowing from perforated holes and it was assumed that the object was 26-OUT-1. Drainage area is assumed to be all impervious and total 1/2 the combined drainage area for outfalls 26-OUT-1,2.

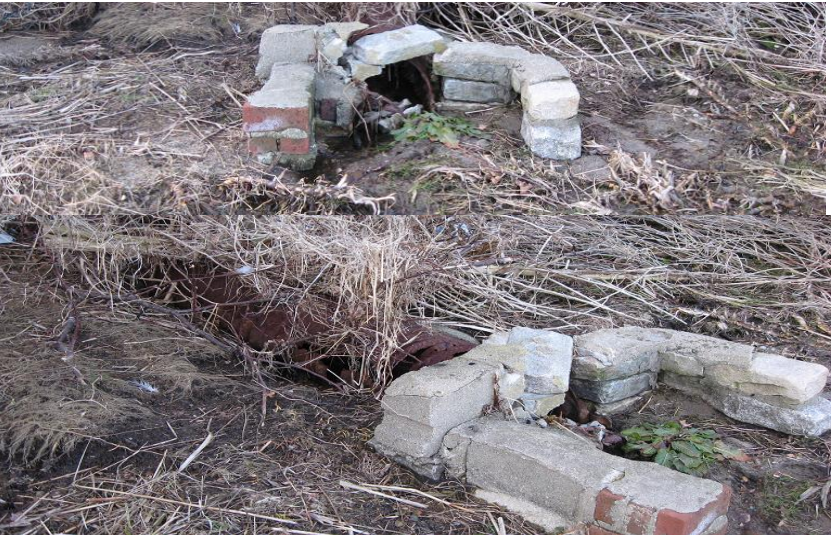
Outfall is in poor shape with multiple holes rusted through. A dead animal was observed next to the outfall. Drainage area is unknown and is assumed to be all impervious and total 1/2 the combined drainage area for outfalls 26-OUT-1,2.

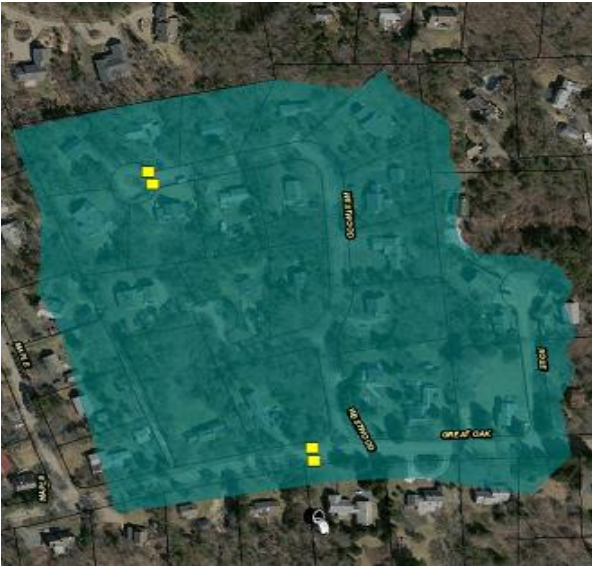
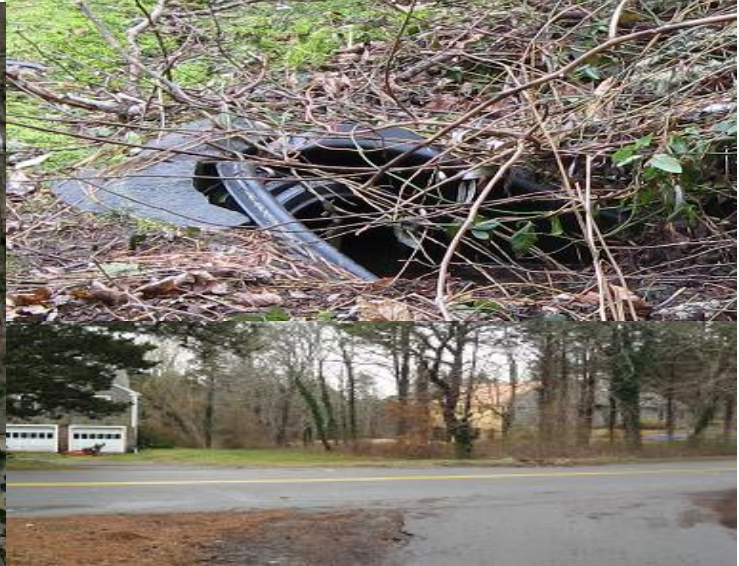
There is an 8" CM culvert located under the road at the top of the hill which drains to the outfall catch basin.

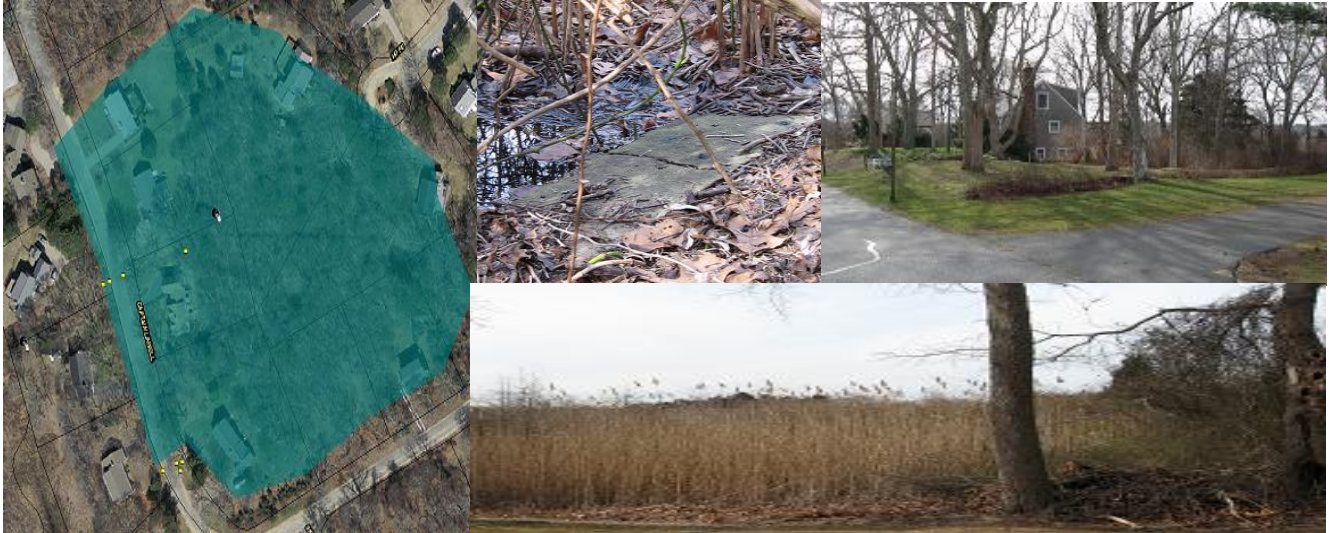
Outfall fully submerged. Cleaning recommended.

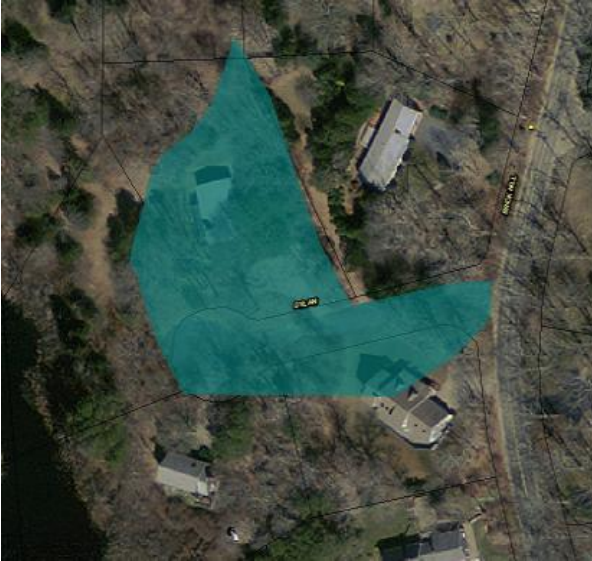
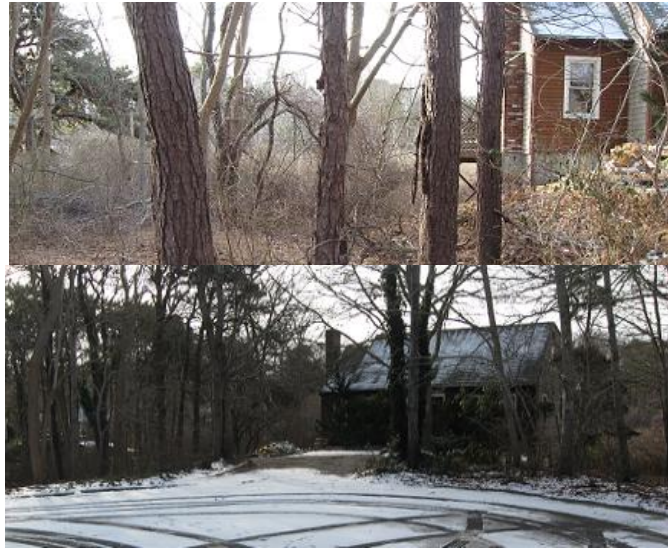
Unable to locate outfall or any drainage structures.

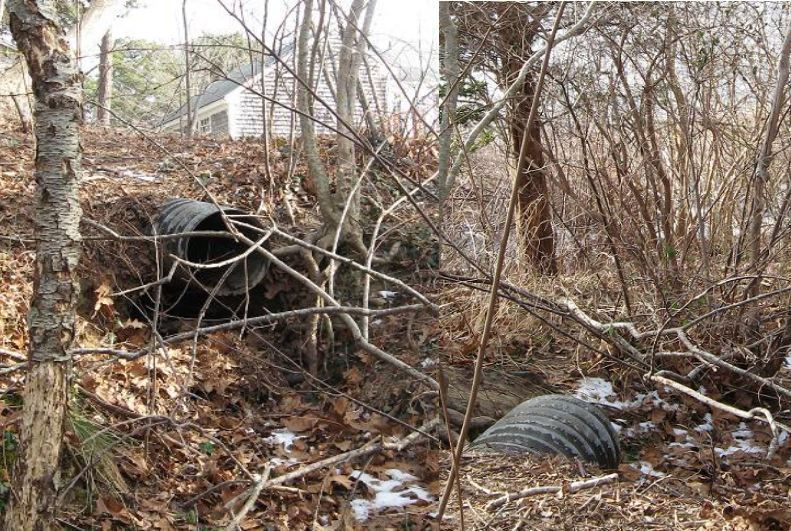
Resident of House No. 11 Uncle Harvey's Way stated there have been numerous recent algy blooms in Uncle Harvey's Pond. Multiple drain manholes observed on Uncle Harvey's road around curve near house No. 17.

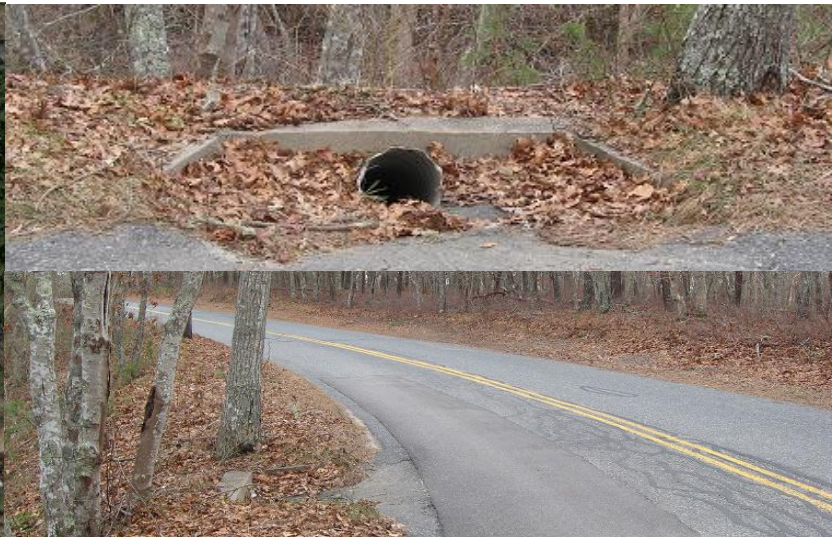
Mostly runoff from Baker's Pond Road and some runoff from adjacent conservation land.

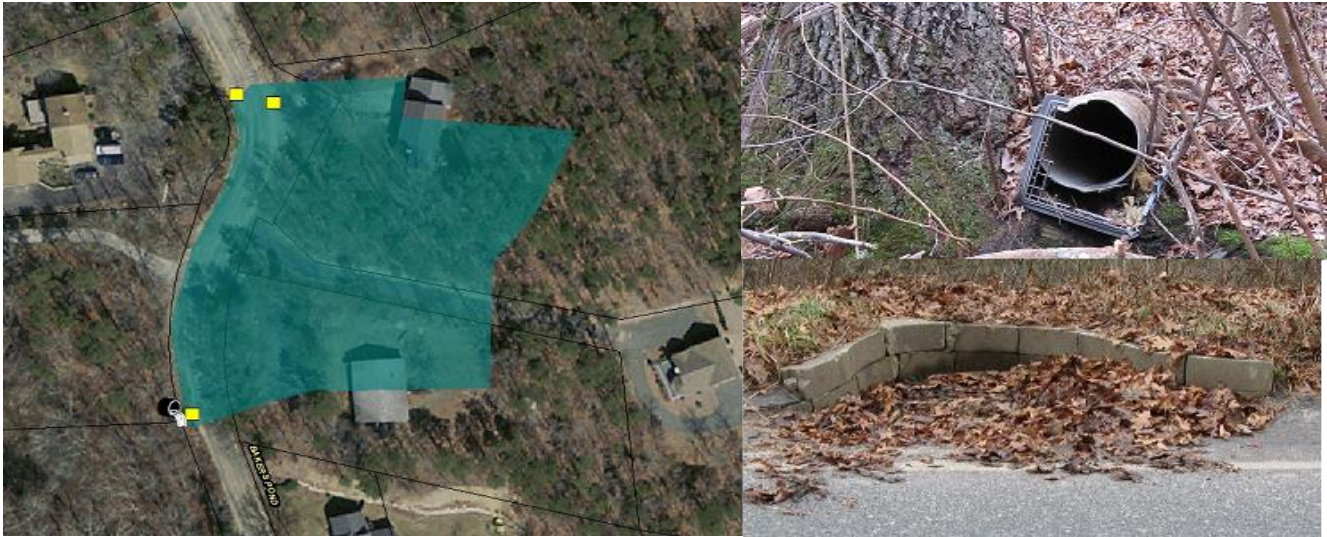
Residential with average 1 acre to 2 acre lots. Drainage area includes mostly runoff from Baker's Pond Road and some runoff from adjacent properties to the East.

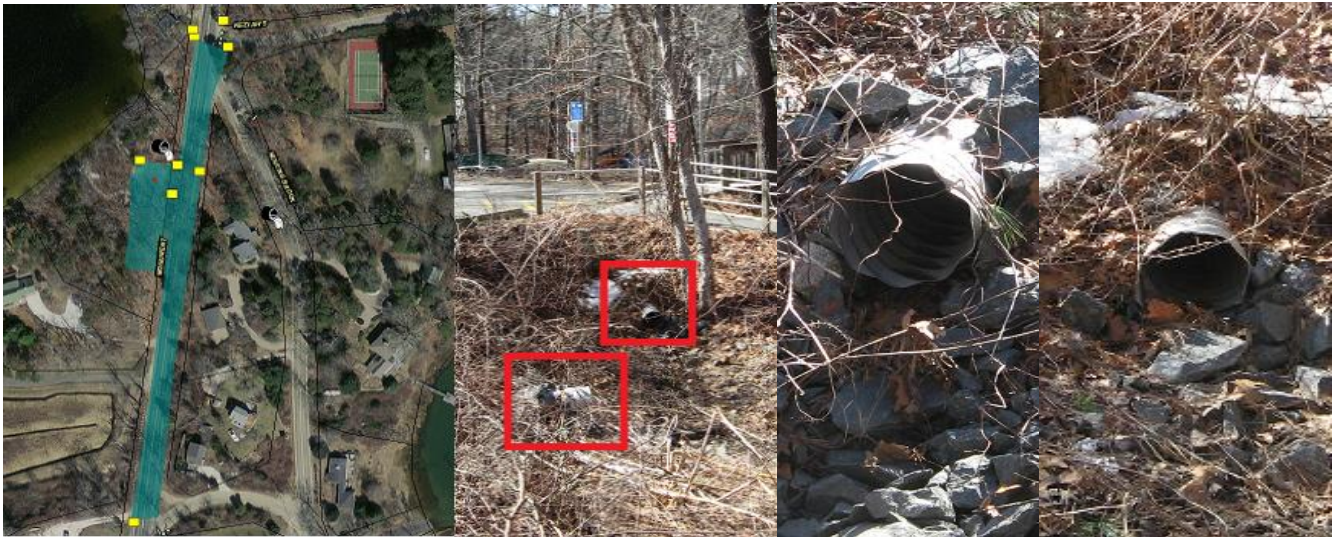
Includes runoff from Monument Road and Dickenson Conservation Area paved parking lot.

Two Outfalls were found and both drain into the same discharge area. Unable to determine which structures lead to each outfall.

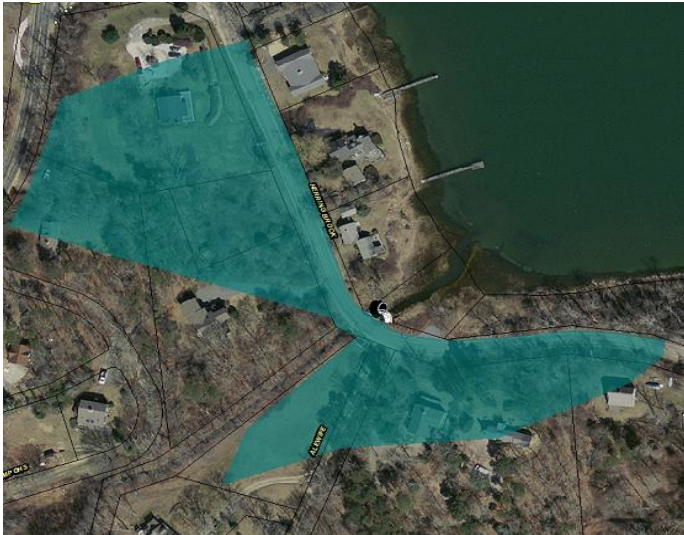
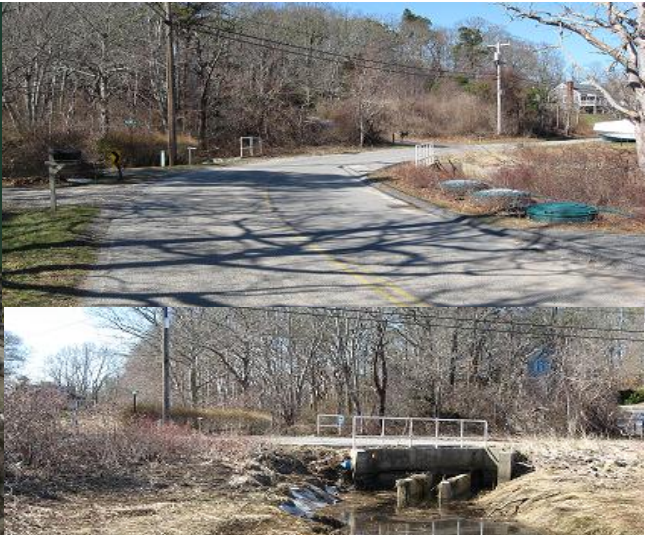
Based on visual observation of StormTreat system it is recommended that maintenance operations be performed. A 6" dia green pvc pipe was observed to be coming up from the drainage catch basin.

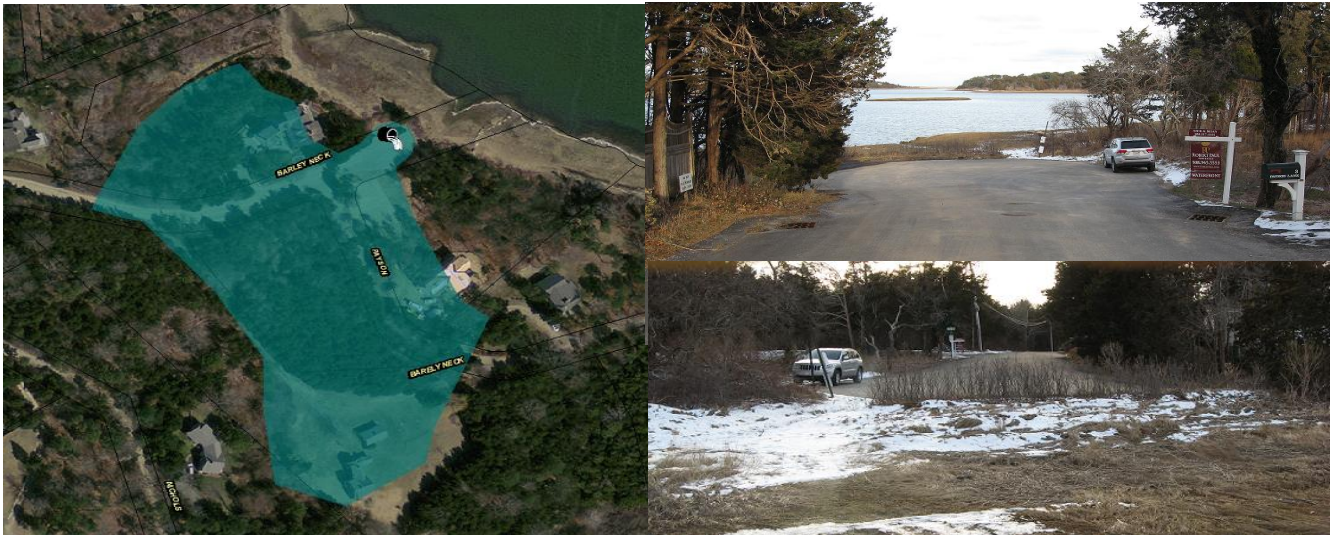
Seasonal residential with average 1 acre to 2 acre lots. Mostly natural woody with moderate brush cover.

Unable to locate 57-OUT-1. All catch basins were observed to be leaching and not pipes leading to outfall could be seen. Cul-de-sac was recently paved and its assumed that the outfall was removed.

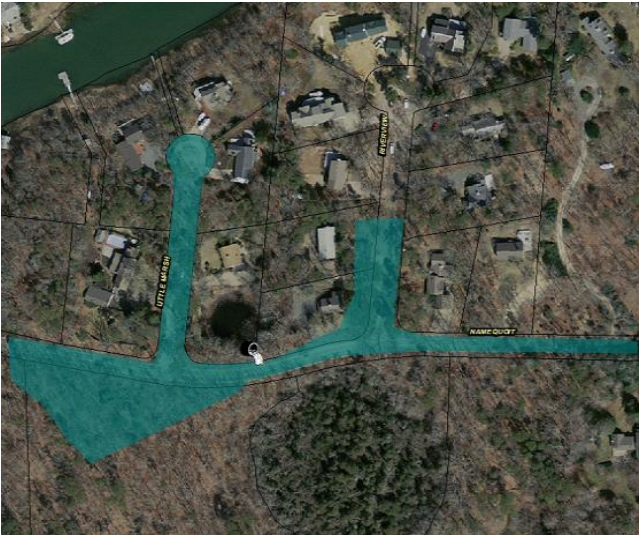
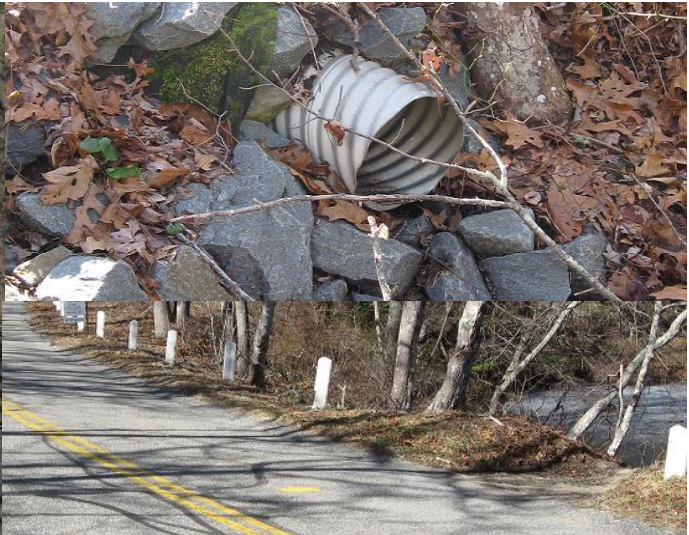
Seasonal residential with average 1/2 acre lots. Majority of runoff from Namequoit Road and some from Little Marsh lane.

Abandoned outfall or old culvert observed near 69-OUT-1

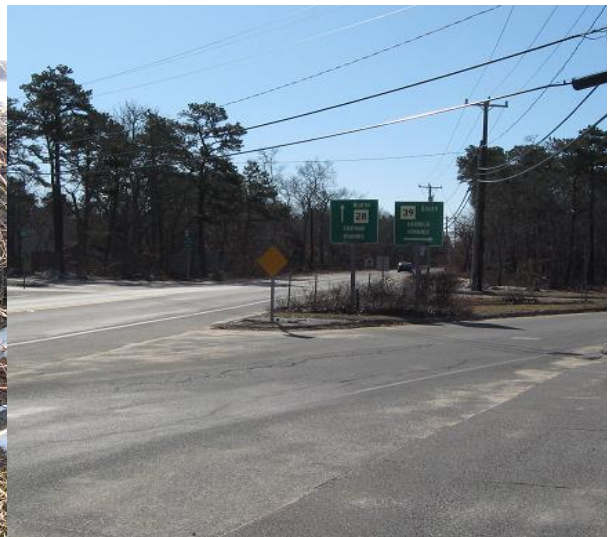
Residential and commercial properties. Drainage area includes mostly road runoff from intersection of Rt. 28, Quanset Road, and Harwich Road.

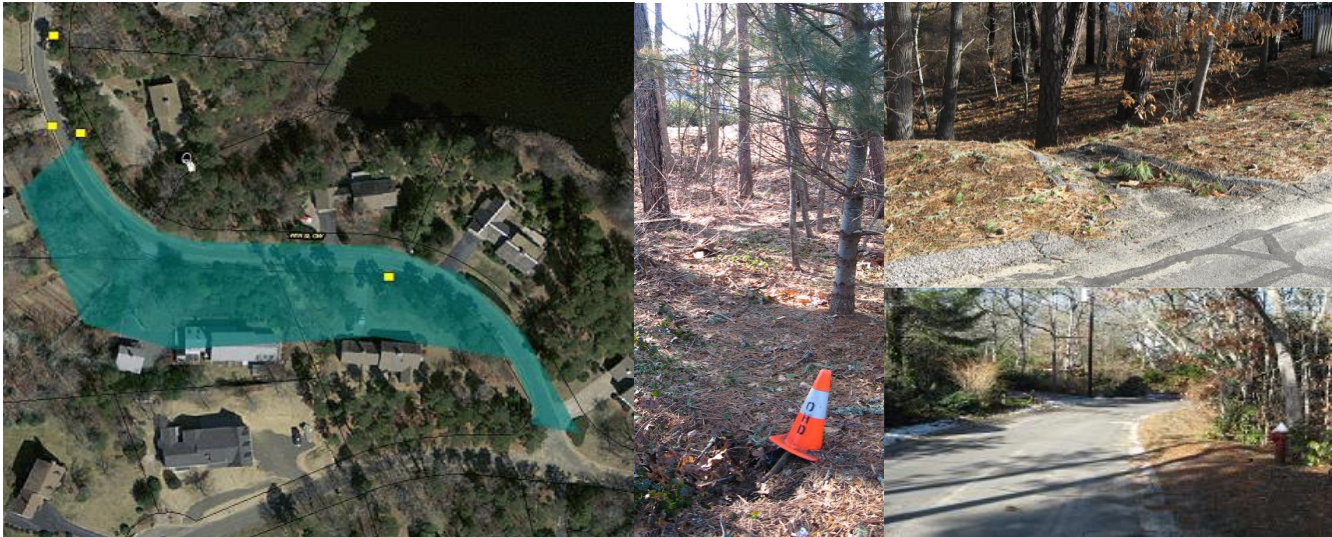
Seasonal residential with average 1/2 acre to 1 acre lots. Runoff from Winslow Drive and properties to the West.

OHD cone was found near a swale - unsure whether this was marking the location of an outfall.
