# CAPITAL ASSET ASSESSMENT

## Orleans Elementary School

46 Eldredge Park Way, Orleans, MA 02653

FINAL REPORT: July 27, 2023

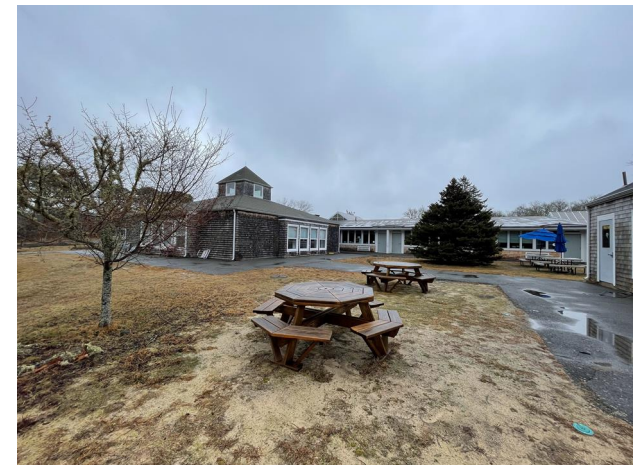
6. Topsoil in many areas is eroded.

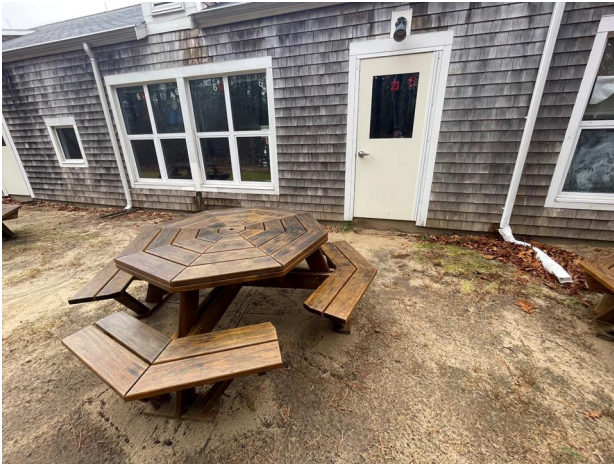
7. Topsoil is eroded and classroom doors are not MAAB accessible to outdoors.

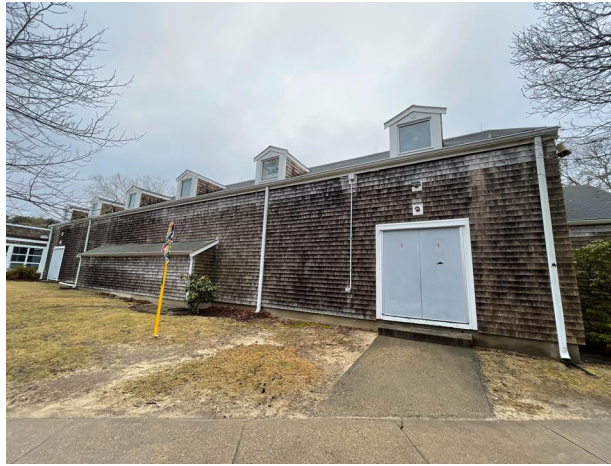
8. More examples of eroded soil and gym exit doors are not MAAB accessible.

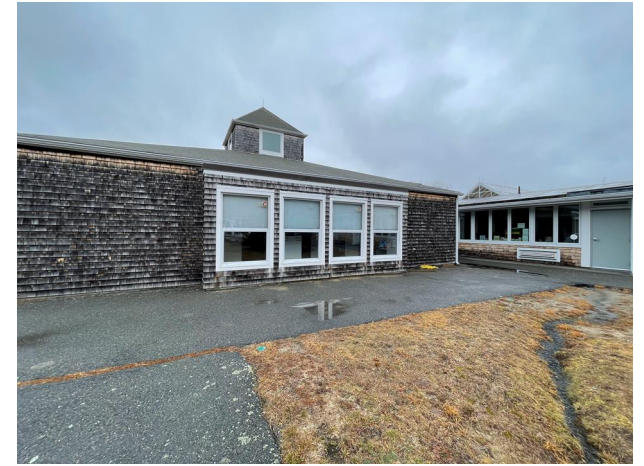
9. Drainage area has eroded soils.

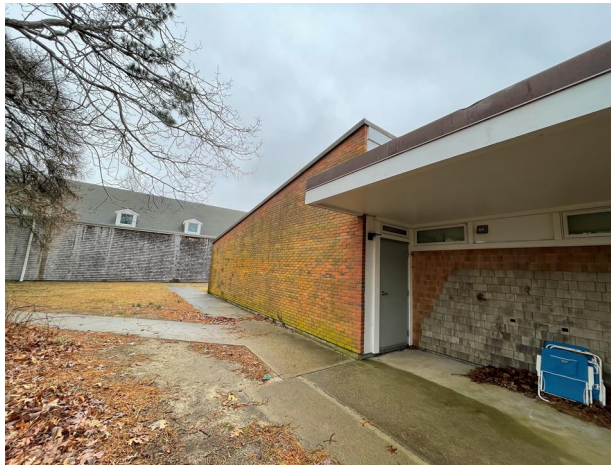
2. Brick is discolored on north elevation.

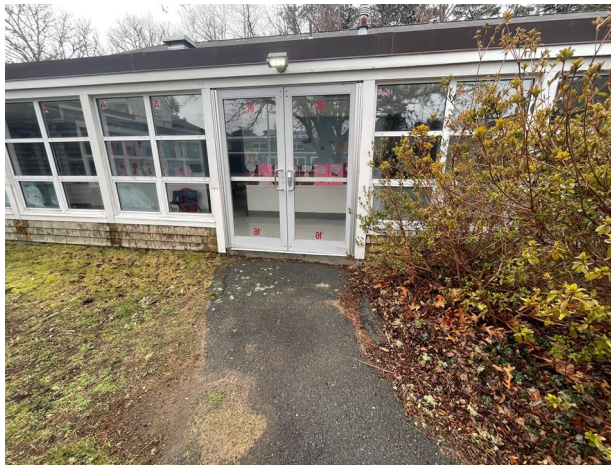
5. Shingles in some areas are too close to finish grade.

<b>2.11 Shingles too close to finish grade:</b> Remove cedar shingles that are within 12" of finished grade. Replace with 1x composite lumber and provide flashing.		2,300	LF	45.00	103,500	134,550		134,550		134,550
<b>2.12 Rotted wood at base of Columns:</b> Remove trim at bottom 12" of columns and replace with 1x composite lumber.		24	LF	45.00	1,080	1,404		1,404		1,404
<b>2.13 Columns at Kindergarten Wing:</b> Prep and paint worn columns.		240	SF	12.00	2,880	3,744		3,744		3,744
<b>2.14 Damaged Soffit:</b> Repair or replace damaged areas of soffits.		300	SF	25.00	7,500	9,750		9,750		9,750

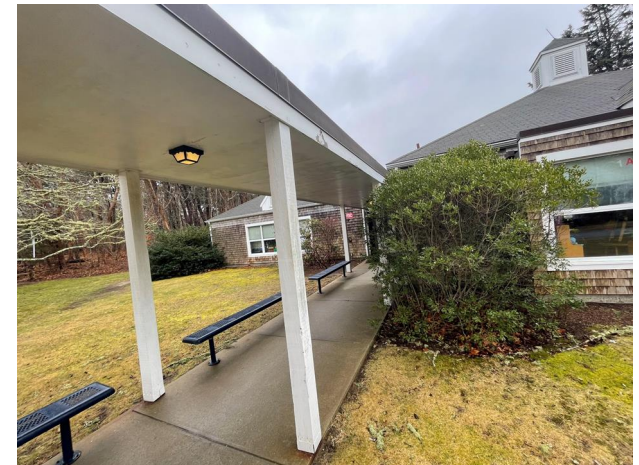
6. Soffits and wood fascia is peeling.

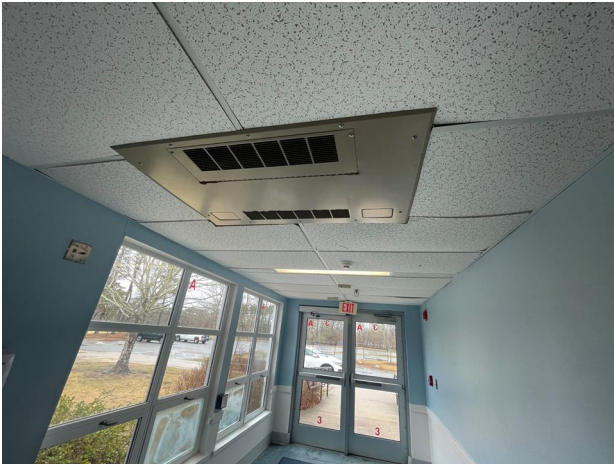
1. Ceiling unit heaters at entry points are outdated.

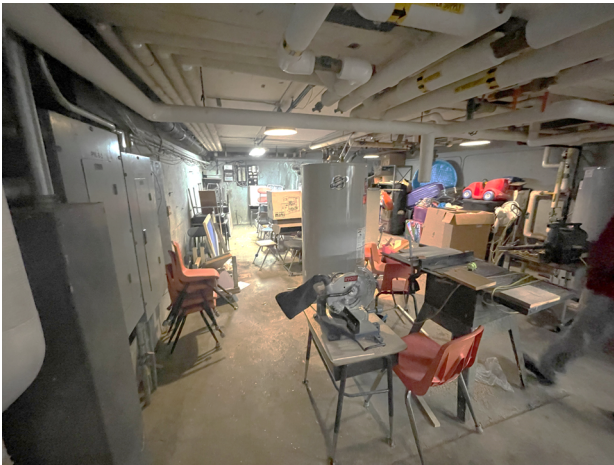
4. Piping is outdated.

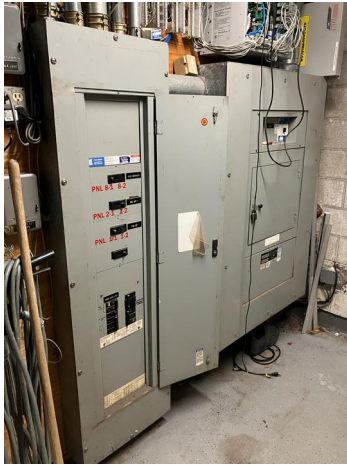
1. Electric/utility room is undersized for equipment upgrades.

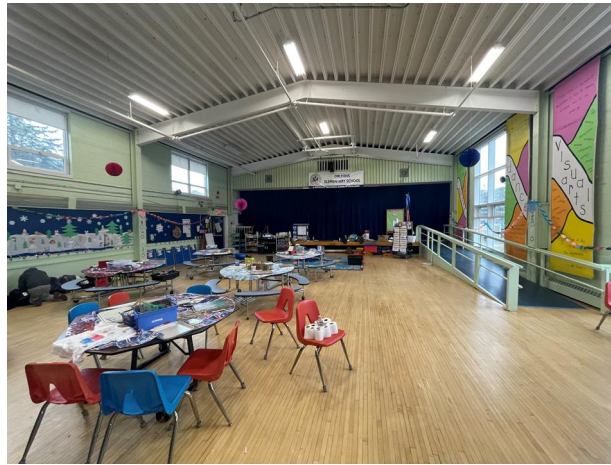
2. Lighting is outdated.

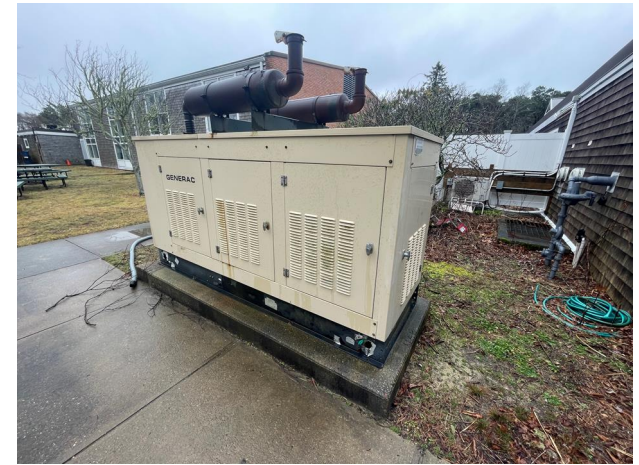
3. Generator is past its anticipated useful lifespan.

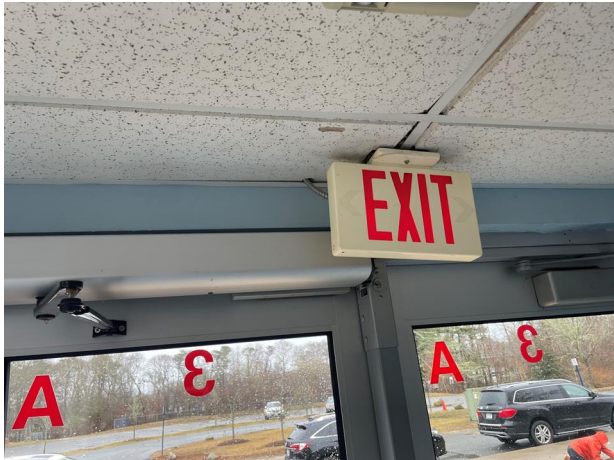
4. Exit lights are outdated.

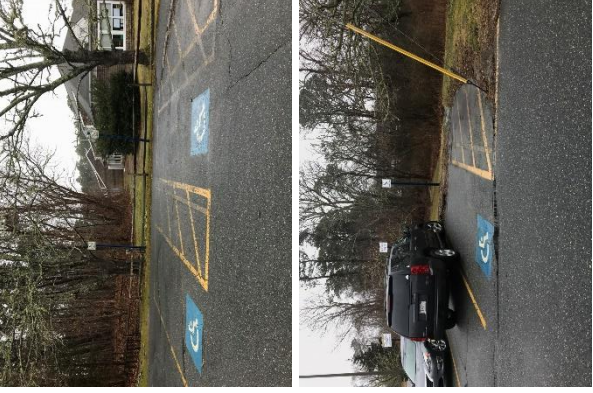
2.	<p><b>Parking Lot serving the Tennis Courts</b></p> <p>The parking lot serving the tennis courts does not provide any accessible spaces.</p> <p>The parking surface is not uniform, paved, or a hard packed smooth surface that prevents pooling or draining water.</p>

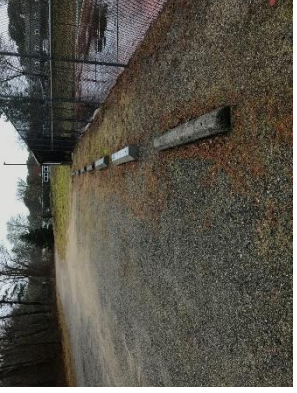
3.	<p><b>Parking Lot serving the Baseball Fields</b></p> <p>The designated accessible parking spaces and their associated access aisle have slopes &gt;2%, @ up to 2.5%.</p> <p>One of the accessible parking spaces lacks the required signage.</p> <p>The curb ramp has running slopes &gt;8.3%, @ 11.7%.</p> <p>The curb ramp lacks a level landing at the top of the ramp run, @ 2.3%.</p>

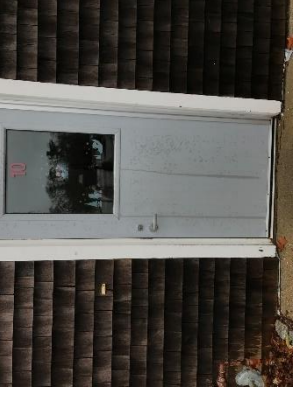
<p>10.</p>	<p><b>Teachers' Lounge Egress Door</b> The door provides &lt;32" of clear width, @ 24".</p>

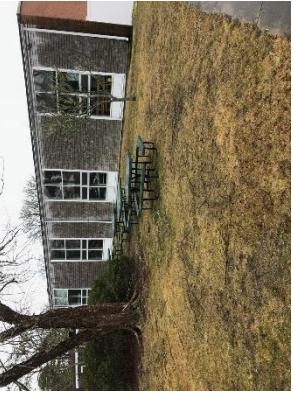
<p>14.</p>	<p><b>Trash Cans</b> The trash cans are not located on an accessible route due to the grass, dirt, and mulch surface.</p>

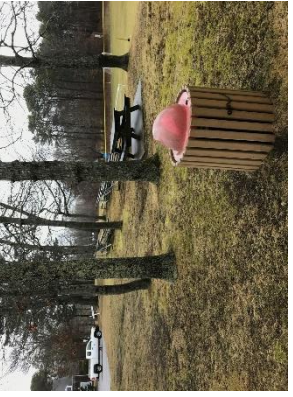
15.	<p><b>Playgrounds</b></p> <p>The playground lacks the required number of ground-level play components and an accessible route between elements due to the woodchips surface.</p> <p>The route leading to the playground area has cross slopes &gt; 2%, @ up to 2.8%.</p>

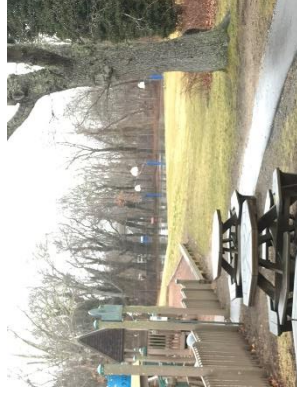
19.	<p><b>Garden</b></p> <p>There is no accessible route provided to the garden due to the grass and mulch surfaces.</p>

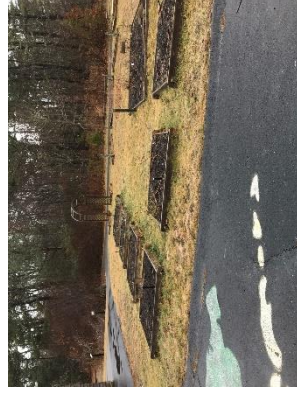
20.	<p><b>Baseball Field</b></p> <p>There is no accessible route to the baseball field due to the grass surface.</p> <p>The bleachers are not located along an accessible route due to the grass.</p> <p>There is no level 30" x 48" clear floor space adjacent to the bleachers.</p>

<b>1.17 Baseball Field Bleachers:</b> Provide a level 30" x 48" concrete landing for clear floor space adjacent to the bleachers. <b>(Accessibility)</b>		1	LS	2,000.00	2,000	2,600	2,600			2,600
<b>1.18 Fencing at Cafeteria Loading area:</b> Replace 6' high wood stockade portion of fence and gate in this area as it is showing signs of rot and is approaching its expected end of useful life.	2010 +/-	44	LF	75.00	3,300	4,290			4,290	4,290

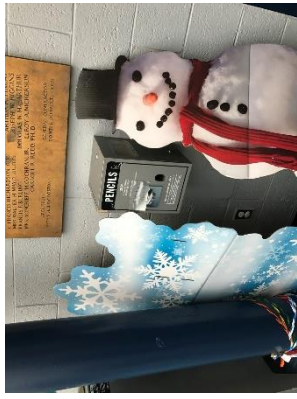
26.	<p><b>Pencils Dispenser</b></p> <p>The pencil dispenser protrudes &gt;4' into the circulation path, @ 9 1/2".</p>

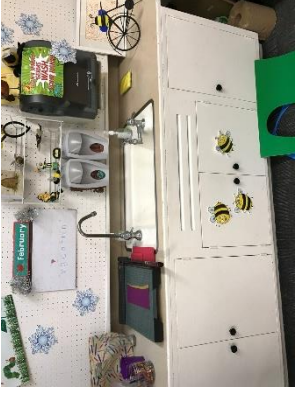
<p>27.</p>	<p><b>Classroom Sinks &amp; Bubblers (Typical)</b></p> <p>The sink lacks the required knee and toe clearance for a forward approach due to the cabinetry.</p> <p>The drinking fountain lacks the required knee and toe clearance for a forward approach due to the cabinetry, and the spout is &gt;30" AFF, @ 32".</p> <p>The work room sink faucets require tight grasping, pinching, or twisting of the wrist to operate.</p> <p><i>Note: ADA 606.2 Exception 4 permits children's sinks to provide 24" AFF minimum knee clearance and Exception 5 permits a parallel approach for sinks primarily used by children 5 years and younger. Similarly, ADA 602.2 Exception permits a parallel approach for drinking fountains primarily used by children when the spout is 30" AFF maximum. However, 521 CMR does not distinguish between adult and children's dimensions for classroom sinks nor drinking fountains.</i></p>

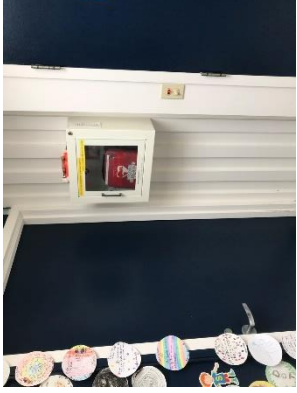
<p>29.</p>	<p><b>AED Cabinet</b></p> <p>The AED cabinet is mounted &gt;48" AFF to the highest operable part, @ 58".</p>

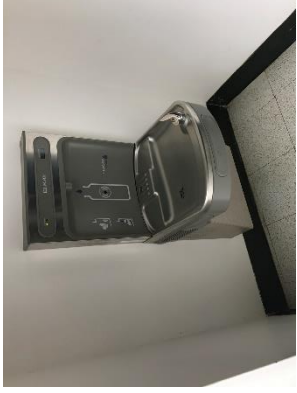
<p>30.</p>	<p><b>Drinking Fountains</b></p> <p>There are no drinking fountains for standing persons provided.</p> <p>The drinking fountain near the light gallery #3 lacks the required knee clearance, @ 24" AFF.</p>

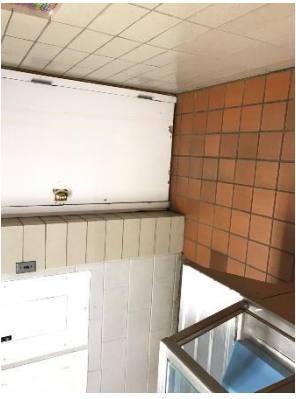
31.	<p><b>Kitchen</b></p> <p>The doors leading to the food service provide &lt;32" clear width, @ 29".</p> <p>The doors lack the required 48" pull-side maneuvering clearance perpendicular to the doorway, @ 40" measured to the tray slide.</p> <p>The doors require &gt;5lbs of force to open.</p>

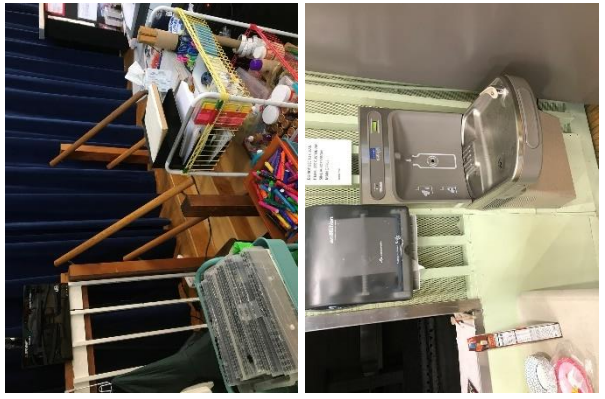
32.	<p><b>Cafeteria</b></p> <p>The ramp has slopes &gt;8.3%, @ up to 8.8%.</p> <p>The ramp lacks edge protection.</p> <p>The handrails lack the required extensions at the bottom of the ramp.</p> <p>The stair to the stage lacks the required handrail extensions at the top and bottom.</p> <p>The drinking fountain's spout is mounted &gt;36" AFF, @ 36 1/2".</p> <p>There is no drinking fountain for standing persons provided.</p>

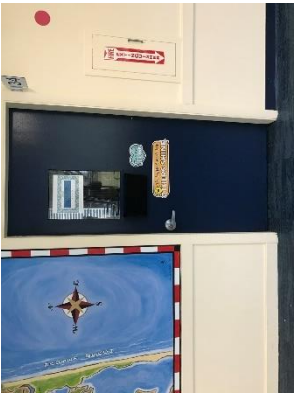
33.	<p><b>Classroom 34</b></p> <p>The vision panel is &gt;43" AFF, @ 49".</p>

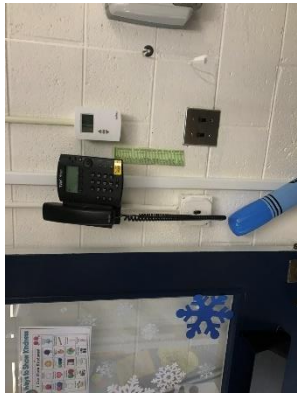
34.	<p><b>Classroom 8</b></p> <p>The phone is mounted &gt;48" AFF to the highest operable part, @ 63", and it protrudes &gt;4" into the circulation path, @ 6".</p> <p>The hand sanitizer is mounted &gt;48" AFF to the highest operable part, @ 49".</p>

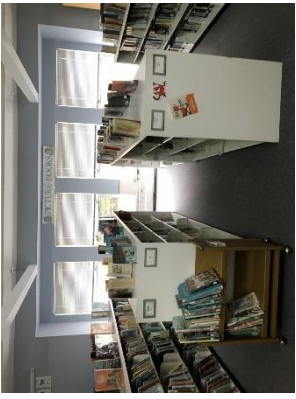
35.	<p><b>Library</b></p> <p>The soap dispenser is mounted &gt;46" above the counter, @ 50".</p> <p>The routes between book stacks provide &lt;36" of clear width, @ 33".</p>

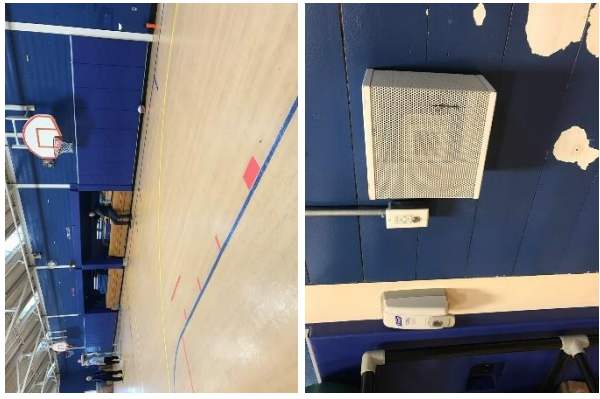
36.	<p><b>Gymnasium</b></p> <p>There are no wheelchair spaces provided at the bleachers.</p> <p>The thermostat cage protrudes &gt;4" into the circulation area, @ 5 1/2".</p>

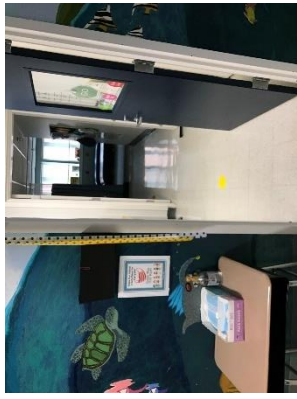
37.	<p><b>Nurse's Office</b></p> <p>The maneuvering clearance is &lt;18" on the latch pull side of the door, @ 8".</p> <p>The vision panel is &gt;43" AFF, @ 45 1/2".</p> <p>The letter box is mounted &gt;48" AFF, @ 56".</p> <p>The hand sanitizer is mounted &gt;48" AFF, @ 52".</p>

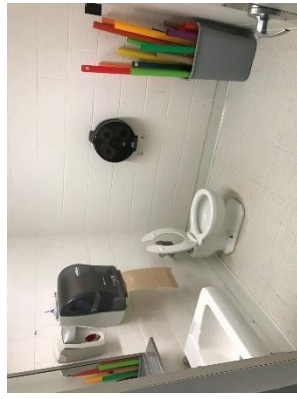
38.	<p><b>Single-User Toilet Room at Music Room</b></p> <p>The door provides &lt;32" of clear width, @ 23".</p> <p>The room lacks the required footprint and elements for an accessible toilet room.</p>

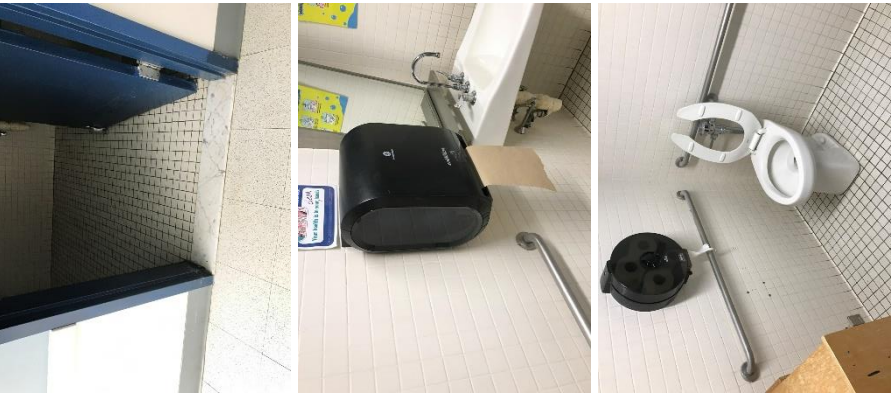
44.	<p><b>Staff Single-User Toilet Rooms serving Corridors 2 &amp; 3</b></p> <p>The threshold is &gt; 1/2" high.</p> <p>The door lacks the required 48" pull-side maneuvering clearance perpendicular to the doorway, @ 41", measured from the door to the sink.</p> <p>The paper towel dispenser protrudes &gt;4" into the circulation area.</p> <p>The flush control at one of the toilet rooms is not located on the open side of the toilet.</p> <p>The rear and side grab bars are not mounted 33"-36" AFF, @ 32 1/2" measured to the top of the gripping surface.</p> <p>The side grab bar extends &lt;54" from the rear wall, @ 48".</p> <p>The toilet paper dispenser is mounted &lt;12" above the side grab bar, @ 5".</p> <p>The toilet paper dispenser is not 7"-9" from the rim of the toilet, @ 1".</p> <p>The clearance between the rear grab bar and the flush valve is &lt;1 1/2".</p> <p>The coat hook is &gt;48" AFF, @ 54".</p>

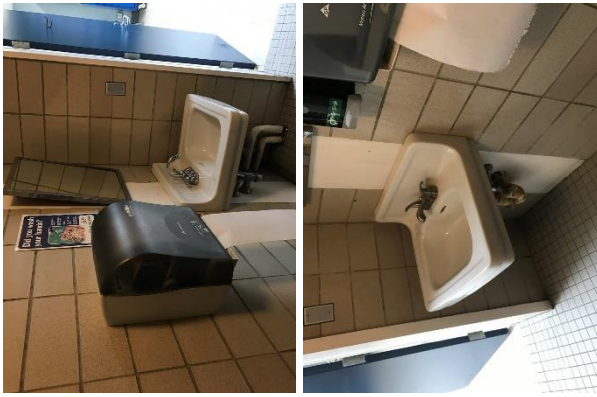
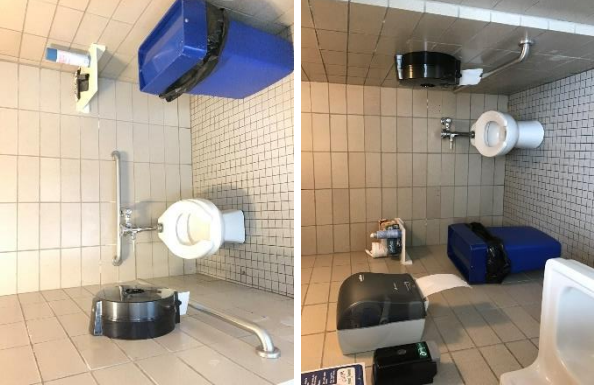
45.	<p><b>Staff Single-User Toilet Rooms near Teachers' Lounge</b></p> <p>The knee clearance at the sink is &lt;27" AFF, @ as little as 24".</p> <p>The pipes underneath the sink are not insulated.</p> <p>The mirror is mounted &gt;40" AFF measured to the bottom of the reflective surface, @ up to 51".</p> <p>The flush control is not located on the open side of one of the toilets.</p> <p>The toilet centerline is not 18" from the side wall, @ 15".</p> <p>The toilet seat is not 17"-19" AFF, @ 15".</p> <p>The rear grab bar is &lt;42" long, @ 30".</p> <p>The rear and side grab bars are not mounted 33"-36" AFF, @ 27" measured to the top of the gripping surface.</p>

<p>The toilet paper dispenser is mounted &lt;12" above the rear grab bar, @ as little as 3".</p> <p>The clearance between the rear grab bar and the flush valve is &lt;1 1/2". One of the toilet rooms lack the required rear grab bar.</p> <p>The clearance around the toilet is &lt;60", @ as little as 55" measured from wall to wall.</p> <p>The shelf and the paper towel dispenser protrude &gt;4" into the circulation area, @ up to 11".</p> <p>The coat hook is mounted &gt;48" AFF, @ 64".</p>

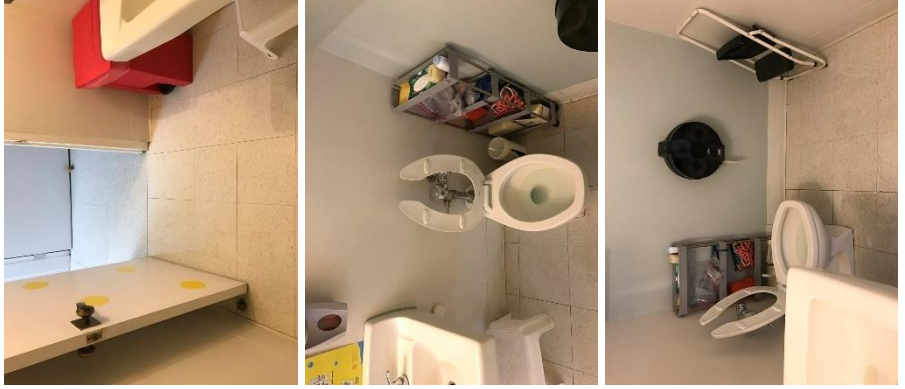
46.	<p><b>Single-User Toilet Room at Nurse's Office</b></p> <p>The maneuvering clearance is &lt;18" on the latch pull side of the door, @ 8" due to the sink.</p> <p>The door provides &lt;32" of clear width, @ 29".</p> <p>The knee clearance at the sink is &lt;27" AFF, @ 24".</p> <p>The pipes underneath the sink are not insulated.</p> <p>The mirror is mounted &gt;40" AFF measured to the bottom of the reflective surface, @ 47".</p> <p>The centerline of the toilet is not 18" from the side wall, @ 21".</p> <p>The toilet lacks the required rear and side grab bars.</p> <p>The toilet seat is not 17"-19" AFF, @ 15 1/2".</p> <p>The clearance around the toilet is &lt;60", @ 42" measured from the side wall to the sink.</p> <p>The clearance in front of the toilet is &lt;42" measured from the rim of the toilet to the front wall, @ 37 1/2".</p> <p>The toilet paper dispenser is not 7"-9" from the rim of the toilet, @ 11".</p> <p>The room lacks a 60" minimum turning space.</p> <p>The room lacks visual alarm.</p>
