# TOWN OF ORLEANS FIRE STATION FEASIBILITY STUDY

August 11th, 2021

# FIRE STATION FEASIBILITY STUDY

A structural inspection of the Orleans Fire Station located at 58 Eldredge Park Way, Orleans, MA 02653 was conducted on June 4, 2021. The visual inspection (no test) was performed to evaluate the overall condition of the existing building as part of the feasibility study for the Fire Station.

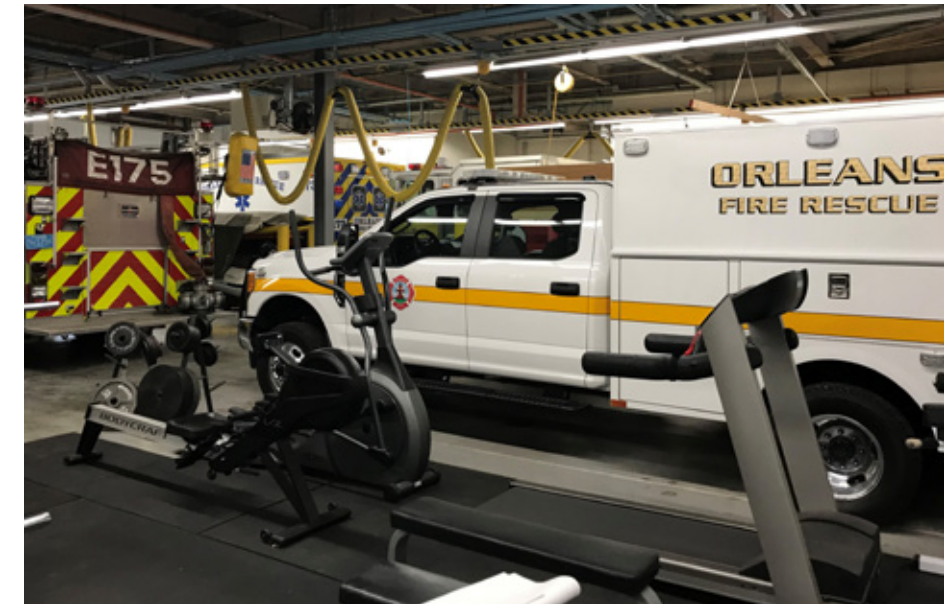
In Orleans, the fitness equipment is located directly on the apparatus floor – the biggest Hot Zone in a fire station – and the worst possible place for deep breathing caused by exercise. Anyone working out on an apparatus floor is breathing in the history of soot, but also potentially any current day carcinogens that return with the trucks and / or the diesel exhaust the trucks emit as they enter the building – even with the Plymovent system. This is a very big hazard and needs to be corrected.

**It is highly recommended that a building be planned and designed to take care of the town's first responders long-term health and welfare by protecting them from carcinogen transfer in the station.**

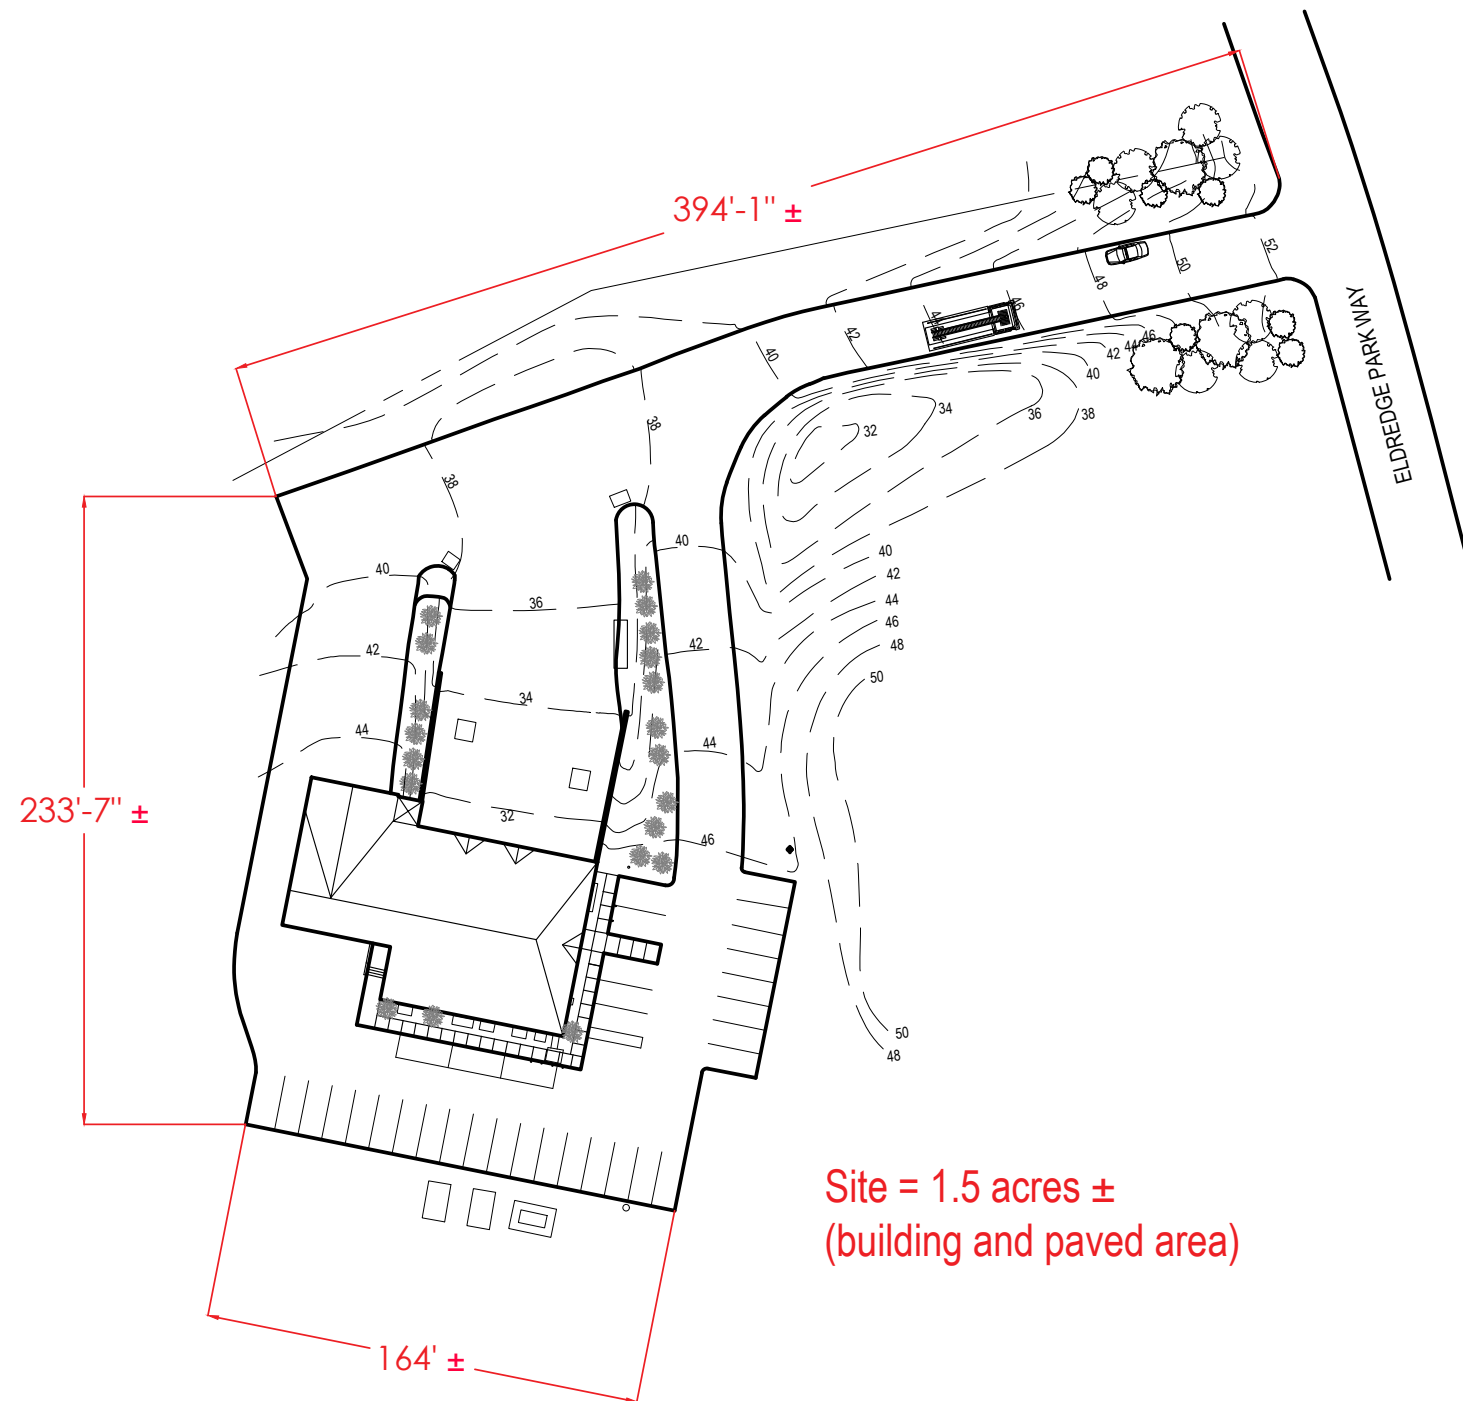
Ex Site 1

- A. Entry - does not have 5' level landing - slopes away from the building. MAAB violation
- B. 3 Interim HVAC improvements - temporary solutions for a larger issue per Facilities Manager

- C. Storage pods on the perimeter of the building due to inadequate space - deterioration of containers causing damage to equipment, and animal/rodent infiltration. Also exterior unsecured storage of flammable liquids

- F. Poor visibility to Eldredge Park Way reducing turnout time - Excessive slopes cause risk to emergency vehicles
- G. Emergency vehicles and visitors use the same driveway - very dangerous

- H. Existing building is not designed with impact-protective systems
- I. Natural gas generator leaves building at risk. Diesel generator is recommended

- L. Due to lack of space in apparatus bay - rescue boat stored outside
- M. When hydrant is used for training it causes low pressure at the Orleans Elementary School

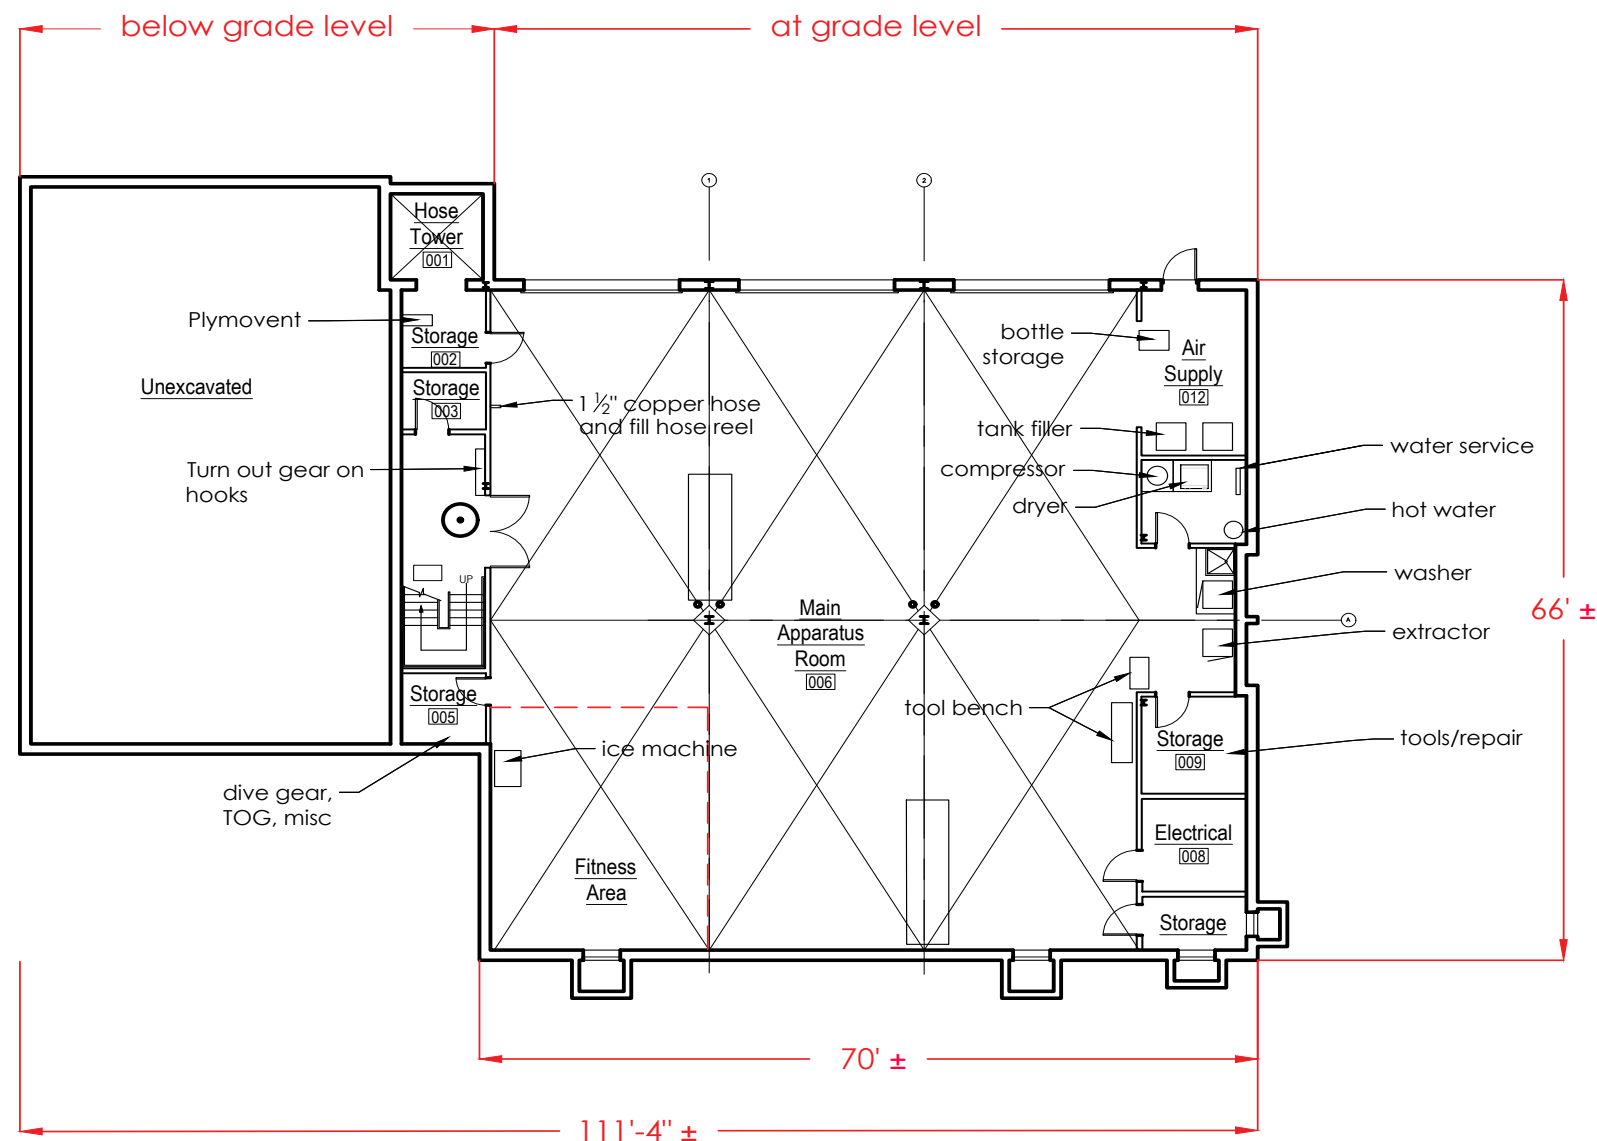
**EX-101**

- C. Domestic washer/dryer in gear area - Hazardous chemical exposure to all occupants and bedding
- D. Ice Machine location - should be located in area safe from carcinogenic contamination. Currently piped to floor drain - tripping hazard

- G. EMS Supplies storage is not centralized and inadequate, on apparatus floor, in contaminated areas, near office and lobby areas
- H. Truck repair - inadequate space for repairs due to ceiling height

- I. Turn out gear stored in apparatus bay - NFPA violation
- J. Fitness area in apparatus bay - leading to carcinogenic exposure
- K. Apparatus floor drains clog and routinely back up, drains go to a septic leech pit, not a tight tank

- L. Plymovent system not designed for vehicles that must be turned around during winter storms due to grade. Installed 2009 - soot stained walls from pre-2009

- Lower floor Apparatus door height/Ceiling height - Inadequate for apparatus. Door height at lowest point is currently 11'6", contemporary standards require 14'-0" doors
- Very limited storage
- Electrical service will be insufficient for new service requirements
- Flooding and equipment loss on basement level - potential mold on walls where supplies are stored

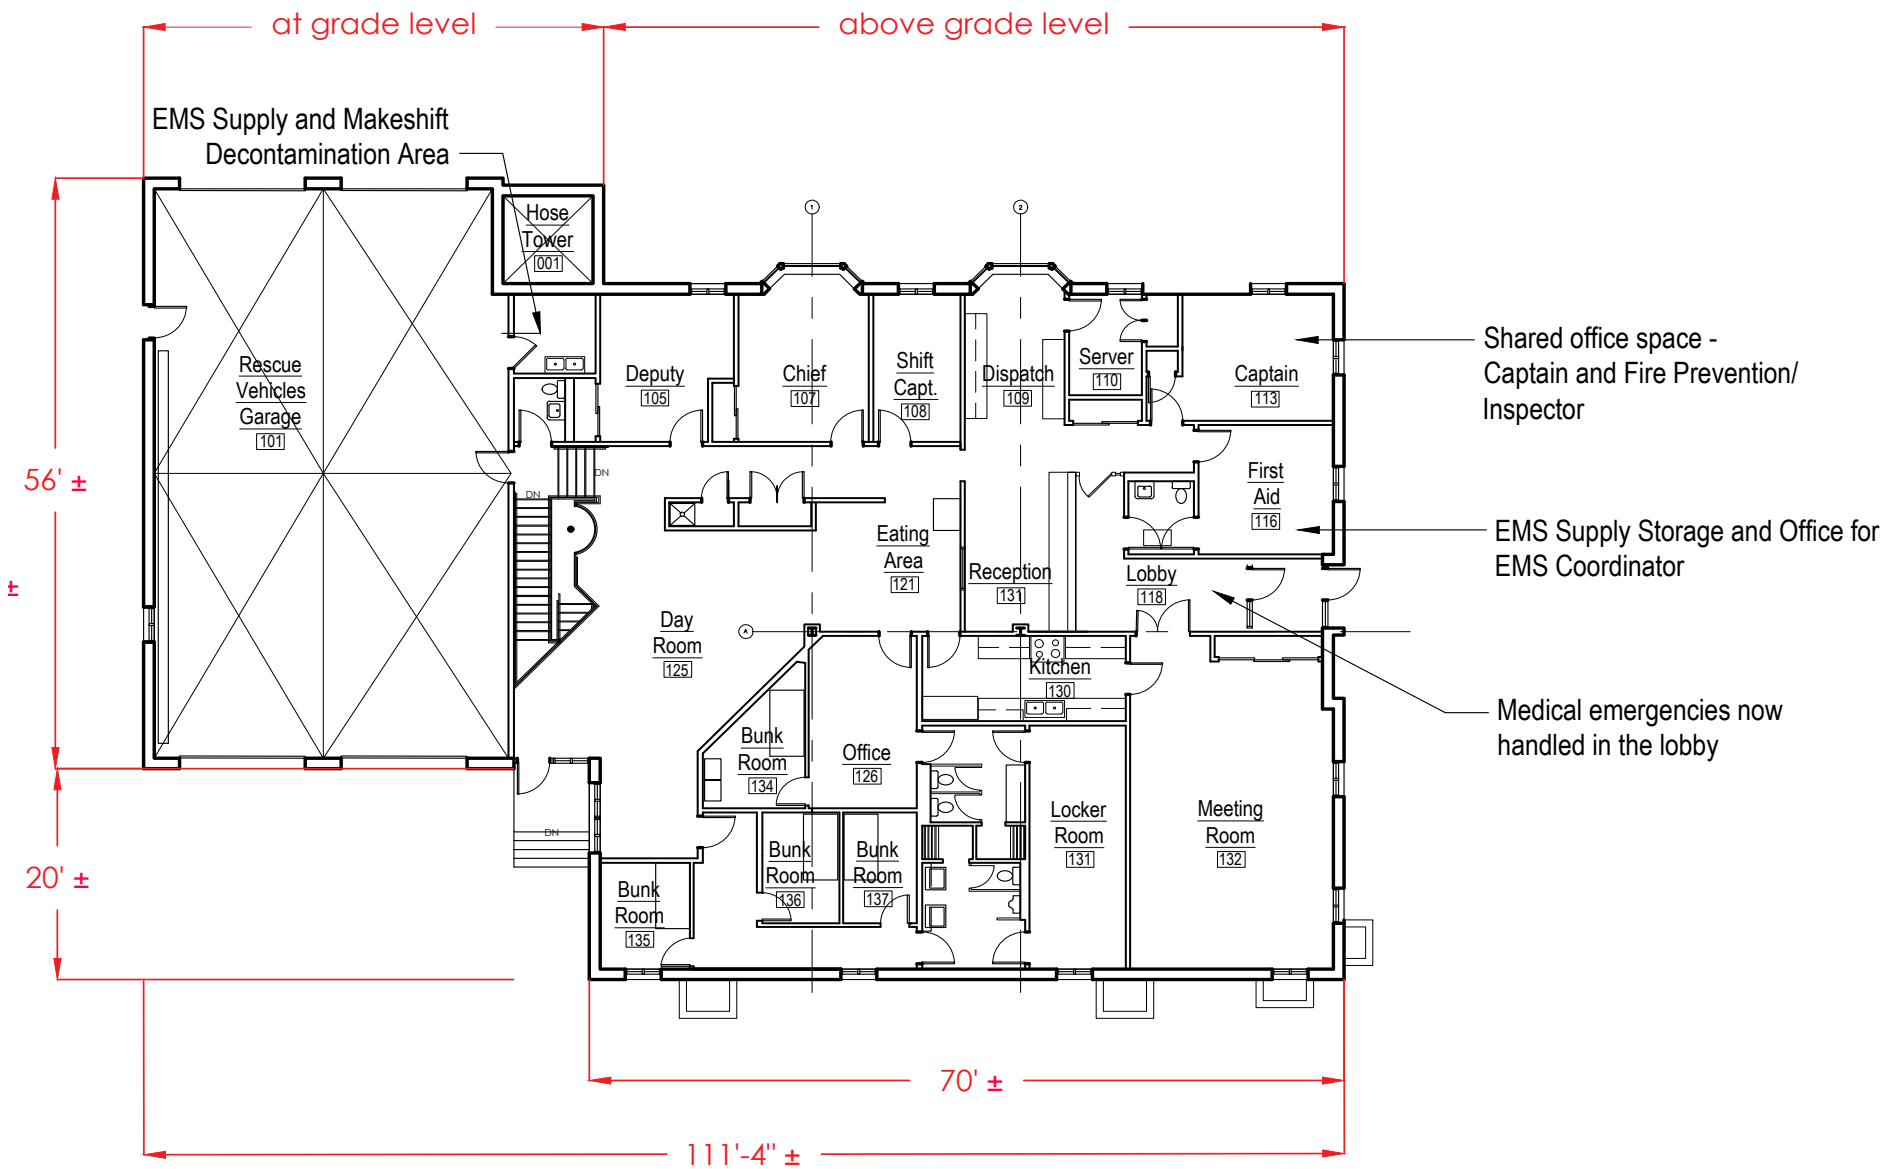
**EX-102**

- B. Public restroom (MAAB Violation) - Unsecured location and privacy issues (odor, etc)
- C. Kitchen - Current facility has been outgrown, is outdated and inadequate for personnel. Not MAAB compliant

- D. Training/Meeting Room - Not large enough to accommodate 30+ station personnel, and to function as backup Emergency Operations Center. Temporary HVAC repair takes up space.

- F. Laundry facilities - No domestic laundry available leading to potential carcinogen transfer.
- G. First floor apparatus door height/Ceiling height - Inadequate for apparatus. Door height at lowest point is currently 10', ceiling height is 13.5' Contemporary standards require 14'-0" doors

- L. Turnout gear on apparatus floor - does not conform to NFPA standards
- M. EMS Medical Supply - Space inadequate  
Two bay sink blocks door swing
- N. Shift capt. office - Used for sleeping but was not designed for this. Poorly located

- O. Dispatch area - No longer used therefore inactive space
- P. Bunk rooms in violation of building codes. No natural light or ventilation. Too small as built.

- Q. Hose tower no longer used
- R. Reception desk not MAAB compliant
- S. No separation of the dayroom from the exterior - door not tight and cold air infiltrates

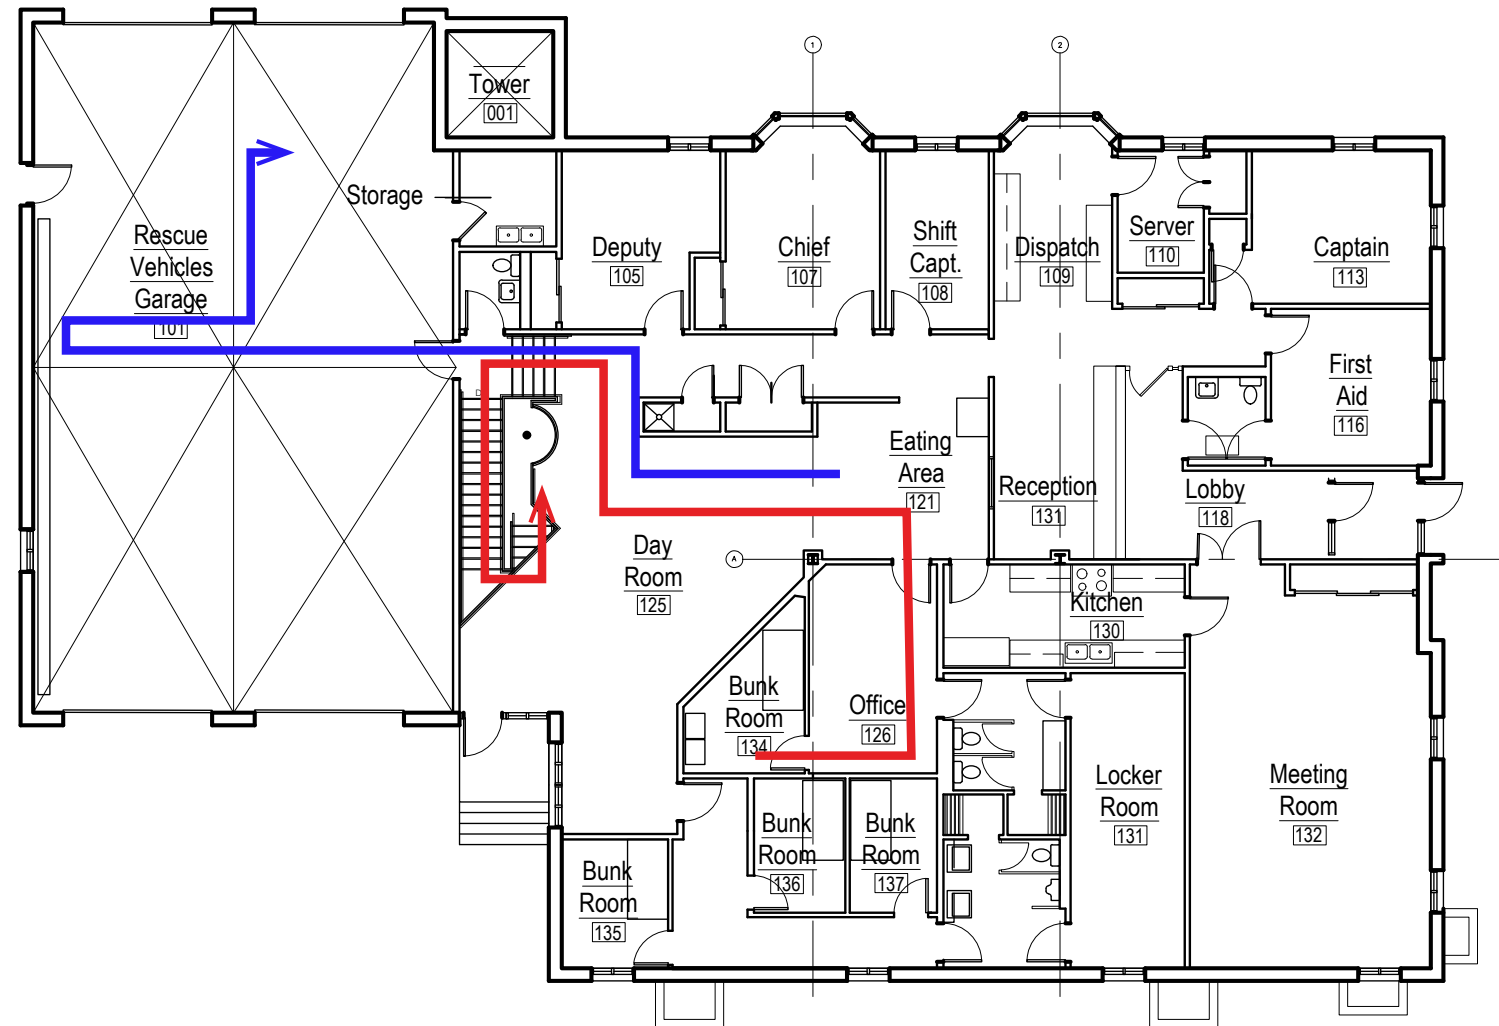
No direct path to apparatus

Slow response times due to poor layout

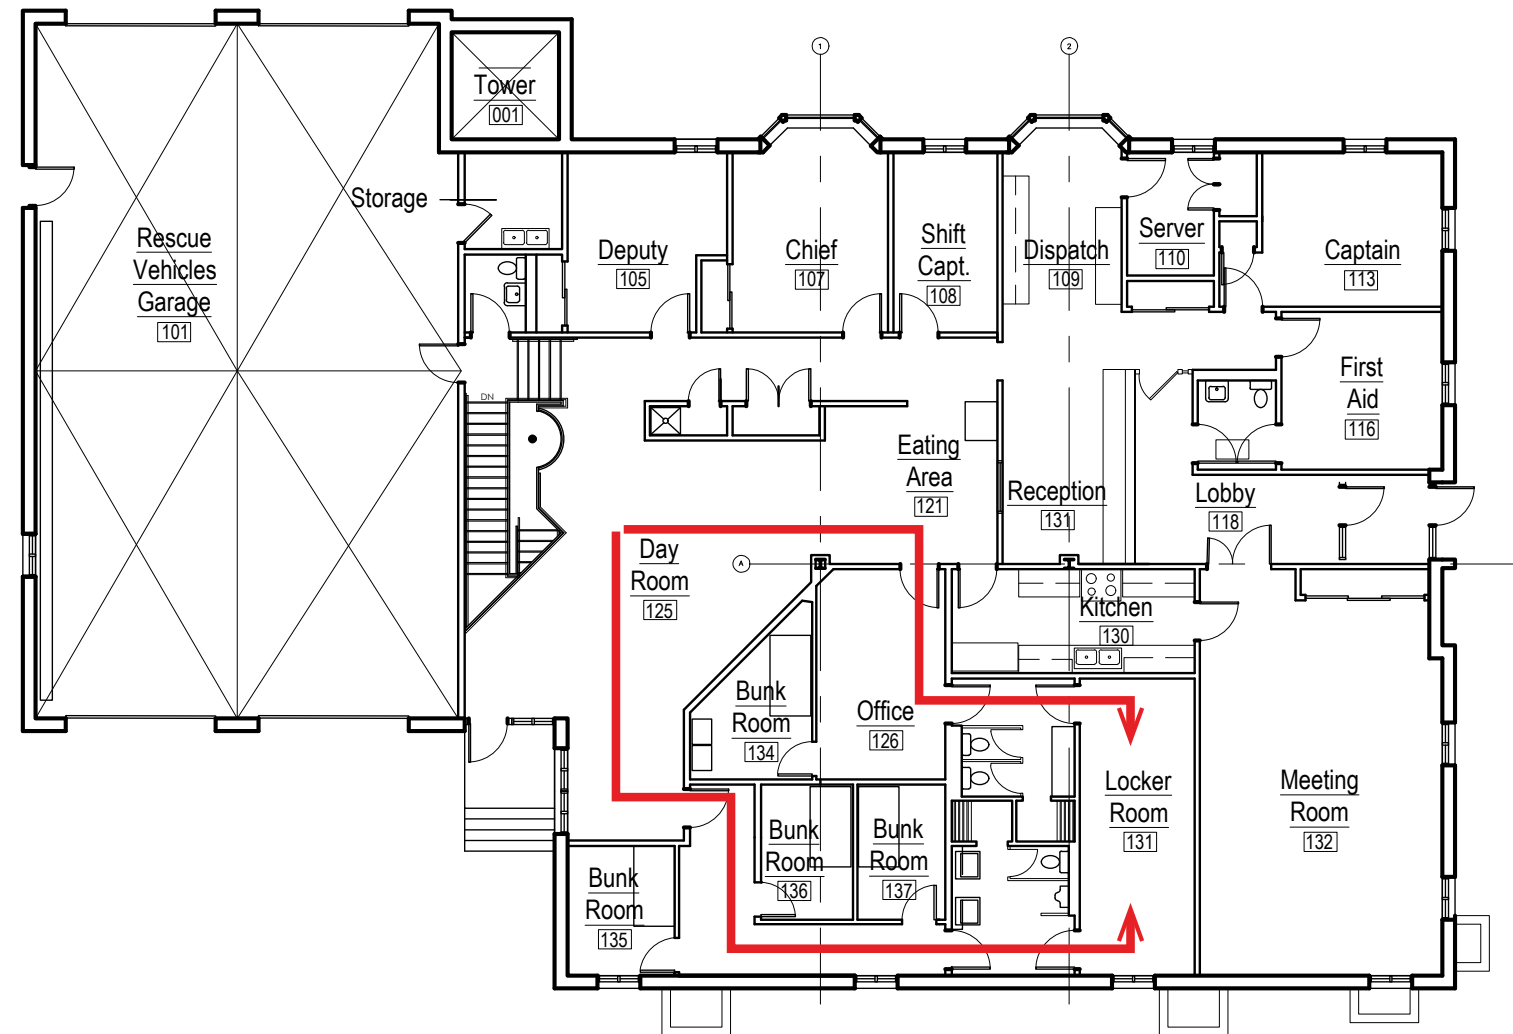
Locker room - path is through the male/  
female bathrooms. Poor circulation path

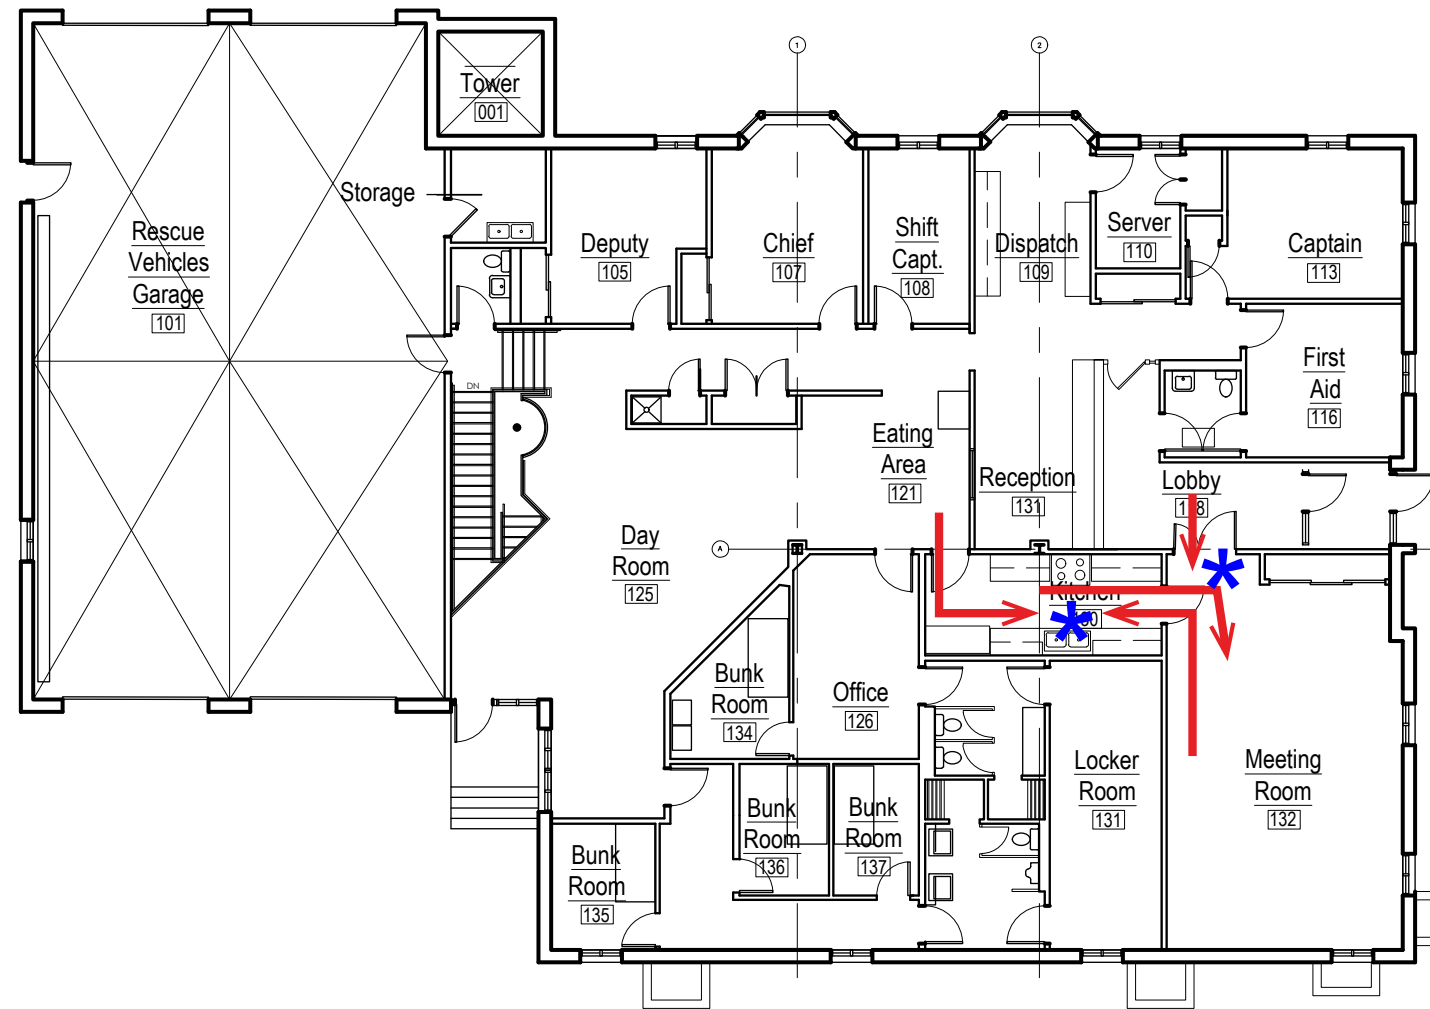
Kitchen - Path in/through kitchen is problematic

Dayroom/eating area is the main circulation hub - Inadequate for station personnel

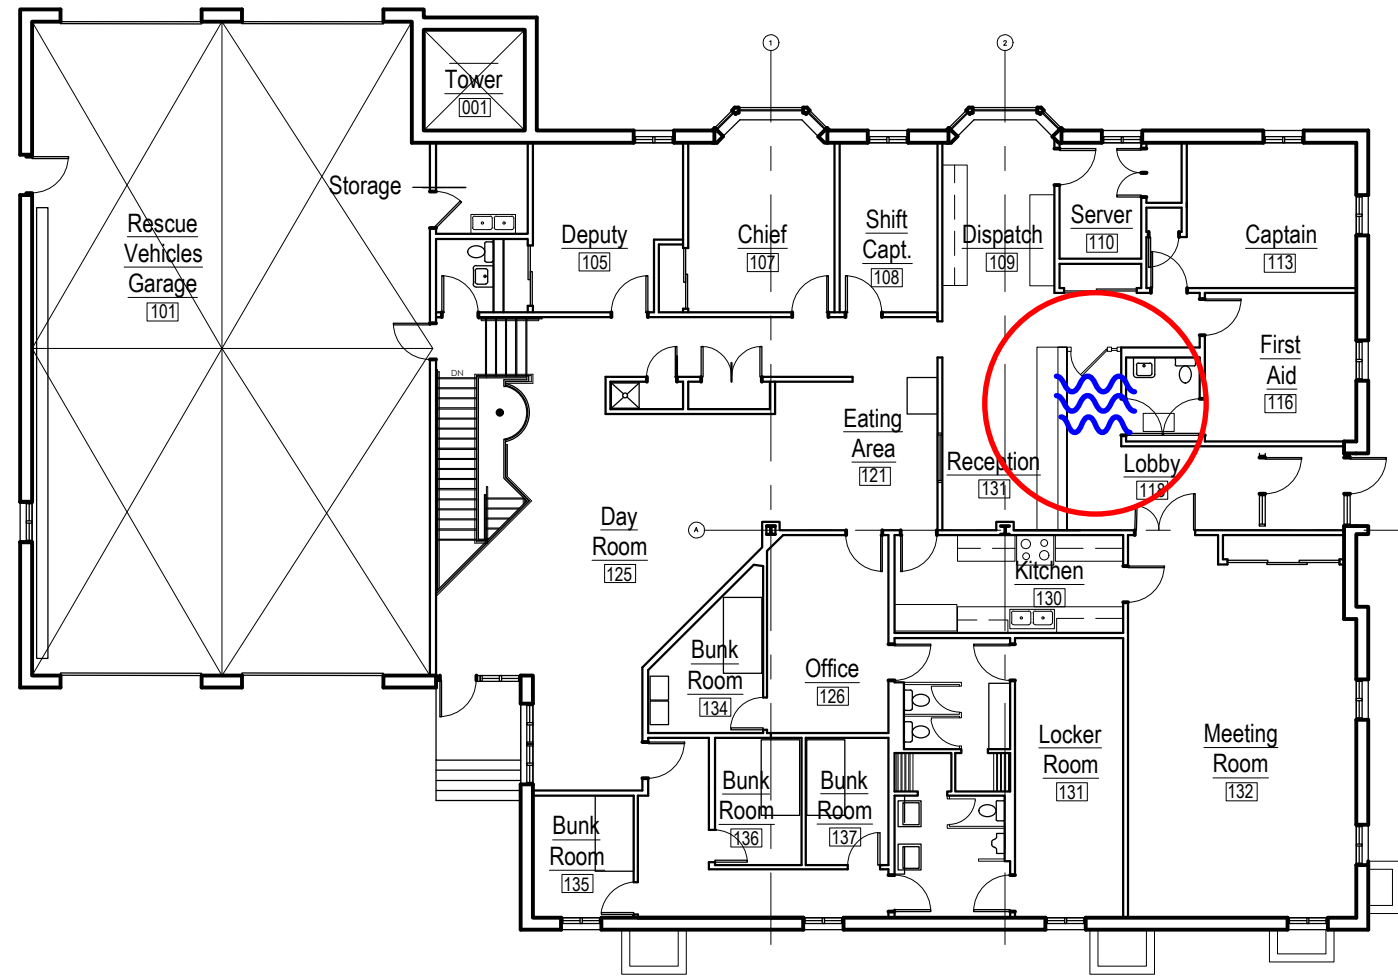
Location of restroom -  
distracting/odors

Re-purposed  
bunkroom too close to  
offices and eating area

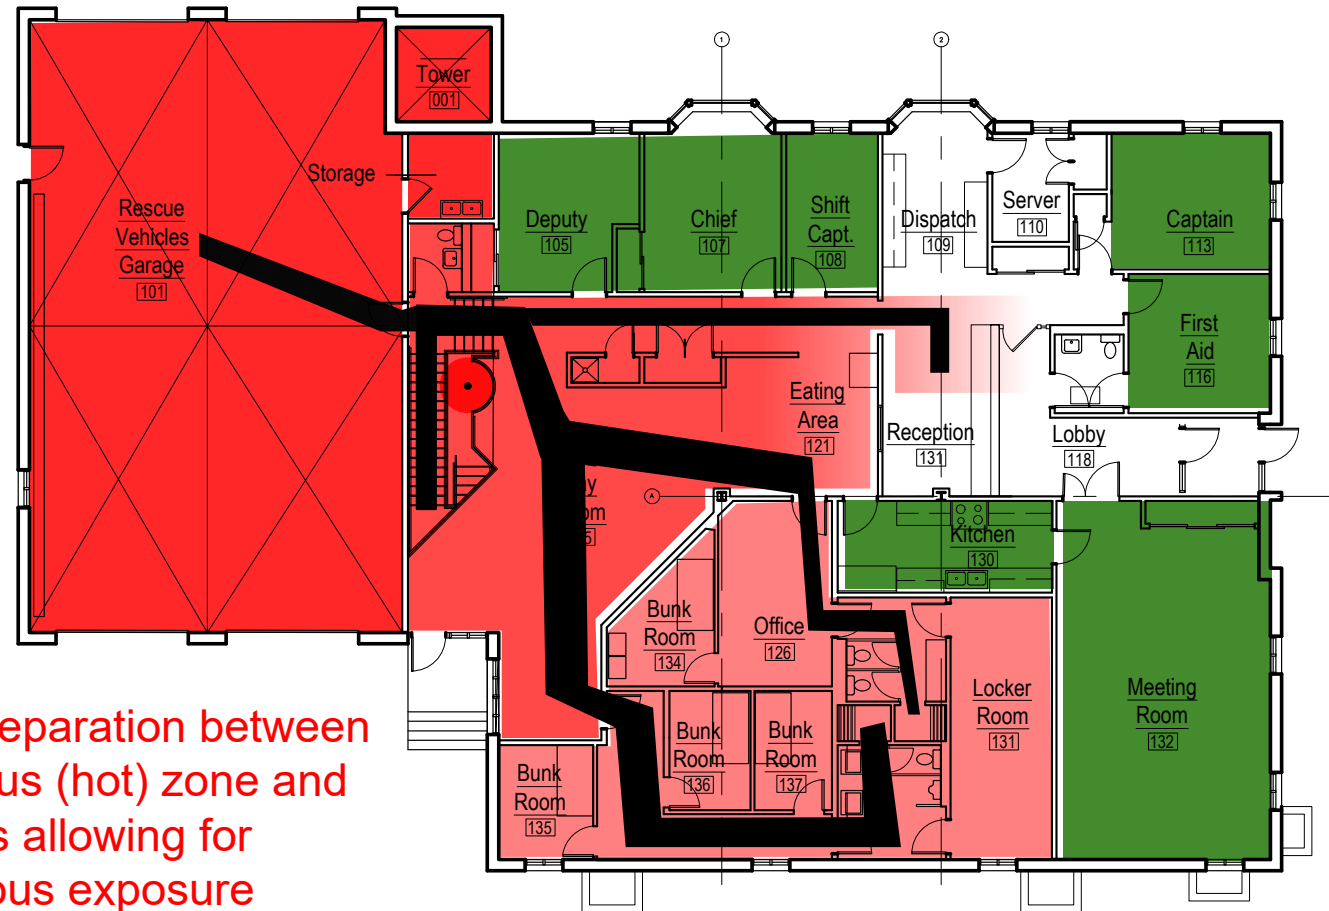
No air separation between apparatus (hot) zone and showers allowing for dangerous exposure in the living quarters

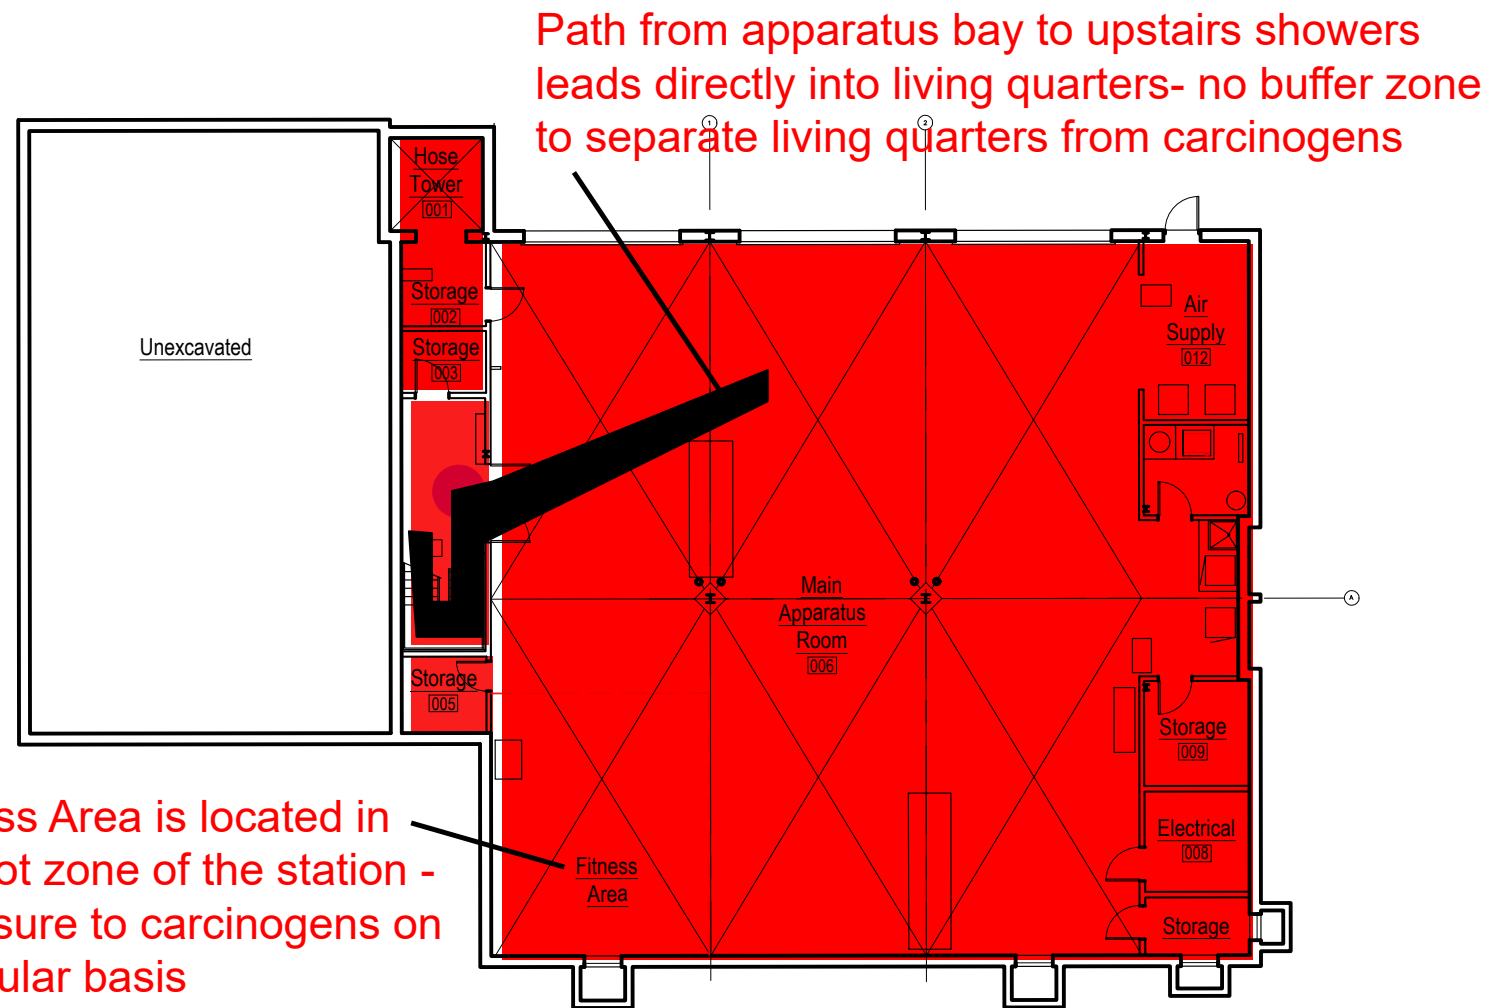
Fitness Area is located in the hot zone of the station - exposure to carcinogens on a regular basis

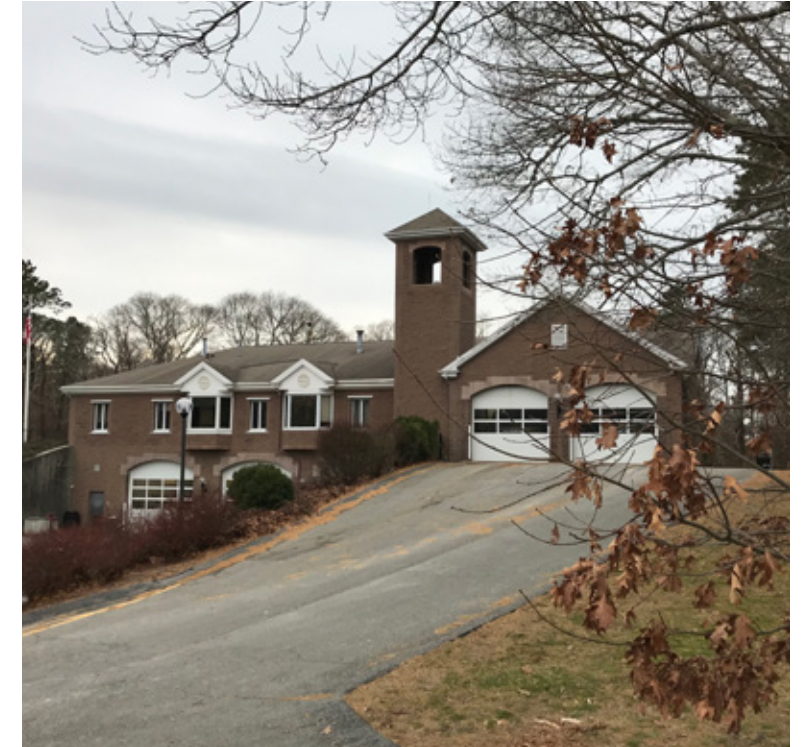
Main Entry to building is not clear, and access has non-compliant slope

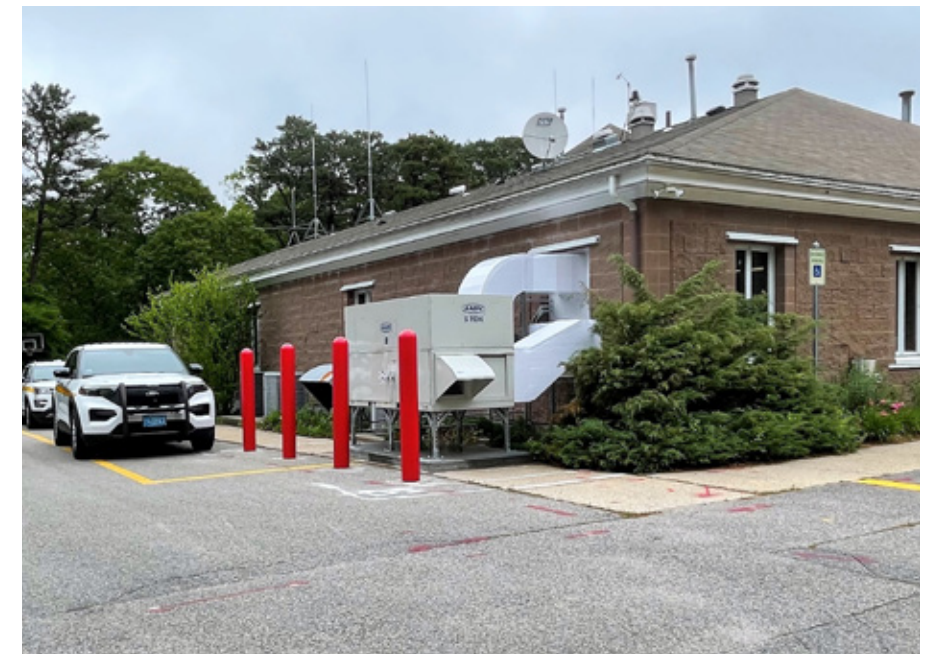
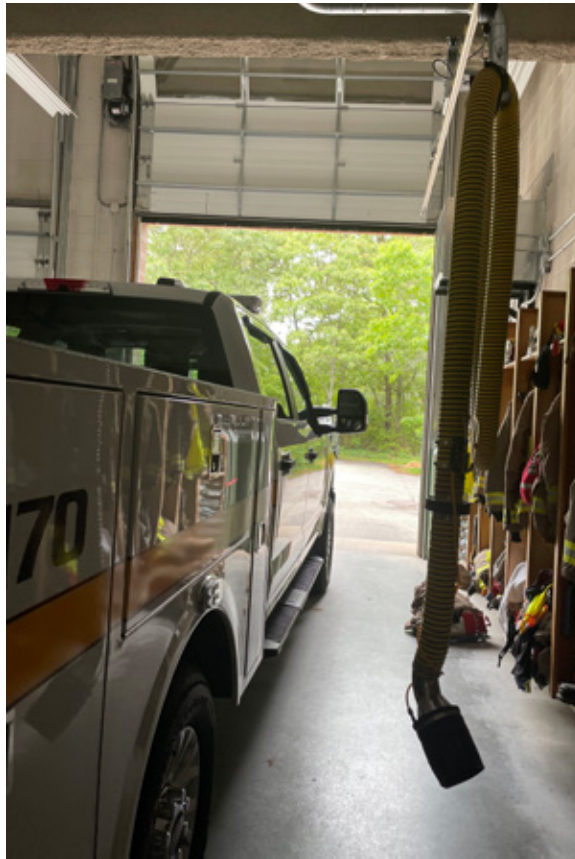
Apparatus bays are too small for current fire-rescue vehicles

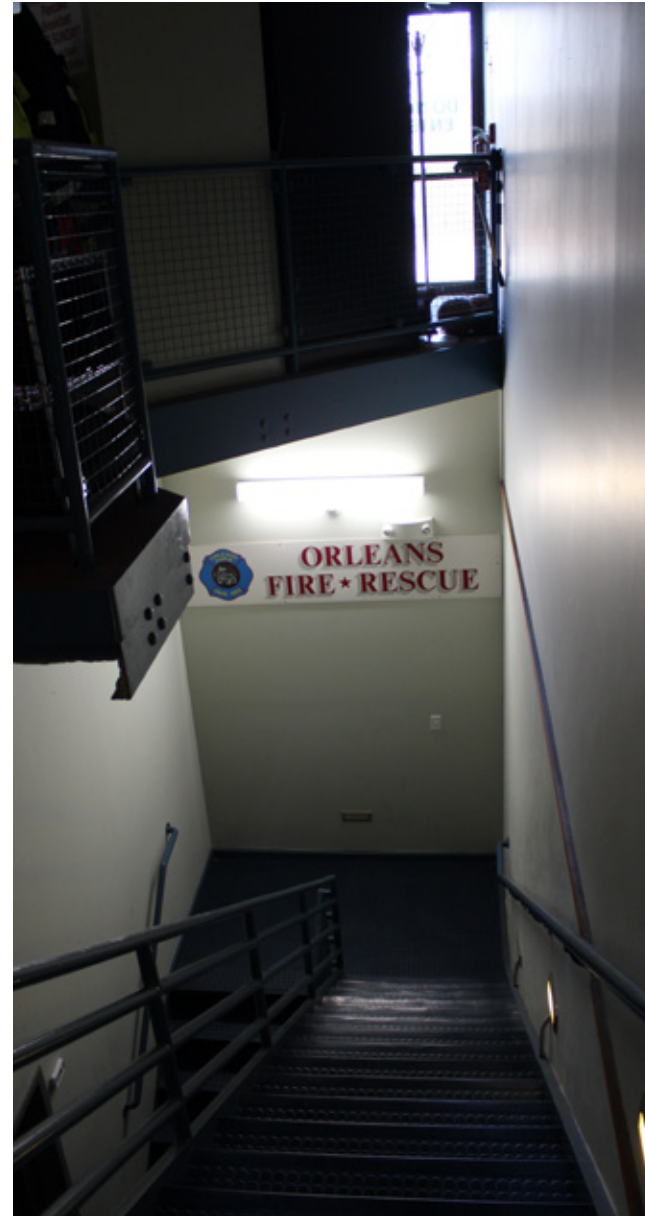
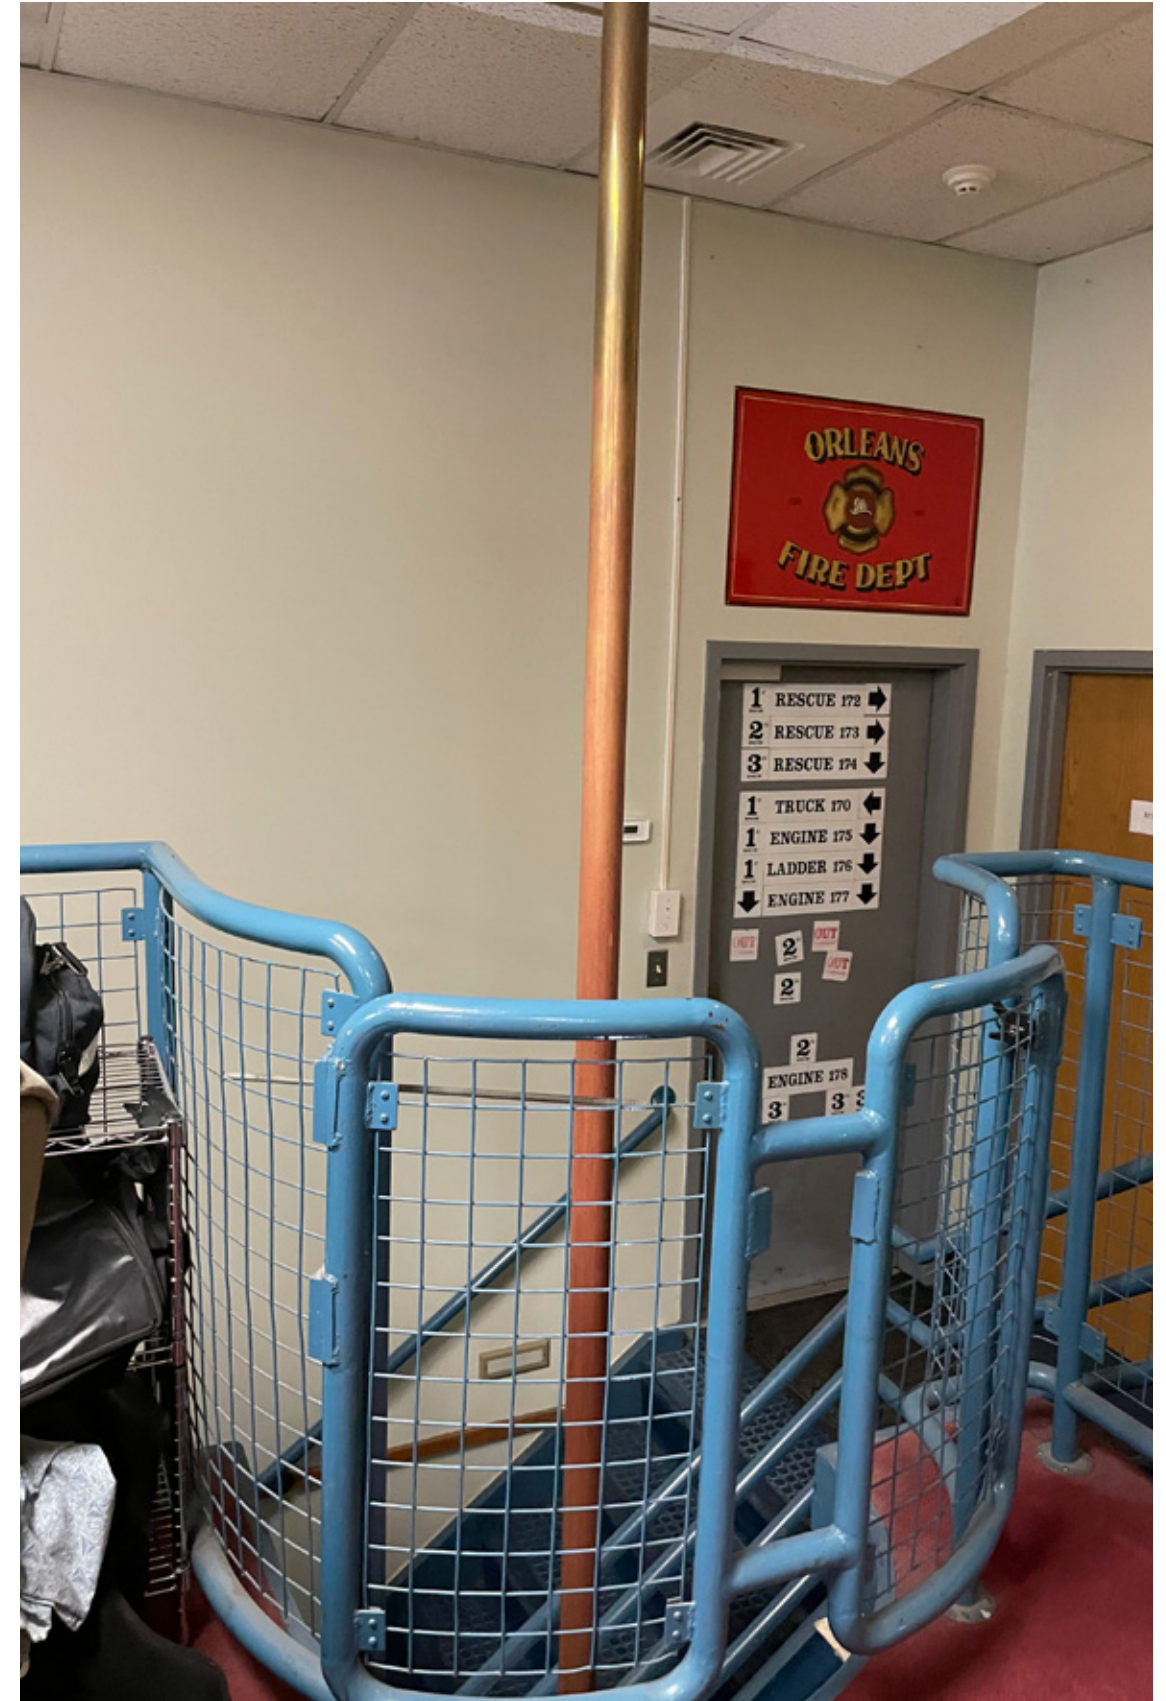
- No air separation between the apparatus bay and the living quarters
- Pole does not meet safety guidelines
- Pole is not used and is a space waster

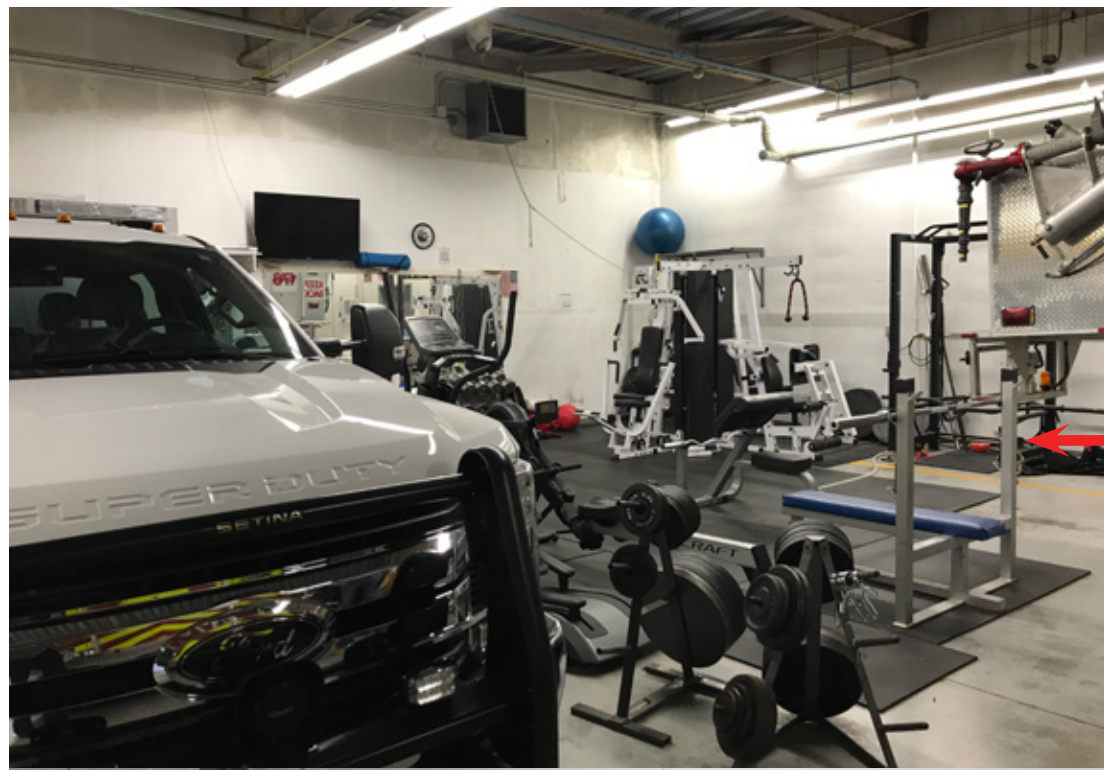
Fitness area in the apparatus bay puts personnel at risk of constant carcinogenic exposure

No janitor's closet so cleaning supplies are continually exposed too
