# TOWN OF ORLEANS FIRE STATION FEASIBILITY STUDY

August 11th, 2021

# FIRE STATION FEASIBILITY STUDY

A structural inspection of the Orleans Fire Station located at 58 Eldredge Park Way, Orleans, MA 02653 was conducted on June 4, 2021. The visual inspection (no test) was performed to evaluate the overall condition of the existing building as part of the feasibility study for the Fire Station.

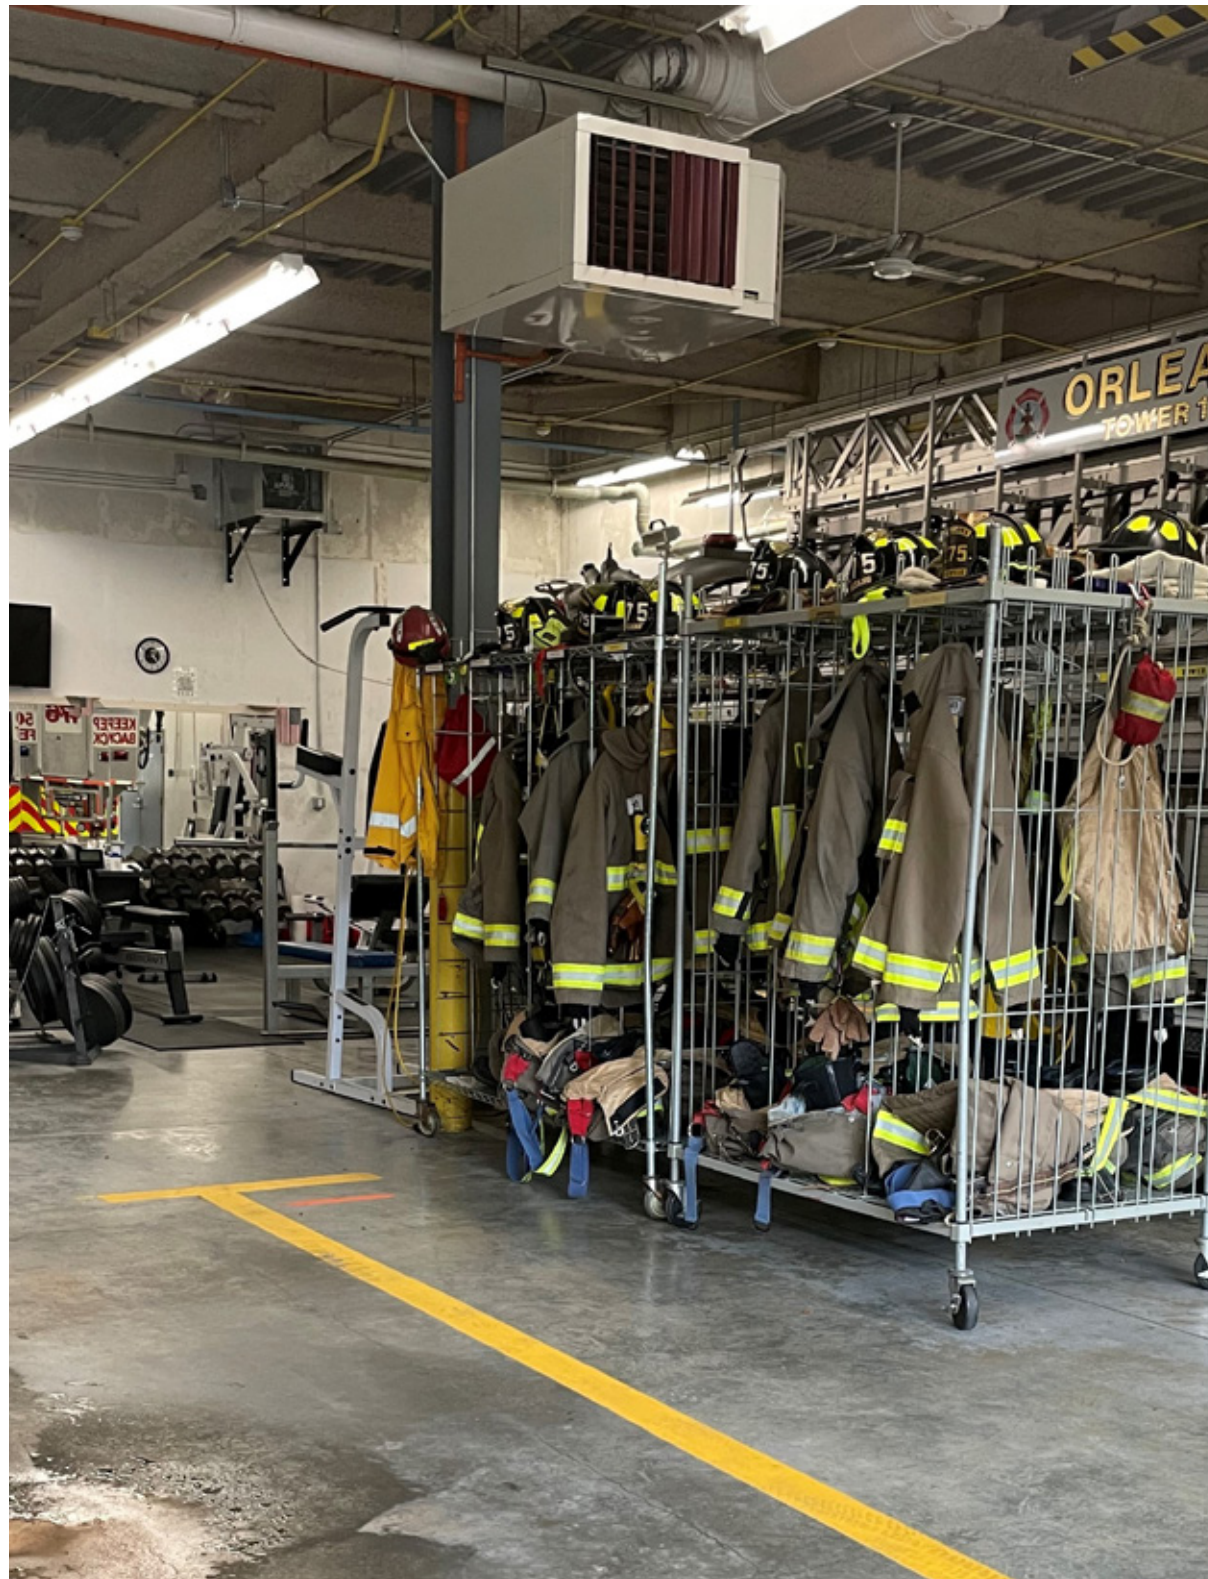
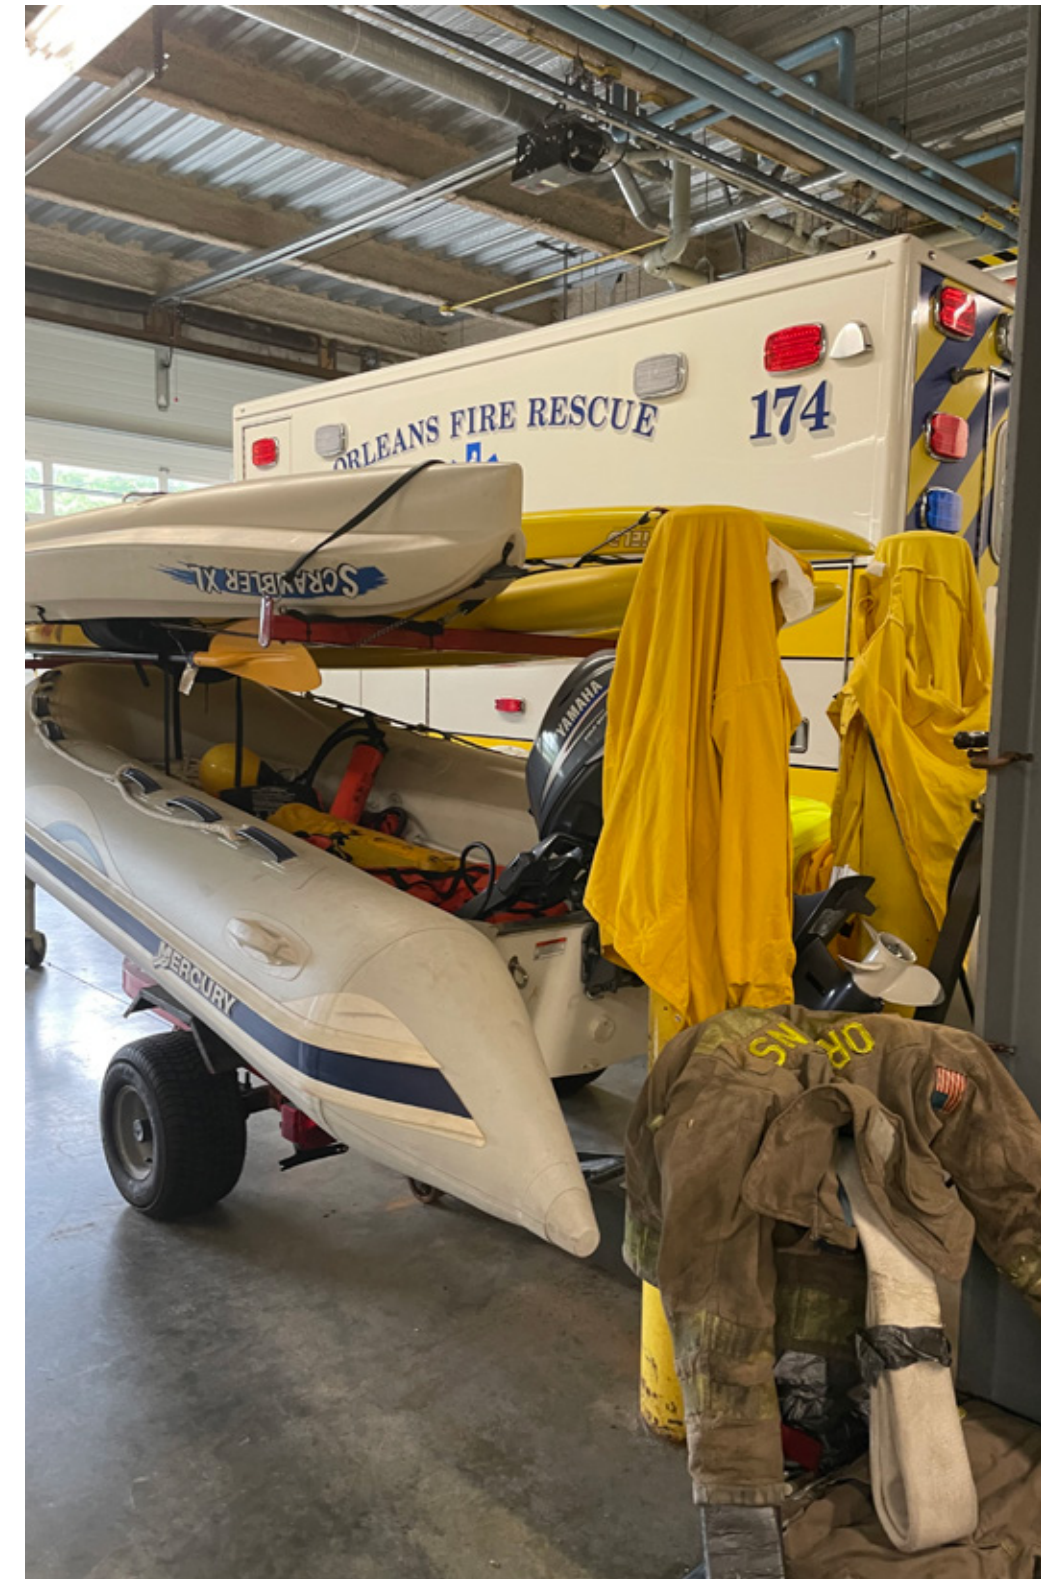
Lower Apparatus Bay

Lacks designated storage for turnout gear - not compliant with NFPA standards

Protective gear is often dried in apparatus bay or outdoors

- Inadequate and not isolated laundry facilities
- Inadequate repair space
- No proper ventilation
- Inadequate plumbing services

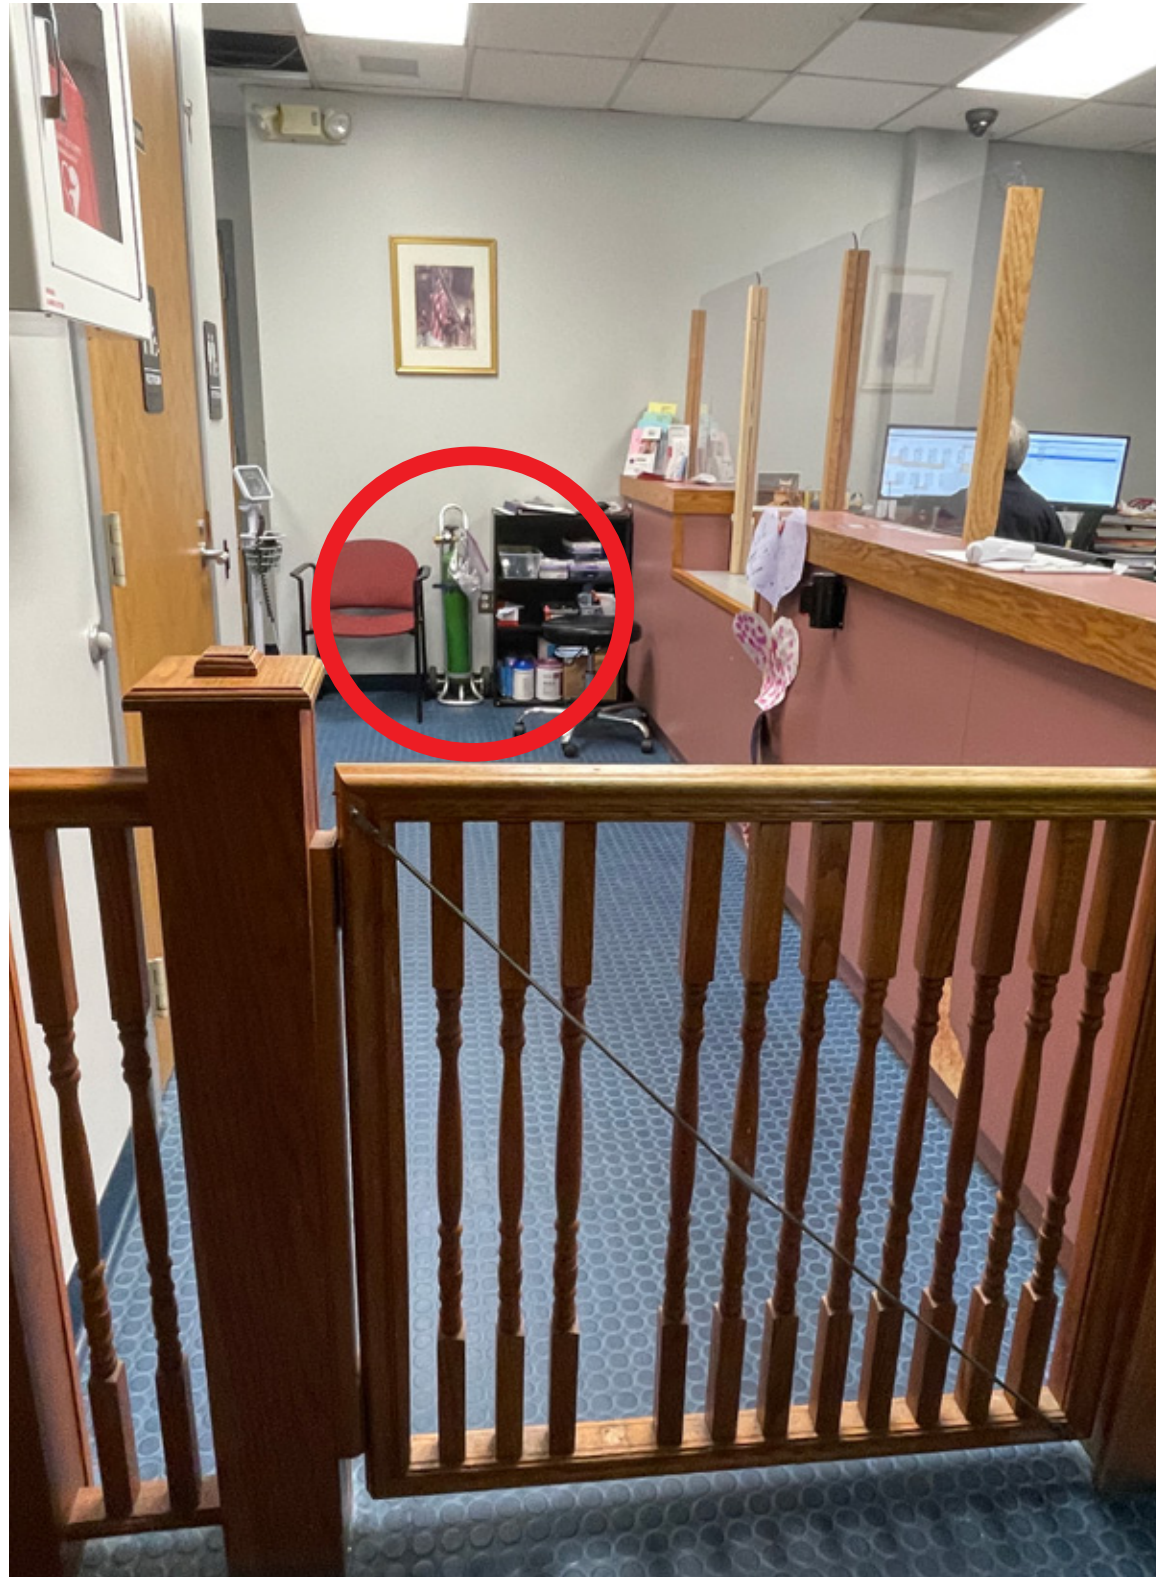
Public, handicap accessible bathroom is directly  
opposite Reception area - odors can be distracting

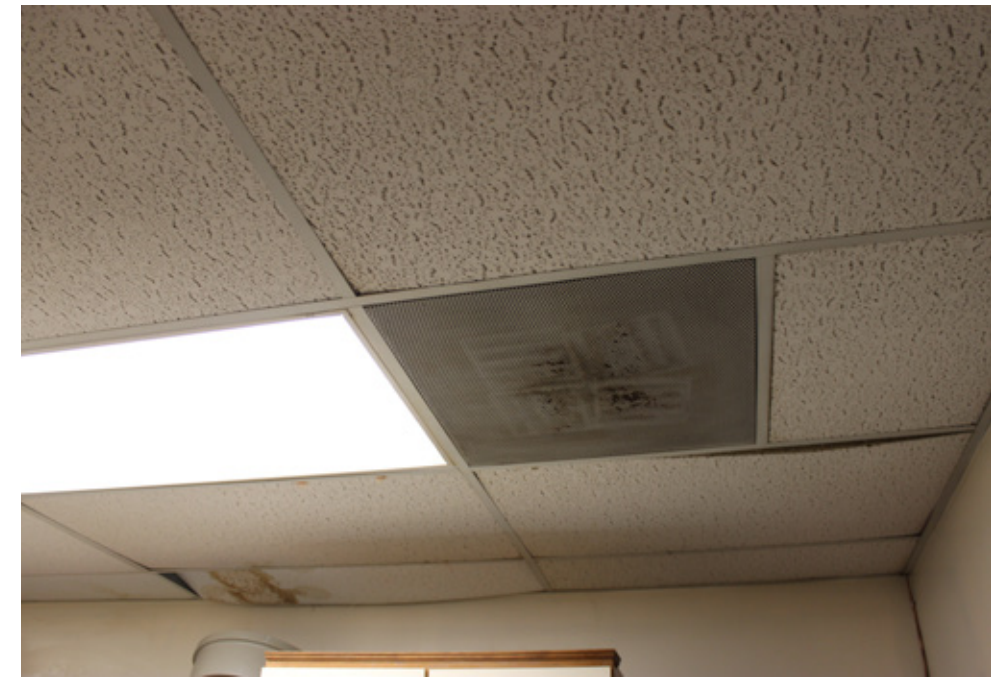
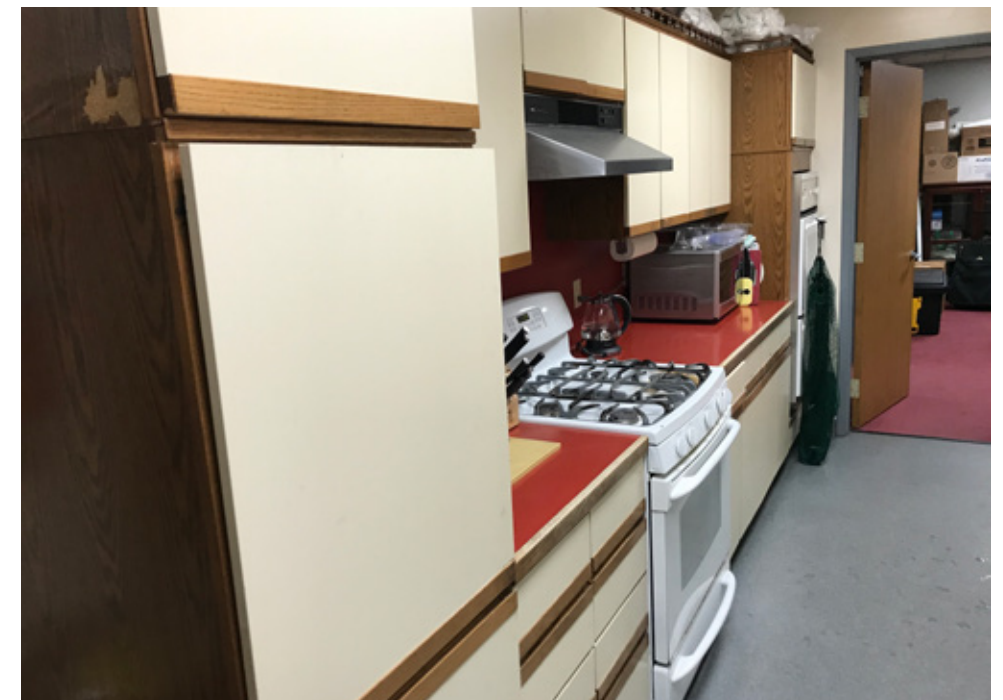
Kitchen:

- Inadequate Facilities
- Outdated and outgrown
- Not MAAB Compliant

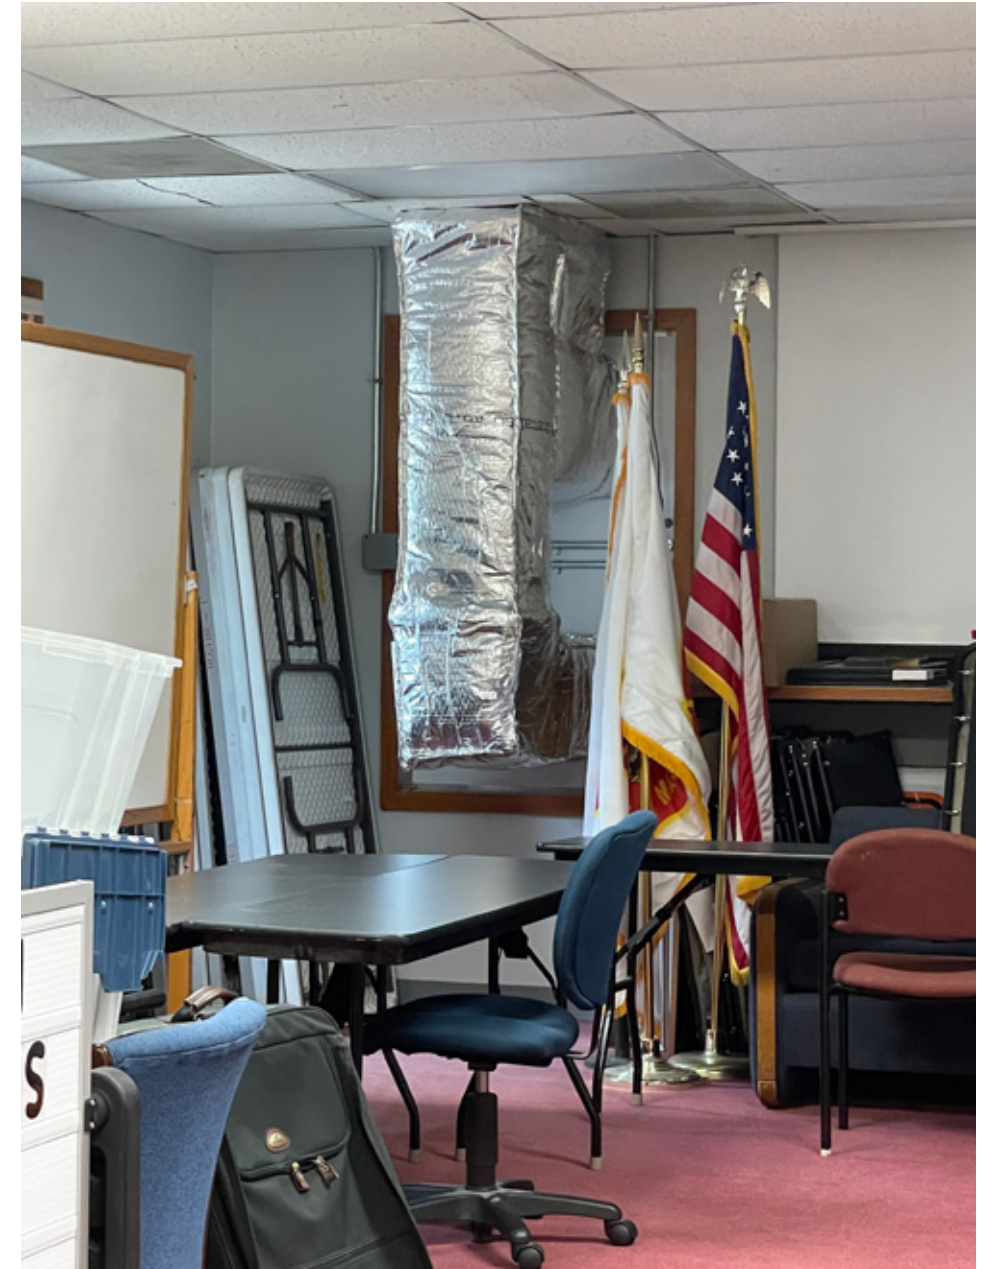
Training/Meeting Room currently serves primarily as storage. Space needed for station meetings/back up Emergency Operations Center

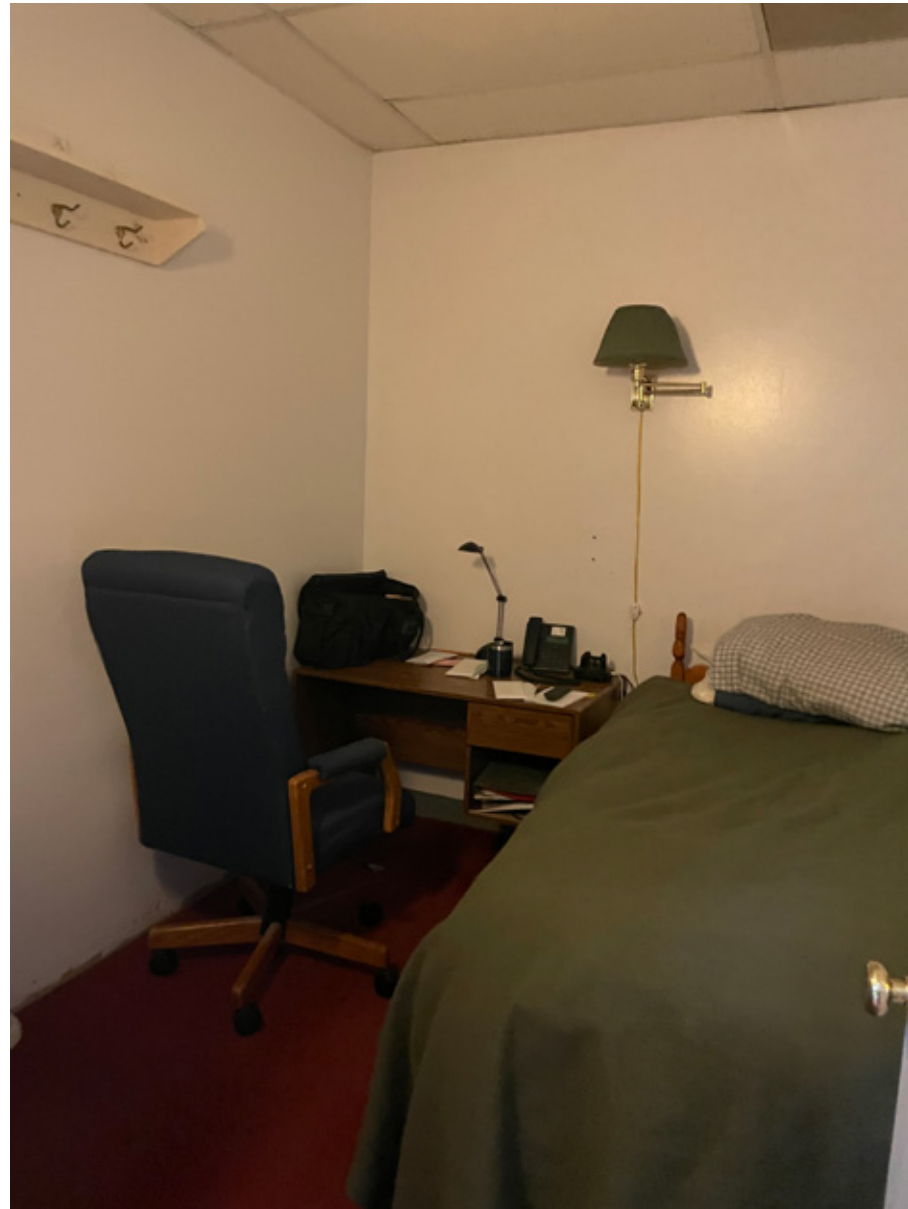
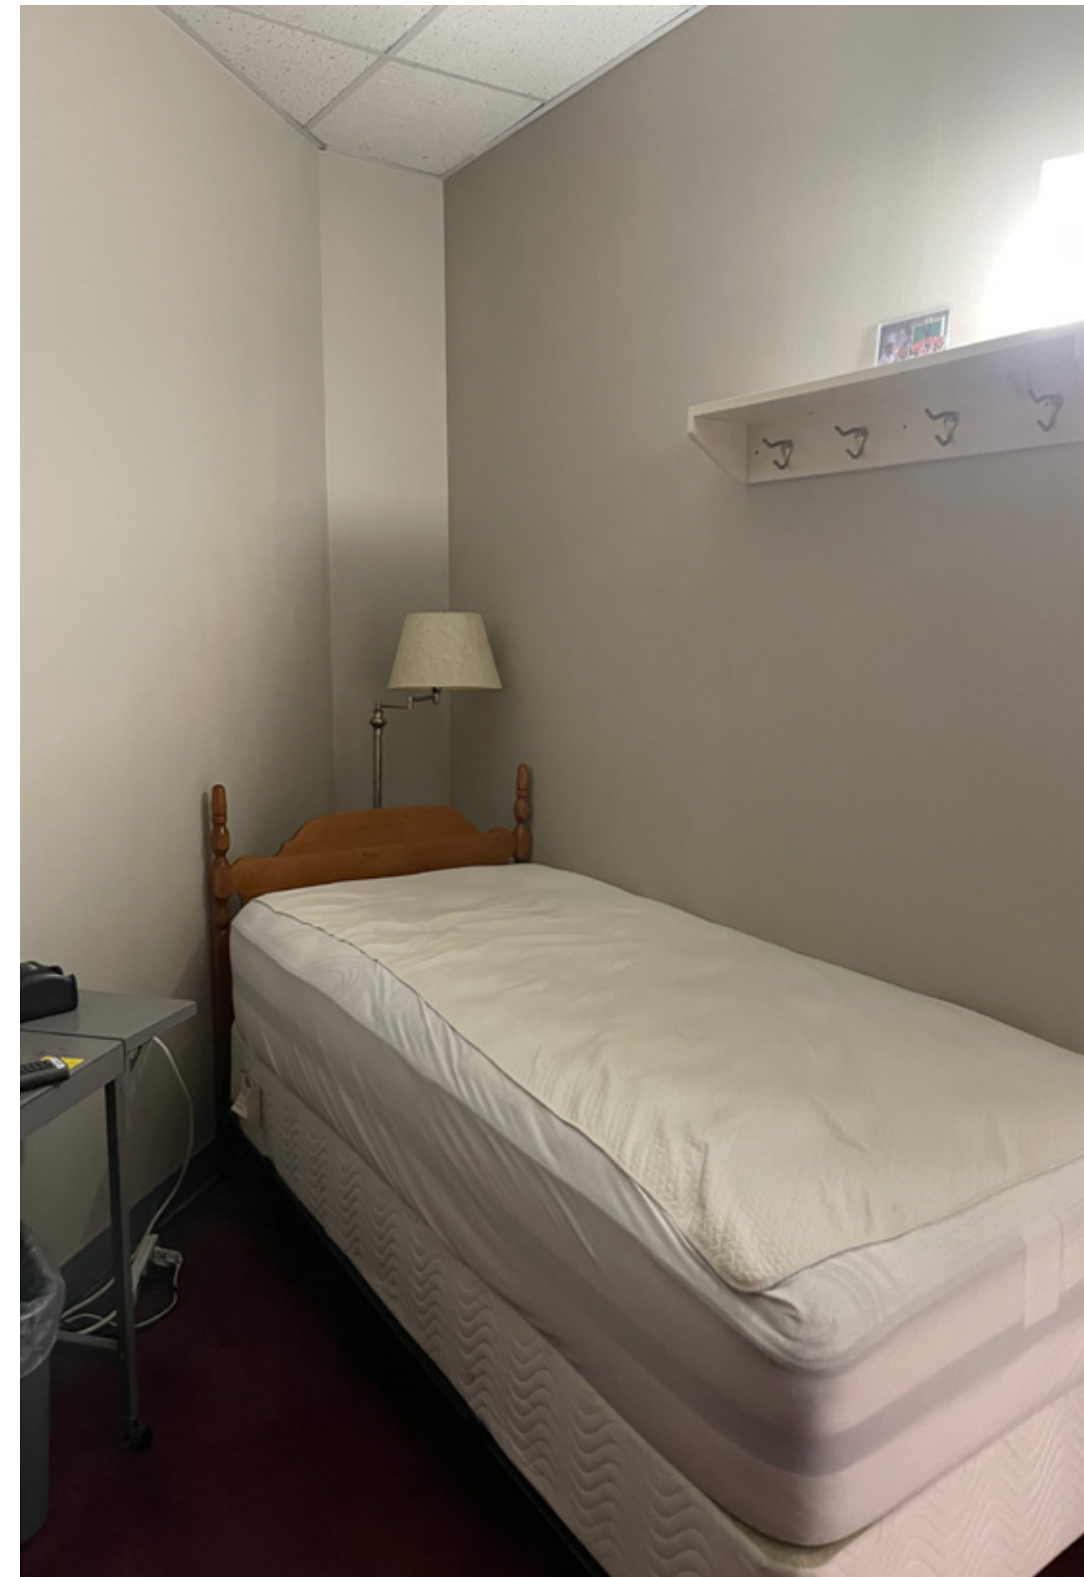
Bunkrooms are not Building Code and MAAB compliant as three of five rooms have no exterior walls and no windows

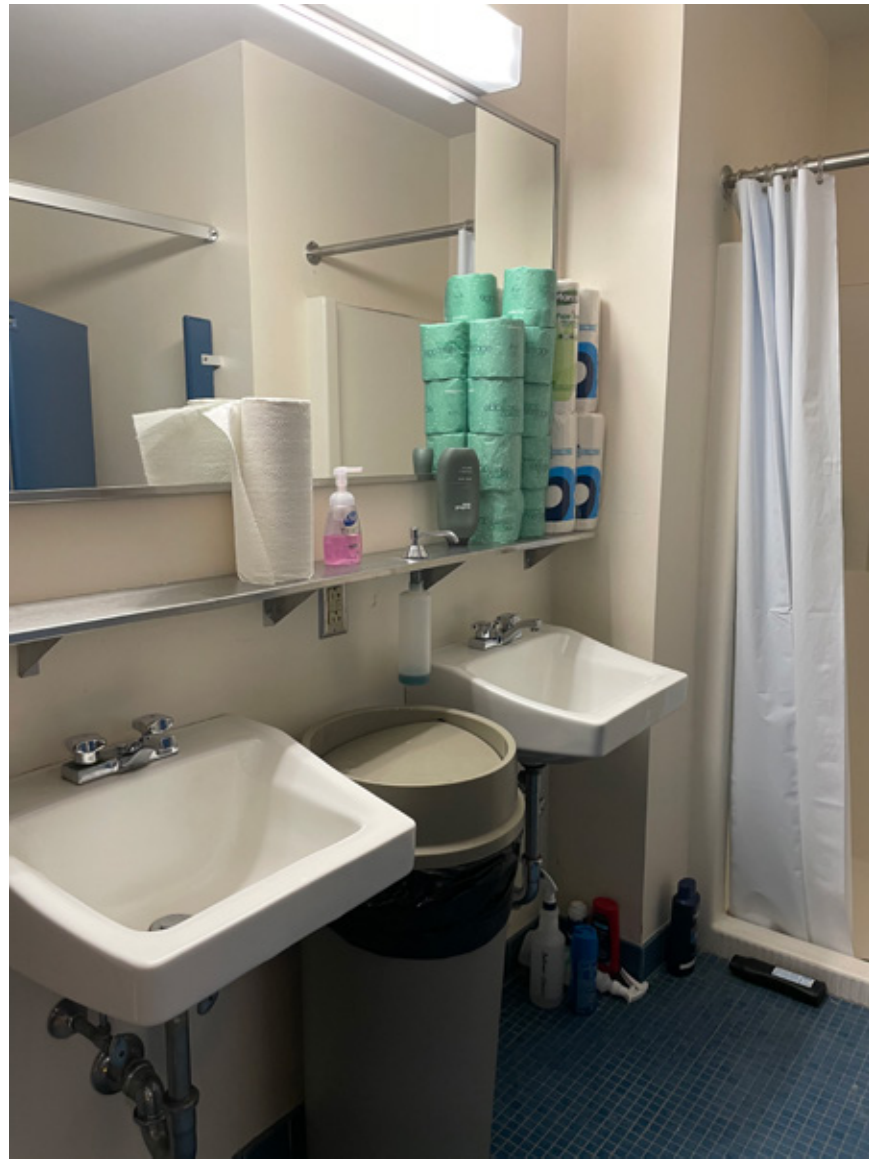
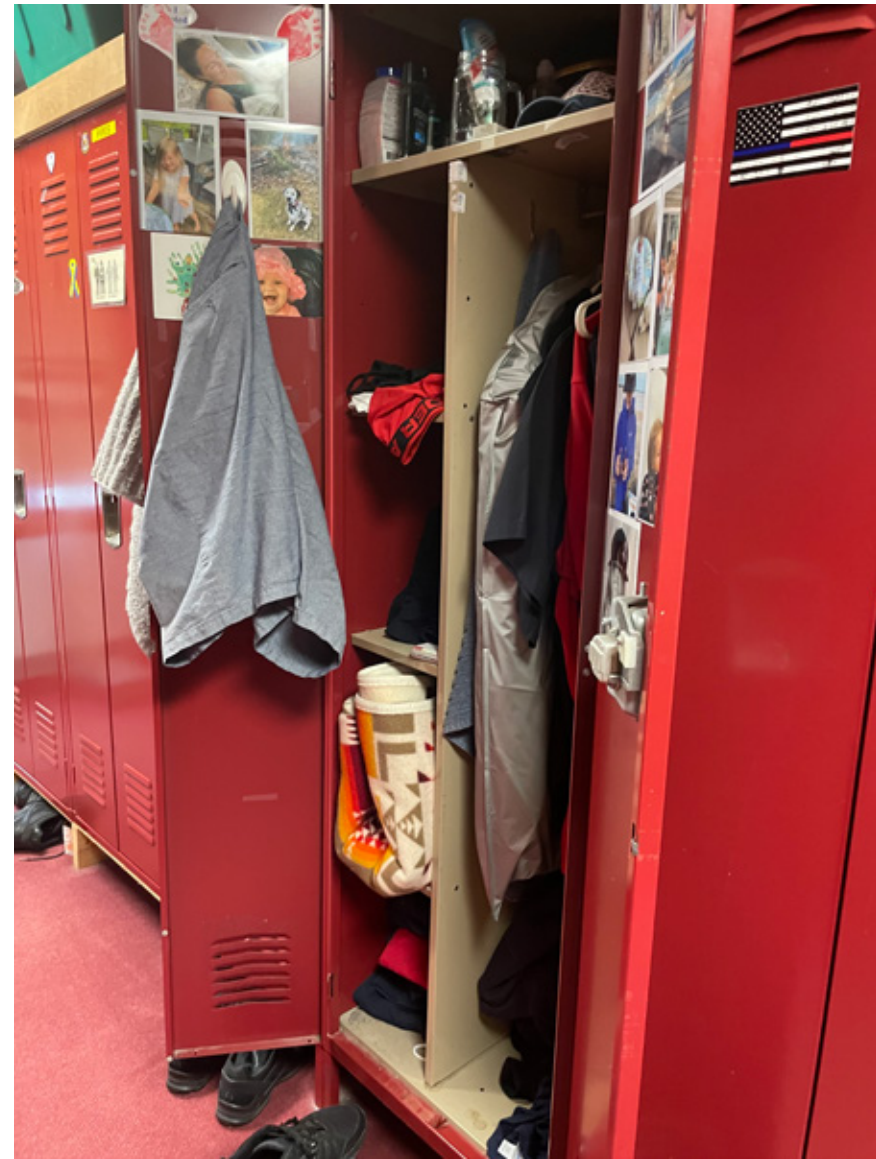
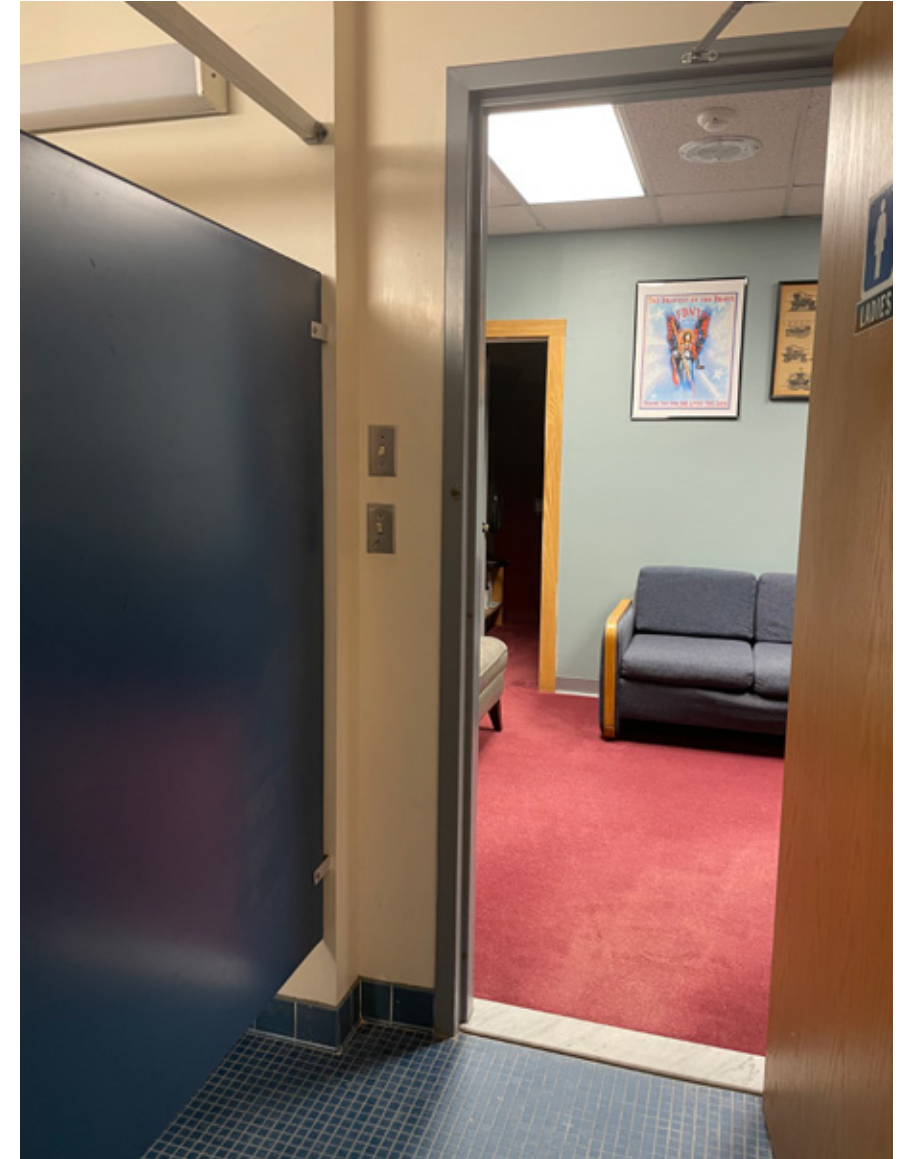
## Bunkroom Bathrooms

- There are two showers that are not MAAB compliant in the entire station (one for males, one for females).
- Due to their location in the center of the living quarters personnel must traverse the whole station following a call.
- Locker room is only accessible through the bathrooms.
- In general, living space is very cramped.

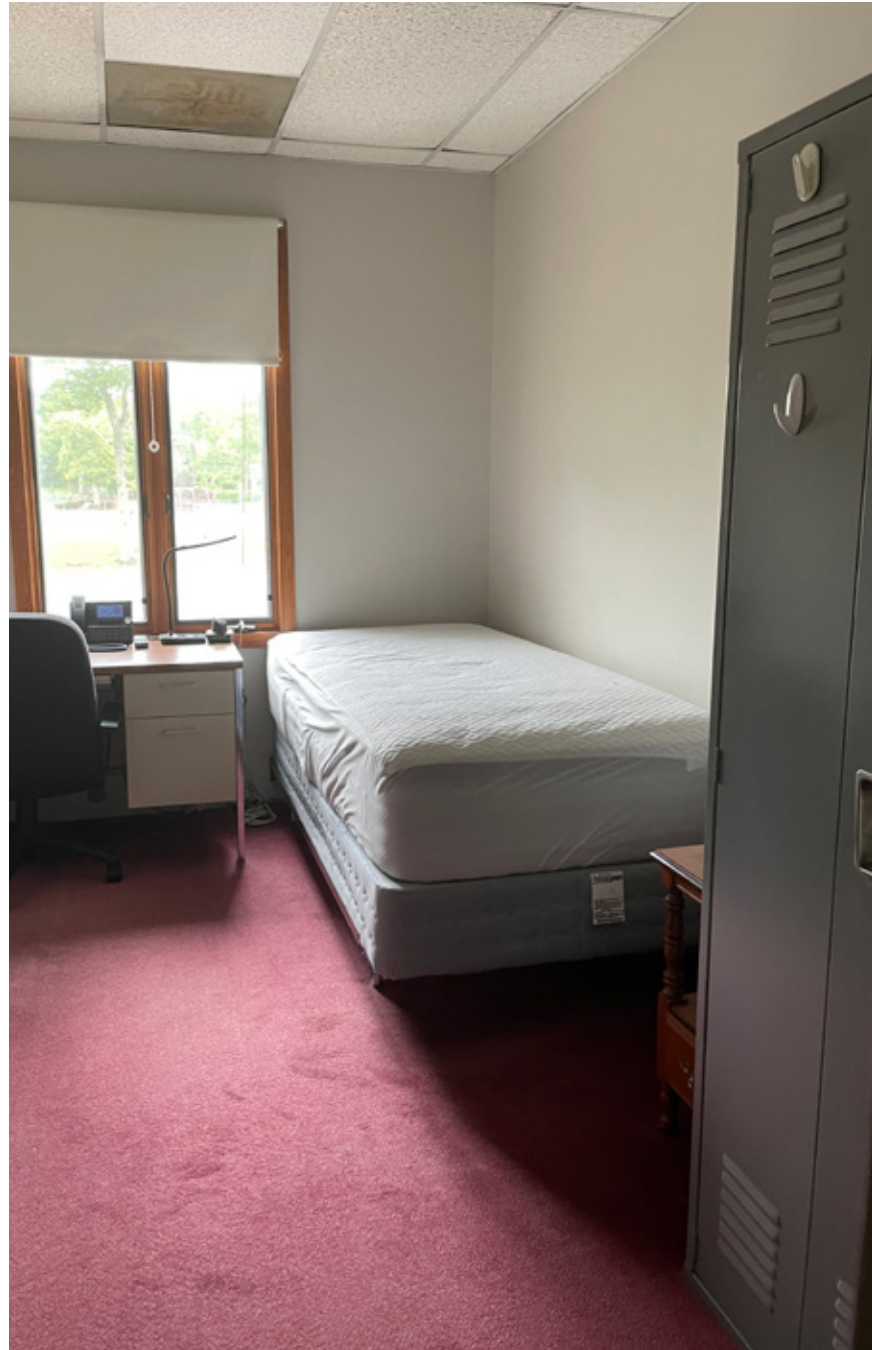
Office currently used as a bunkroom, poorly located

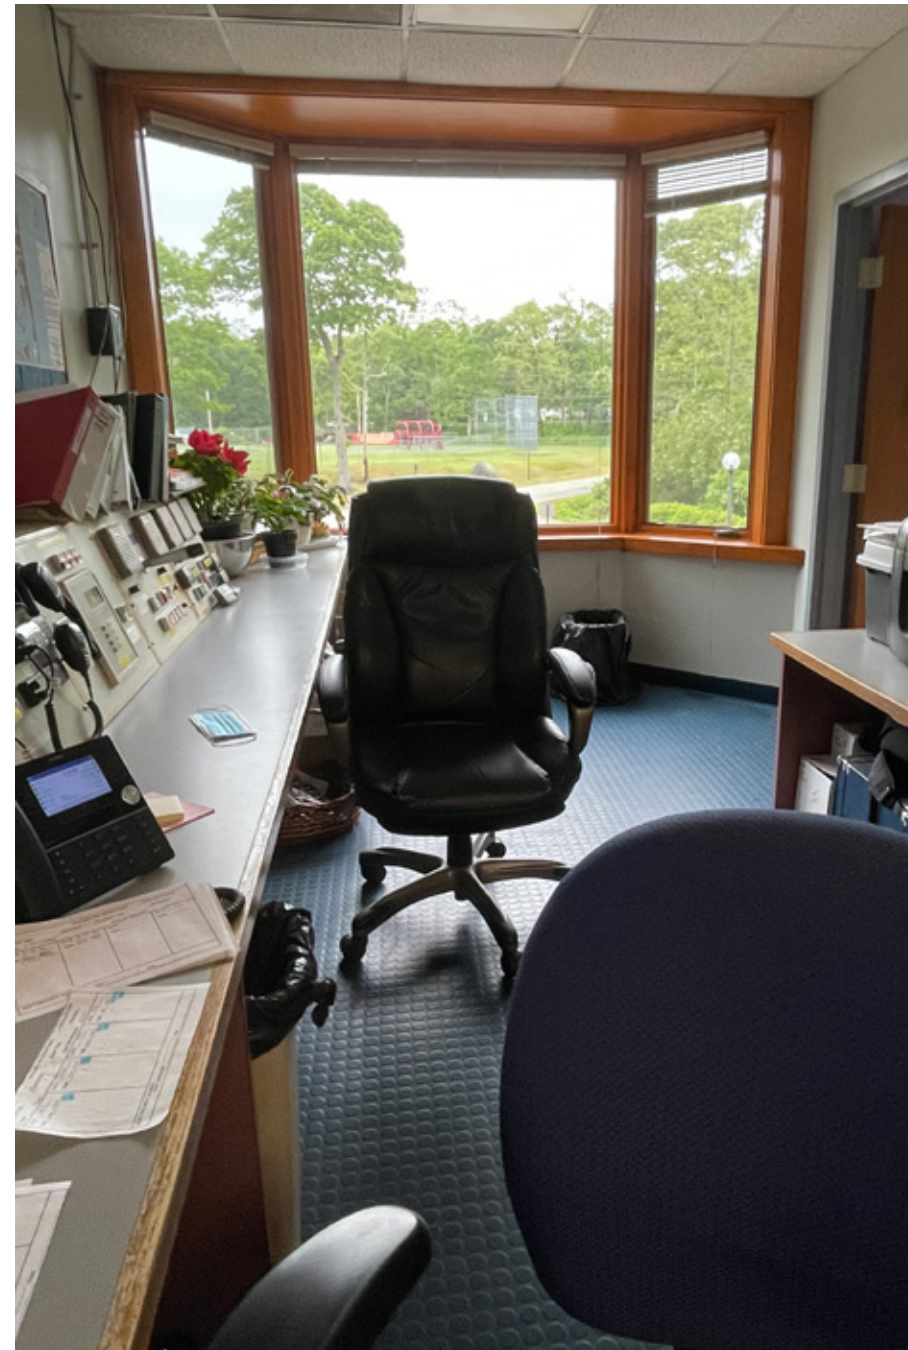
Dispatch area no longer used

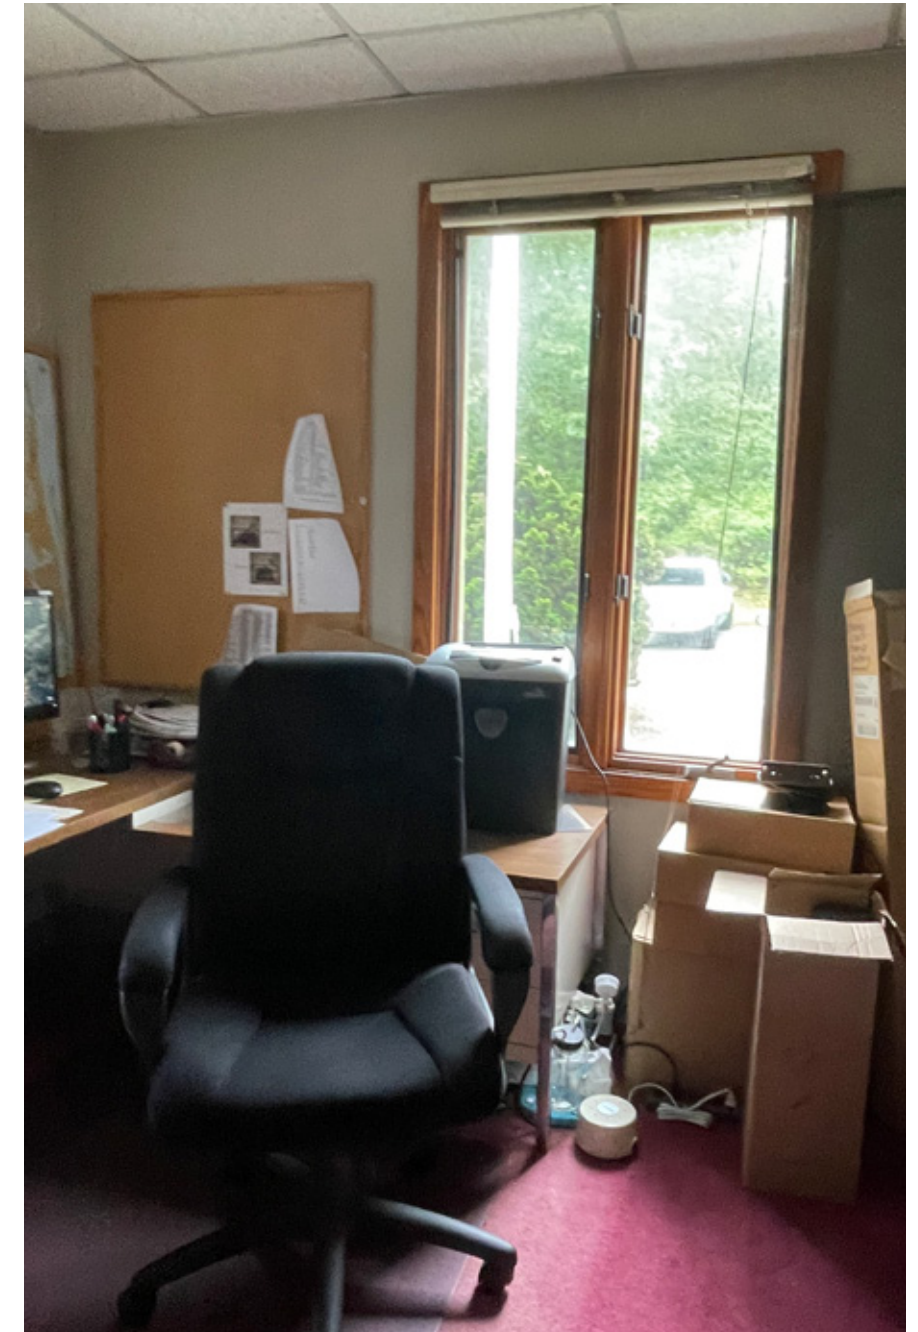
Office space crowded with stored equipment and supplies

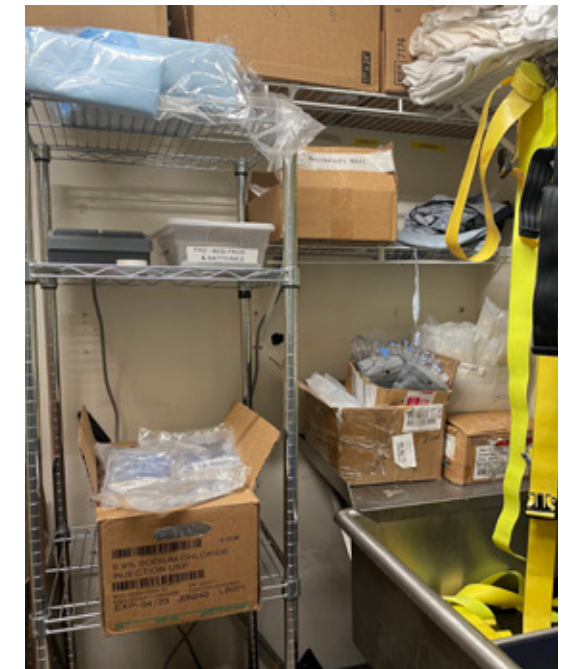
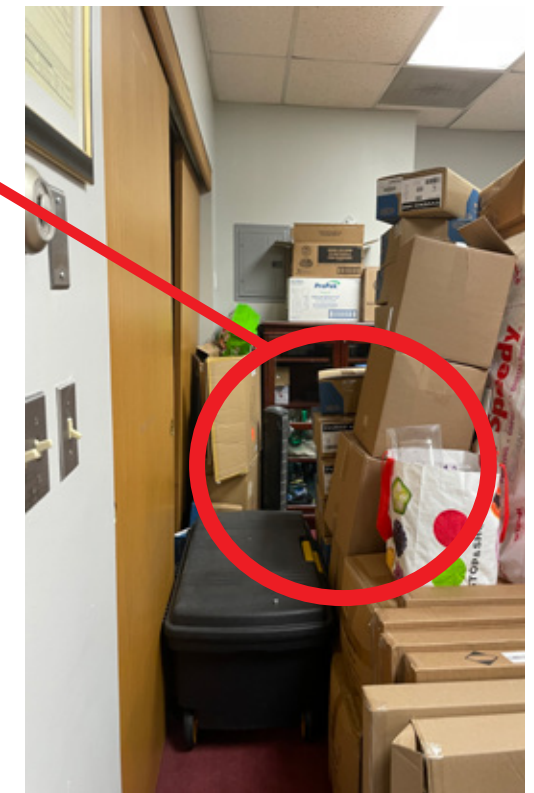
Storage found throughout the building in non-designated areas including in the dayroom, under stairs, and on top of cupboards

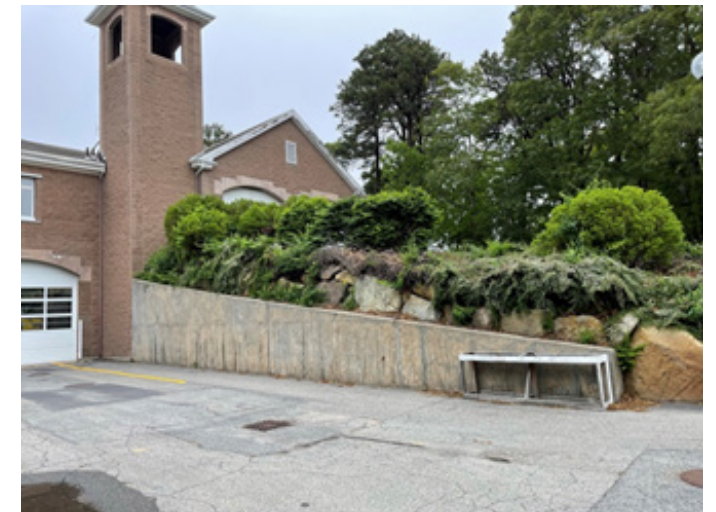
Photo #8 North Retaining Wall

- c. No surface erosion observed around the base of the building and soil line.
  - d. Both retaining walls in front of the main apparatus room entrance were generally in good condition with some hairline cracks but no sign of movement or settlement.

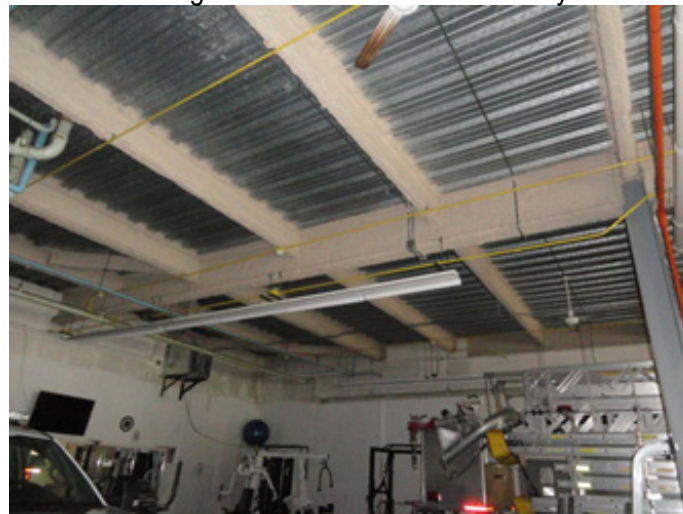
Photo #13 First floor steel framing above the main  
apparatus bays

- c. The first floor steel framing and deck is in good condition with some surface rusting observed at the base of the steel columns and minor rusting at the underside of the steel deck and around the floor penetrations observed at the main apparatus room.

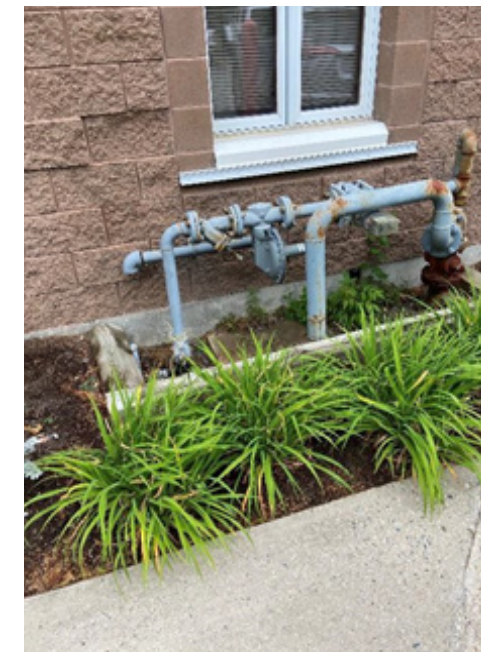
Gas Service

1. Domestic Water Service: The existing building is currently served by a 2-1/2" domestic water service fed from the local water company. The service equipment includes a water meter and isolation valves. If the building is expanded, a new domestic water service would be required.
2. Natural Gas Service: The existing building is currently served by a single natural gas service which enters the building at grade level outside of the First Aid room. The gas service serves the water heater, unit heaters, fan coil furnaces, generator, and kitchen equipment. Natural gas piping within the building is schedule 40 black steel pipe. Shut-off valves and regulators are provided where required. Natural gas supply is regulated at the building exterior prior to the gas piping entering the building. If the building is expanded, a new larger gas service would be required.

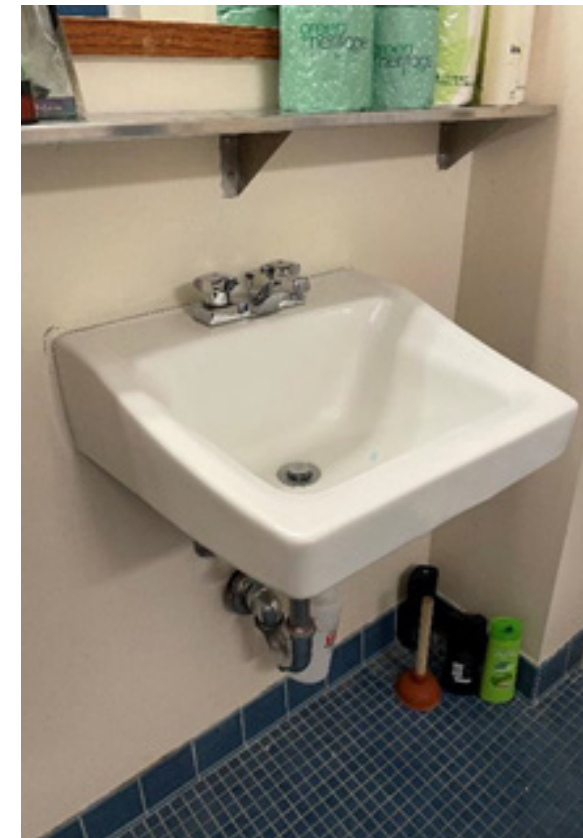
Existing Lavatory

3. Lavatories: Lavatories are wall hung vitreous china with two twist or two lever handle faucets. These fixtures do not have low-flow water usage and do not meet current code. It is recommended that these be upgraded to current plumbing code standards for water usage. It was brought to CES' attention that the lavatories drain slow and backup routinely. This problem is commonly because of an undersized waste and/or vent pipe

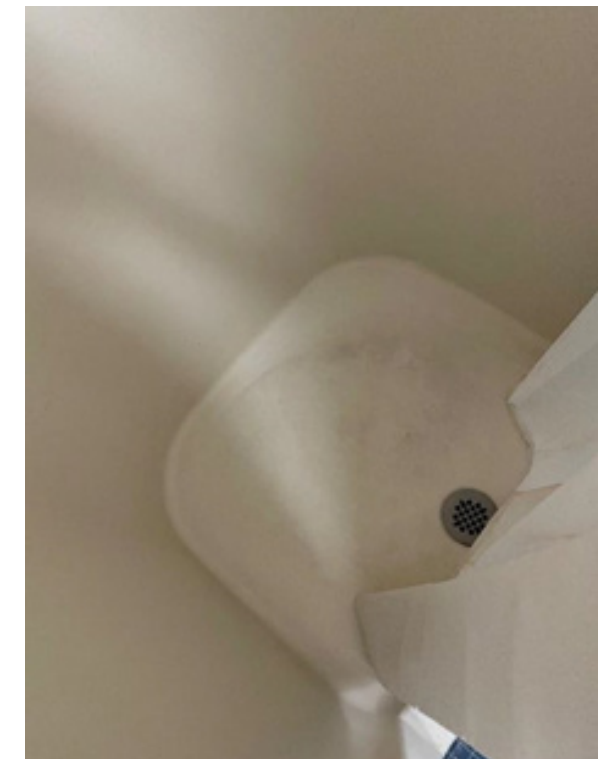
Existing Shower Drain

5. Showers: The two showers in the building are fiberglass units with integral thermostatic mixing valves. The showers appear to be in poor condition and it is recommended that these be replaced.

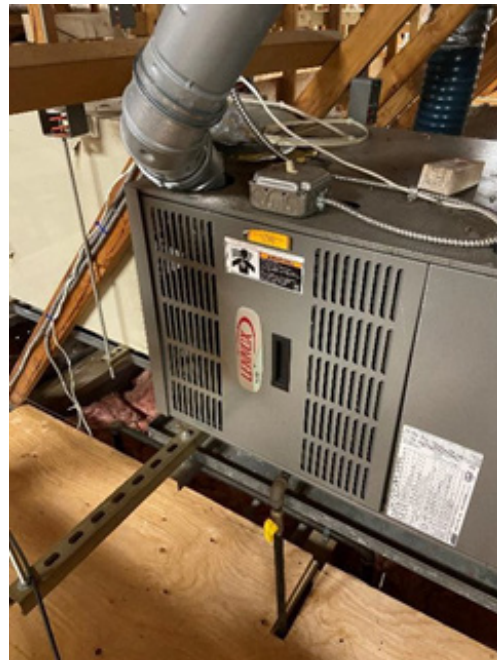
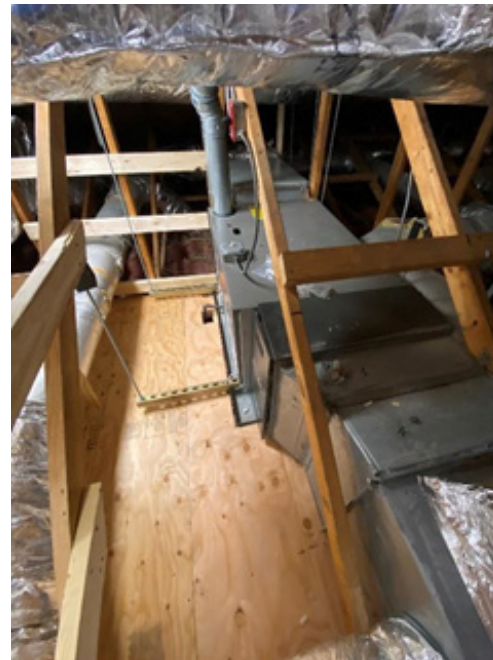
Furnace Unit in Attic Space

1. Heating and Cooling System: Heating and cooling is provided for the non-apparatus bay portions of the building via gas furnaces with duct mounted DX cooling coils. These units are located in the attic space of the building and ductwork is distributed to each space. The furnaces are at the end of their useful life and only in fair condition.

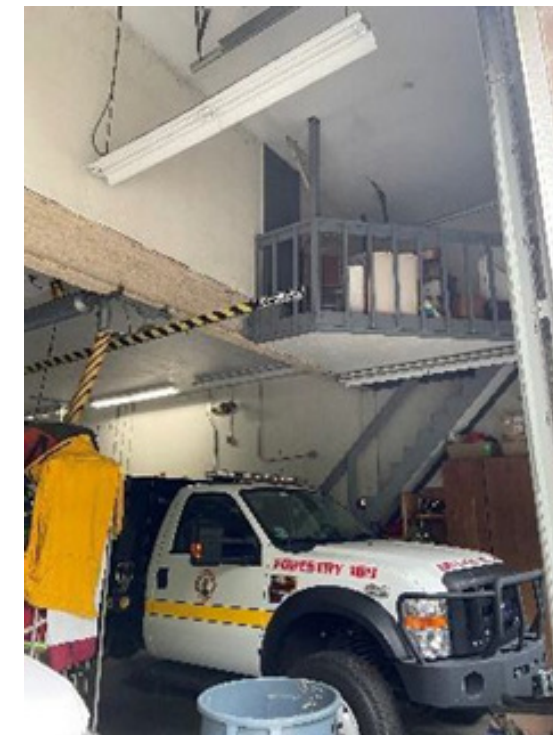
Pendant Industrial Fixture

4. Lighting: Lighting throughout the facility consists of a number of type of light fixtures including but not limited to the following below. Fixtures are technologically outdated. There is a rudimentary Fire Station Alerting System that is tied to the building lighting systems. However, given the age of the lighting and wiring in the existing building, this type of Fire Station Alerting System cannot be used. It is recommended that the Fire Station upgrades their lighting systems to incorporate with the Fire Station Alerting System.
