# TOWN OF ORLEANS FIRE STATION FEASIBILITY STUDY

August 11th, 2021

# FIRE STATION FEASIBILITY STUDY

A structural inspection of the Orleans Fire Station located at 58 Eldredge Park Way, Orleans, MA 02653 was conducted on June 4, 2021. The visual inspection (no test) was performed to evaluate the overall condition of the existing building as part of the feasibility study for the Fire Station.

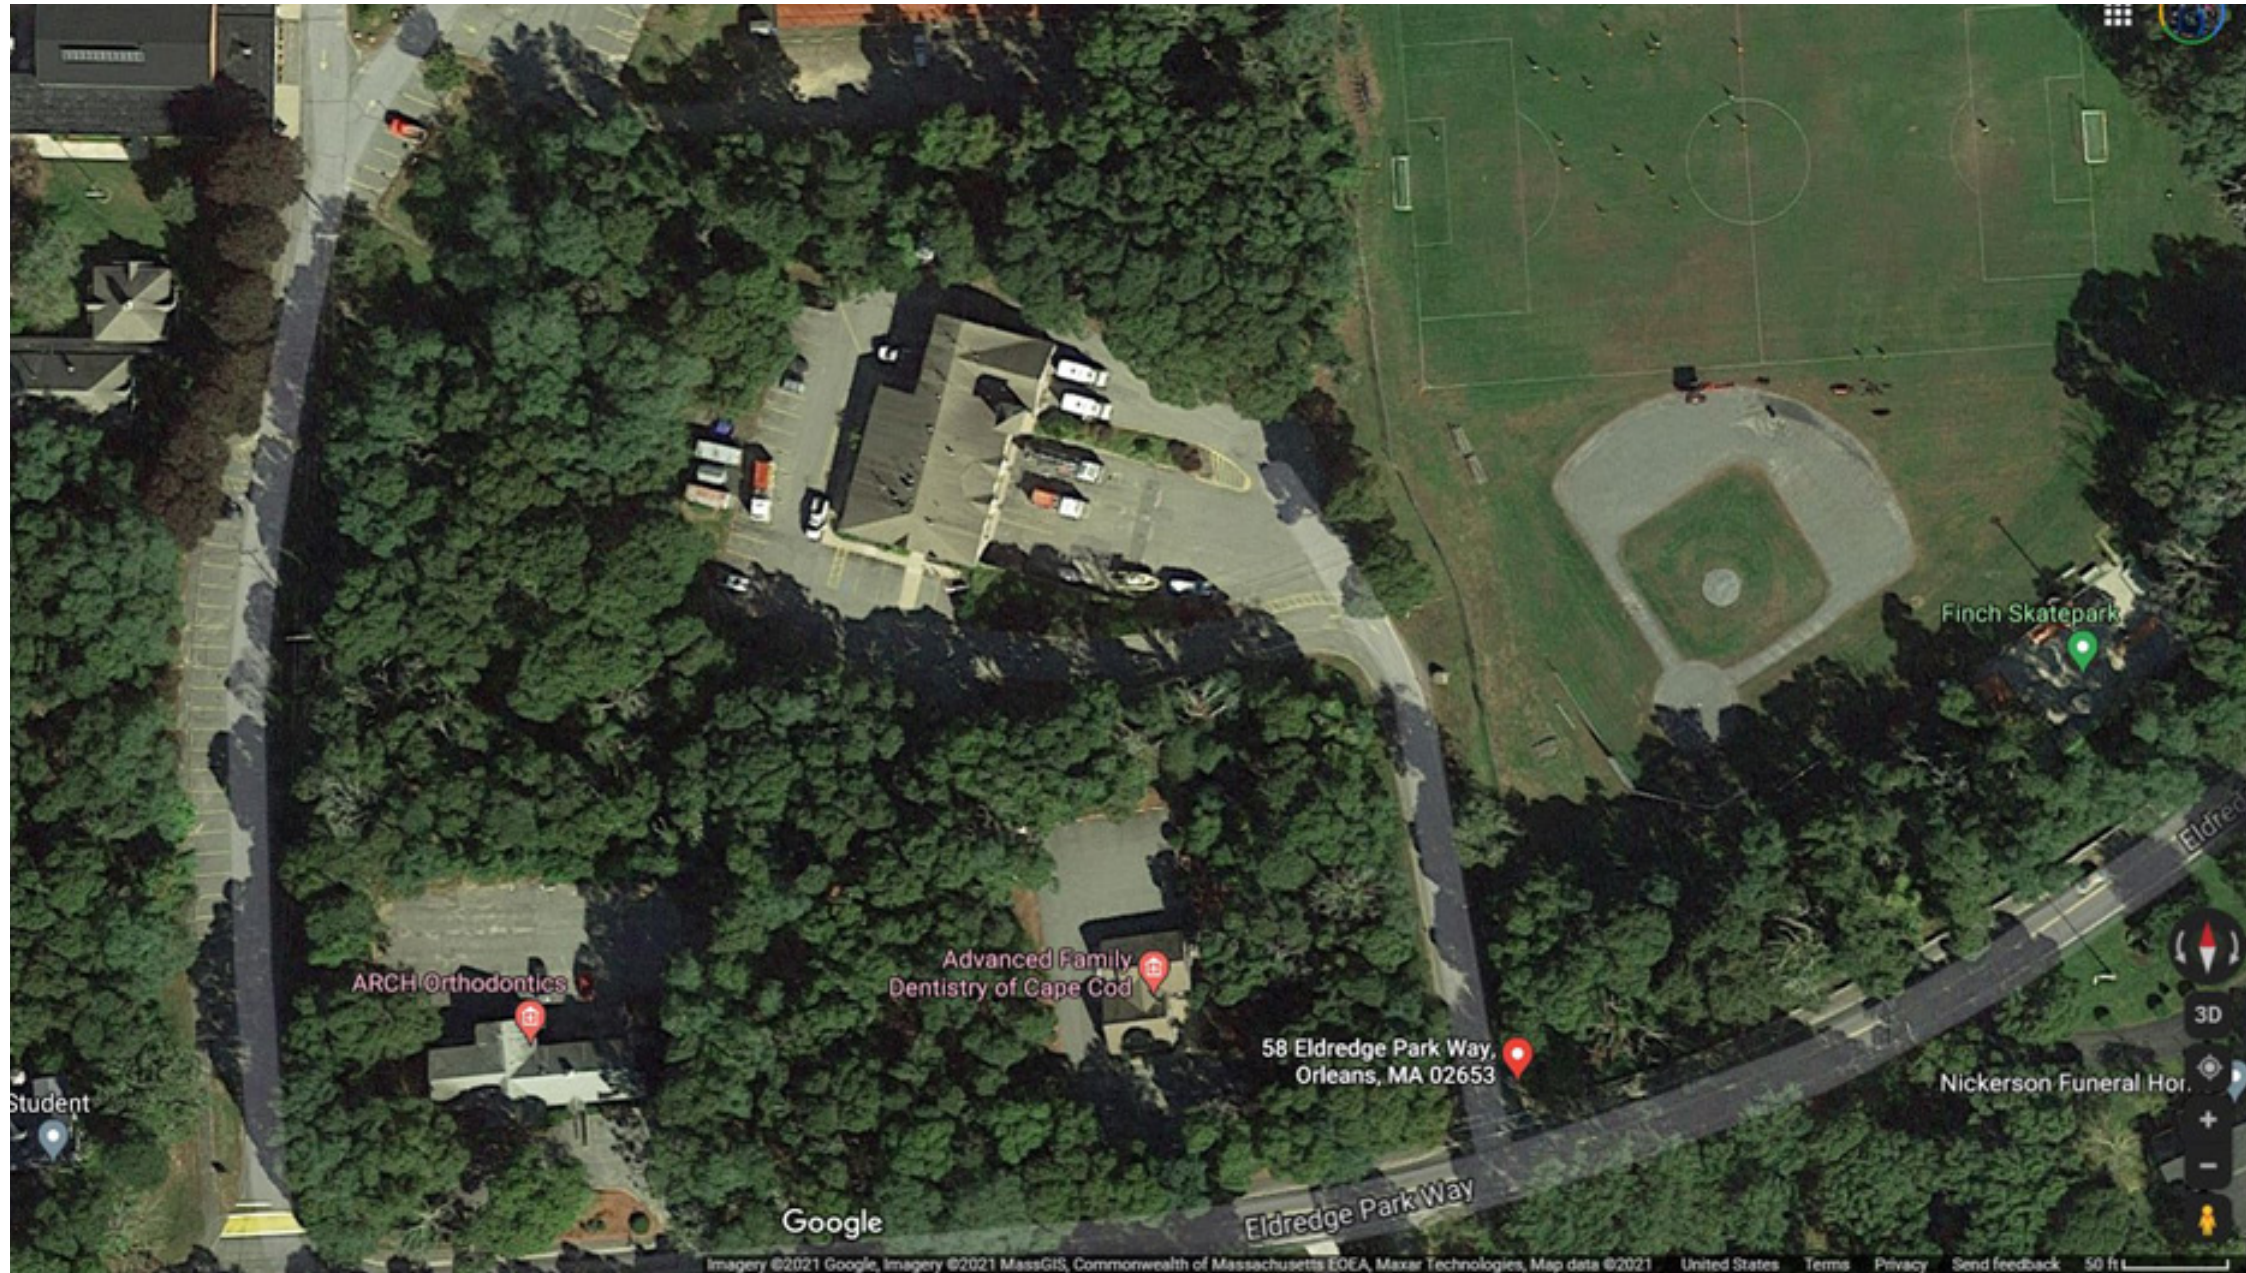
Based on visual inspection, the on-site parking areas and access drives are primarily asphalt pavement and in fair to poor condition (See Figure 6). Lateral cracking was visible throughout, with conditions approaching gross failure (i.e. alligator cracking) in some areas – specifically adjacent to the lower vehicle bay driveway area. Multiple asphalt patches were also present in the bay driveway area, surrounding below grade utility structures.

Figure 6: Existing asphalt conditions - Public entrance (left); Lower Apparatus Bays (right). Varying levels of pavement deterioration.
