# Ownership of Pressure Sewer Systems

Henry S. Albro, F. R. Mahony & Associates

## Abstract

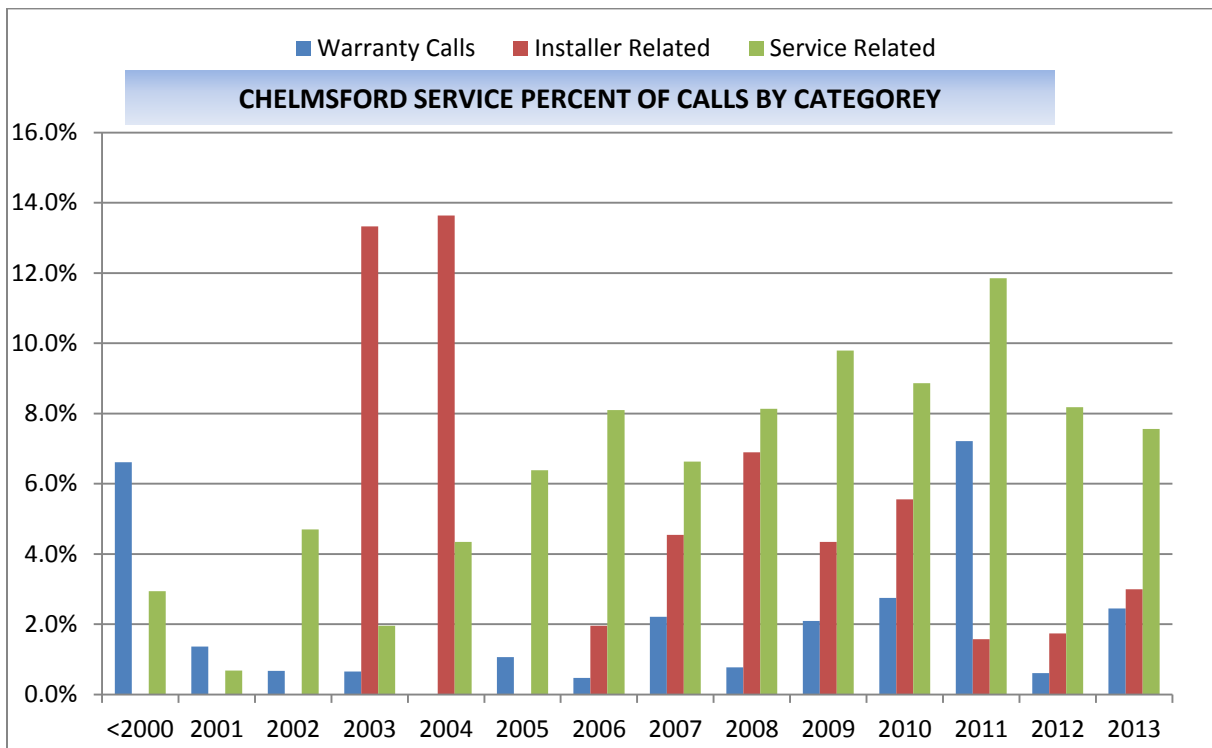
**Figure 2**

Looking back over the period from 1999 to present day, the data shows service from all of these sources. Recent service policies further distinguish the root cause of service calls to better isolate the areas that require attention though stepped up training and education. We did pull records for Chelmsford and isolated many of the sources of the service calls to gain a better understanding of the types of calls and what portions of these calls are presently beyond the control of the manufacturer. (See Figure 2 Below)

- Warranty Calls average 2% of the installed pumps (0-7%)
- Installer Issues average 4% of the installed pumps (0-14%)
- Service Issues average 6% of the installed pumps (1-12%)

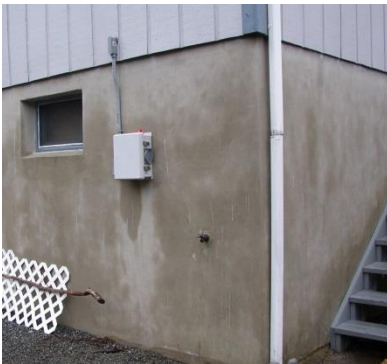
**Figure 4 – Typical Exterior Control Panel**

*Homeowners had a certain amount of responsibility to maintain their units. But how the service agreement worked was easy and limited the amount of effort on the homeowner's part. Each grinder pump unit is equipped with an exterior mounted control panel as shown in Figure 4 to indicate alarm conditions. In alarm conditions residents call the number on the box, or the same number which is located on an O&M pamphlet given to the residences and F.R. Mahony, who the service agreement is with, will come out to the home and determine cause of the problem and how to fix it. In addition, each resident was provided with an interior alarm panel which will sound in case of high water.*
