Cedar Pond  
Adaptive Management Monitoring Program:  
Annual Technical Report  
January 2018 to December 2018

Town of Orleans

Coastal Systems Group  
School for Marine Science and Technology  
University of Massachusetts Dartmouth  
706 South Rodney French Blvd.  
New Bedford, MA 02744-1221

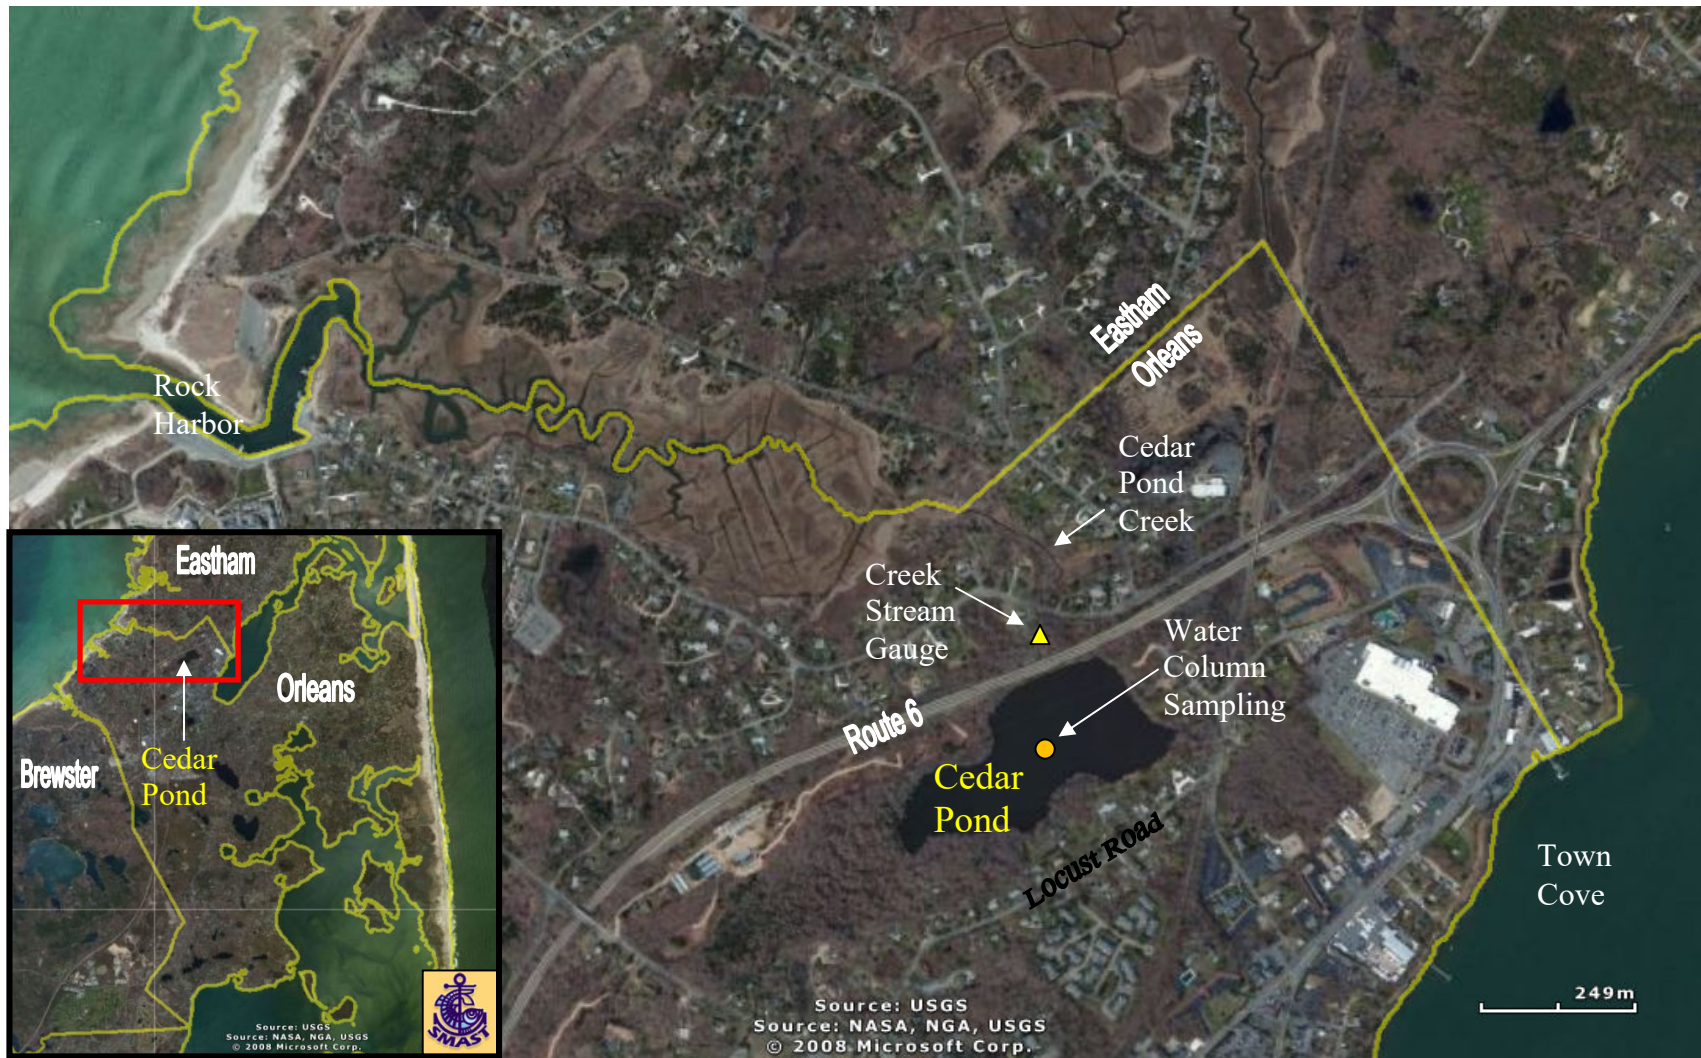
**Figure 1. Cedar Pond Locus in the Town of Orleans, MA**

Cedar Pond is located in northern Orleans, south of Route 6 and west of Town Cove. The stream outlet from Cedar Pond flows under Route 6 and discharges into the Rock Harbor estuary on Cape Cod Bay. Rock Harbor straddles the town boundary between the Towns of Orleans and Eastham. The outlet stream gauge location (used consistently since the MEP) is indicated by the yellow triangle and the deep water column sampling location is indicated by an orange circle.

As part of the Cedar Pond water quality monitoring, CSP/SMASST staff installed a continuous stage recorder in the pond creek north of Route 6 (see **Figure 1**). Stage recordings can be translated to continuous flow readings with collection of sufficient flow readings to develop a stage/flow relationship, but collection of stage readings also provides a measurement of the tide elevations when tides flow toward Cedar Pond. Staff reviewed the stage elevations to determine the high tides between January 4 (when the boards were installed) and December 31. This review found that 38% of all high tides were above the initial target elevation of 1.45 m NAVD88, but the lowering of the boards as required in the Fishway Plan allowed higher percentages of tides to reach the pond. Overall, 68% of all high tides during 2018 (1/4 to 12/31) reached Cedar Pond with 100% of tides reaching the pond during the period when the board elevation was at its lowest (May 5 to July 8) and lower percentages when the boards elevations were higher (**Figure 2**). The higher percentage of high tides reaching Cedar Pond corresponded with a rise in water column salinity (see discussion below).

As mentioned above in the discussion of tides, a continuous stream gauge was installed on November 3, 2017 at the same location (see **Figure 1**) that was used for MEP measurements between June 28, 2002 to May 23, 2004 (23 months)<sup>22</sup> and the monitoring to support development of the Cedar Pond Management Plan between June 5 and September 20, 2012 (3 months),<sup>23</sup> so data should be directly comparable except for whatever changes have occurred in the Cedar Pond Stream between Rock Harbor and the gauge. Flow readings (and water quality samples) were collected approximately every two weeks beginning November 3, 2017. Flow readings and stage recordings were reviewed and then combined with previous readings to produce a reliable stage-flow relationship (**Figure 12**). Water quality samples were also collected at the same time as flow readings (low tide only) to determine nutrient export from Cedar Pond.

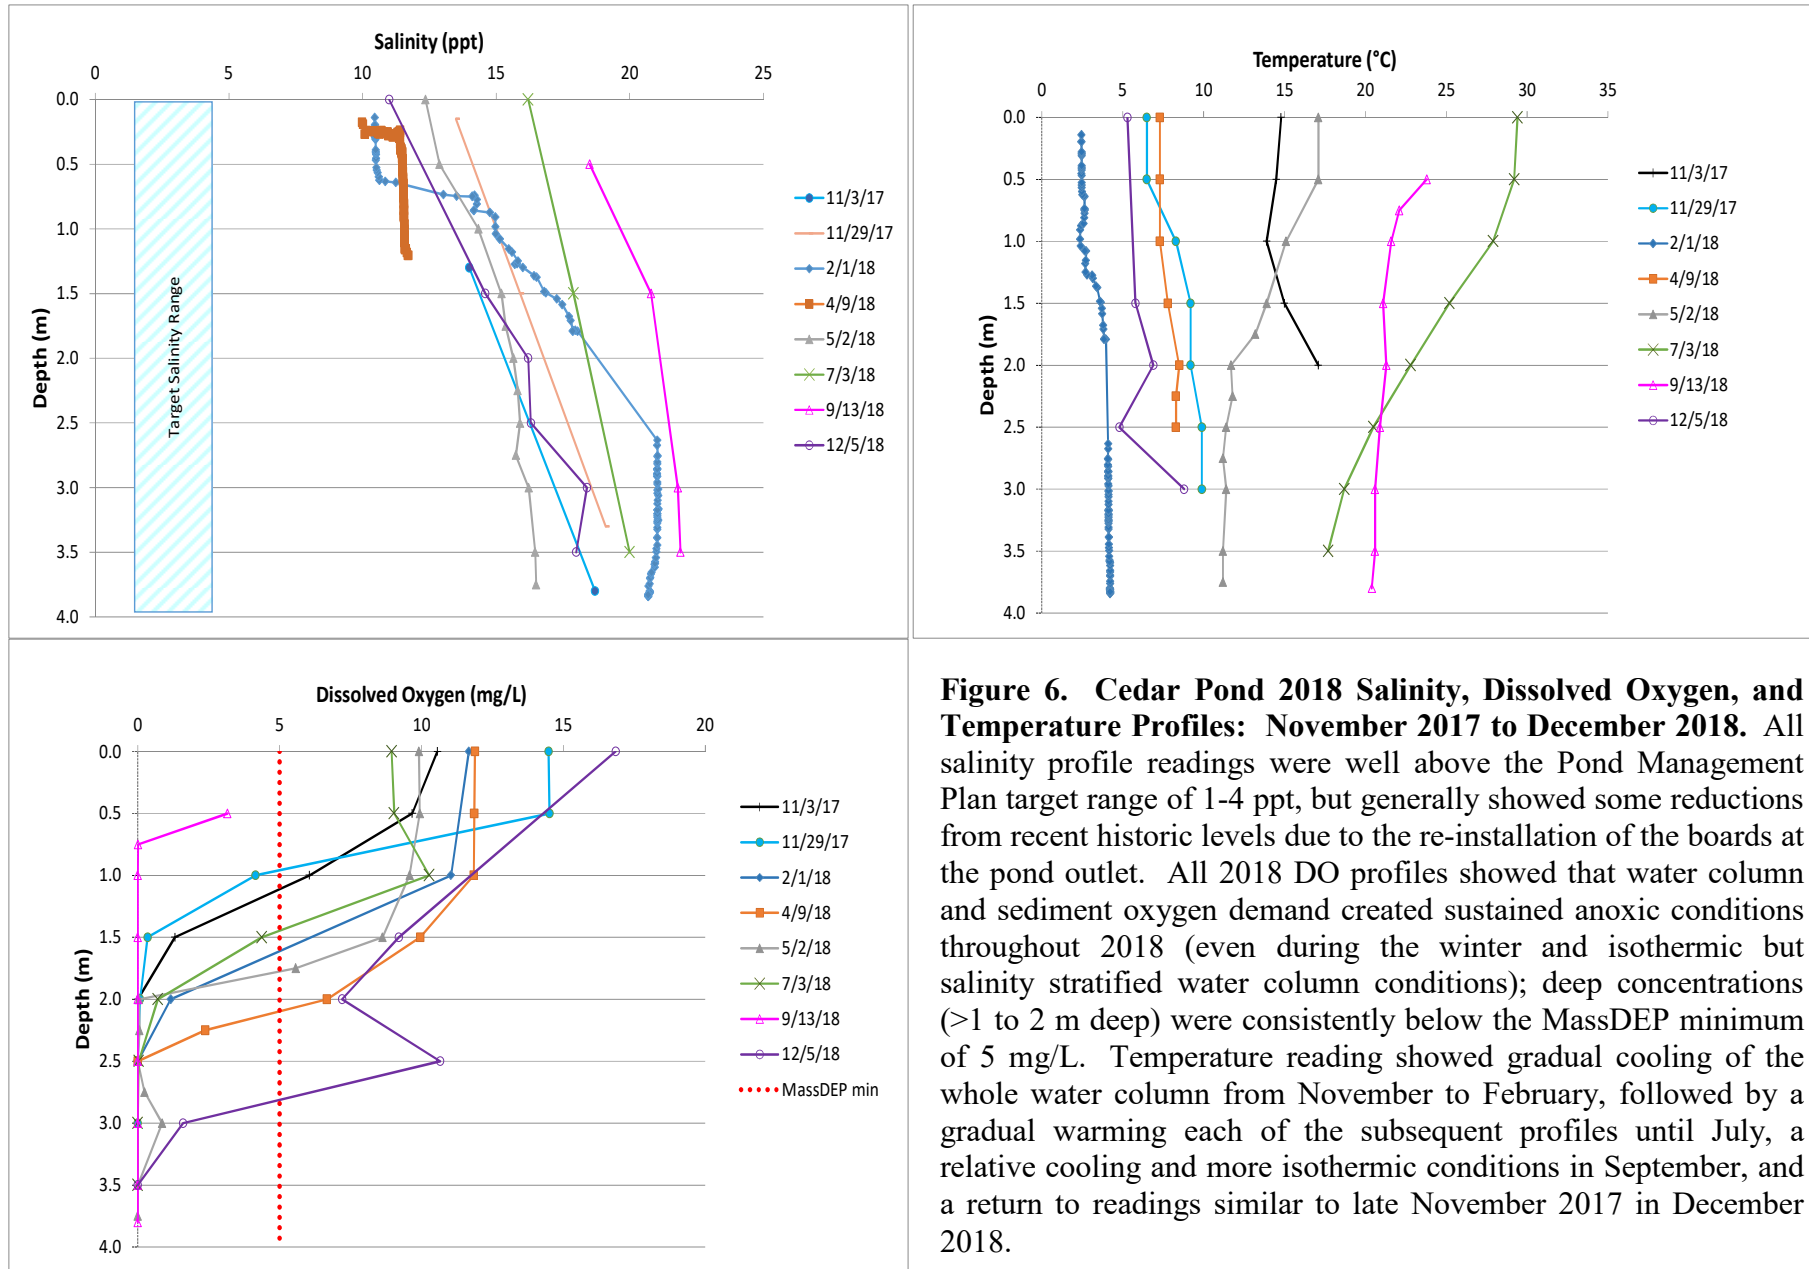
**Figure 6. Cedar Pond 2018 Salinity, Dissolved Oxygen, and Temperature Profiles: November 2017 to December 2018.** All salinity profile readings were well above the Pond Management Plan target range of 1-4 ppt, but generally showed some reductions from recent historic levels due to the re-installation of the boards at the pond outlet. All 2018 DO profiles showed that water column and sediment oxygen demand created sustained anoxic conditions throughout 2018 (even during the winter and isothermic but salinity stratified water column conditions); deep concentrations (>1 to 2 m deep) were consistently below the MassDEP minimum of 5 mg/L. Temperature reading showed gradual cooling of the whole water column from November to February, followed by a gradual warming each of the subsequent profiles until July, a relative cooling and more isothermic conditions in September, and a return to readings similar to late November 2017 in December 2018.

Water quality samples were collected on the same dates, as the temperature and oxygen profiles shown in Figure 6, at shallow, middle, and deep depths: averages of 0.5 m, 1.5 m, and 3.5 m, respectively. All collected samples were assayed at the Coastal Systems Analytical Facility at SMAST using the same assays utilized for MEP assessments, including those for Rock Harbor and the Cedar Pond Management Plan. Sampling procedures and chemical assay methods are presented in the Town's QAPPs for freshwater<sup>19</sup> and estuarine<sup>20</sup> water quality monitoring. Samples were analyzed in the laboratory for the following constituents: salinity, ortho-phosphorus, total phosphorus, ammonia-nitrogen, nitrate+nitrite-nitrogen, total dissolved nitrogen, particulate organic nitrogen, particulate organic carbon, chlorophyll-a, and phaeophytin.

TN and TP concentrations generally followed the same pattern as shallow readings collected at the water column sampling site, though the TP and TN concentrations were more synchronous at the stream site. Concentrations decreased from a November 2017 high until reaching an annual minimum in April 2018 (low in-pond shallow and deep salinities) and then more rapidly increased to peaks in late August/September 2018 (in-pond salinities returned to pre-board levels) before progressively decreasing again through December 2018 (**Figure 13**). Comparison of flow between 2018 and 2012 during the summer months showed that flows were between 9% and 42% higher in 2018, while TN and TP export loads were comparatively much higher indicating changes in conditions to create additional/greater TN and TP sources (**Table 3**). TN average daily exports loads were 38% to 179% higher than 2012, while TP loads were 3X to 4X higher. The increase in the TN loads were only slightly higher than the flow increases except for September (+179%); this September increase is likely related to additional sediment N release reaching into the shallow portions of the water column (and being available for stream outflow) when anoxic conditions reached within 1 m of the surface (see **Figure 6**).

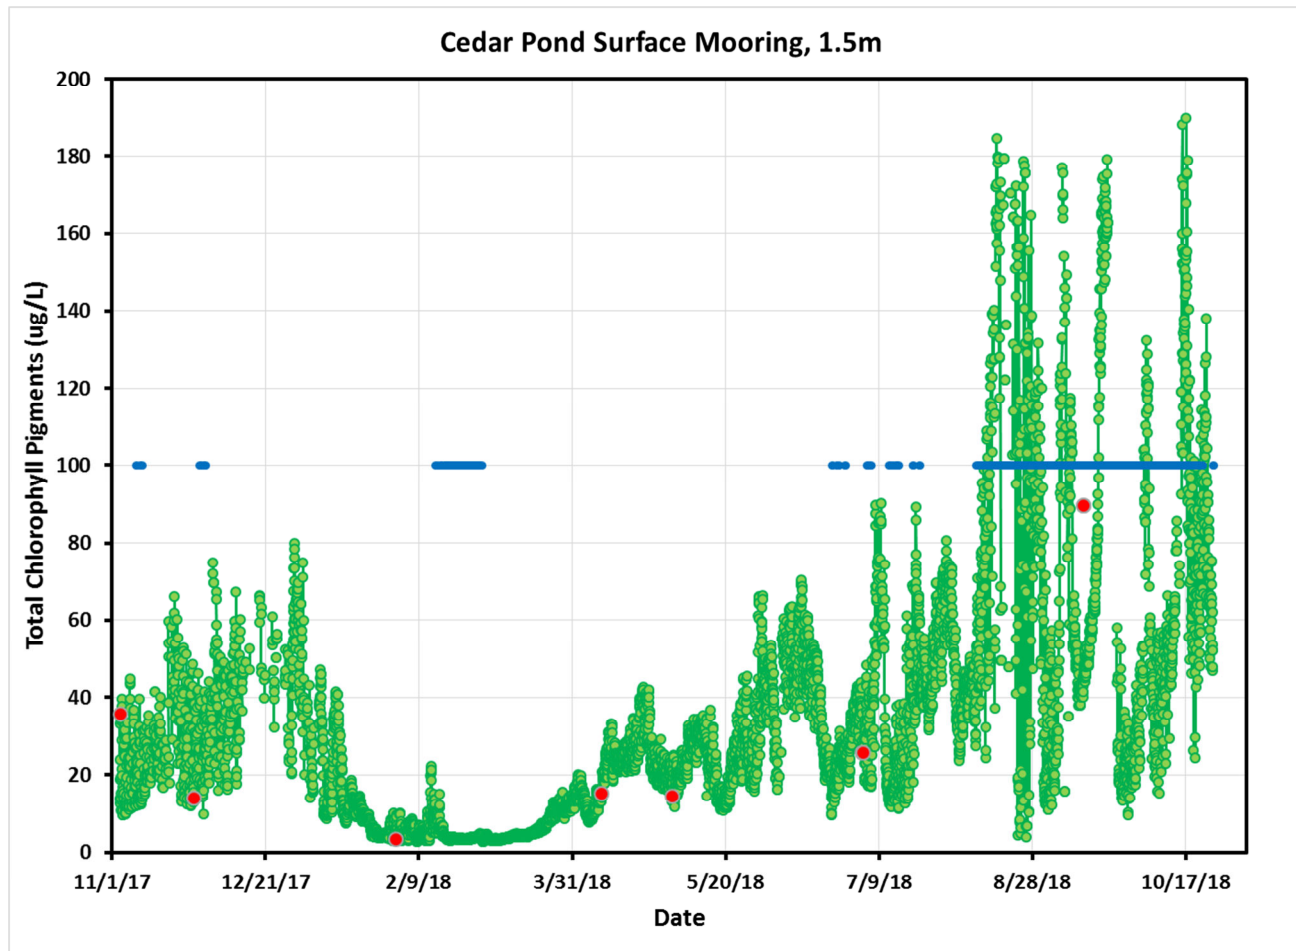
**Figure 10. Cedar Pond Continuous Chlorophyll Readings (November 2017 to October 2018).** Continuous recording devices were installed on November 3, 2017 and recorded chlorophyll fluorescence readings at 1.1 m (shallow) until October 24, 2018 when the batteries failed (deep readings at 3.5 m depth were recorded, but were unreliable and are not presented). Boards were installed at the Cedar Pond outlet on January 4, 2018 at an initial elevation of 1.45 m NAVD88 and then were adjusted by removing and adding board according to the schedule in the Fishway Operations and Maintenance Plan. Chlorophyll readings were complicated by regular (deep) and intermittent (shallow) periods of anoxia (shallow anoxia shown by blue horizontal bands in figure) and associated bacterial fluorescence. Shallow readings were regularly above regional and system-specific levels and were consistent with severely degraded conditions.

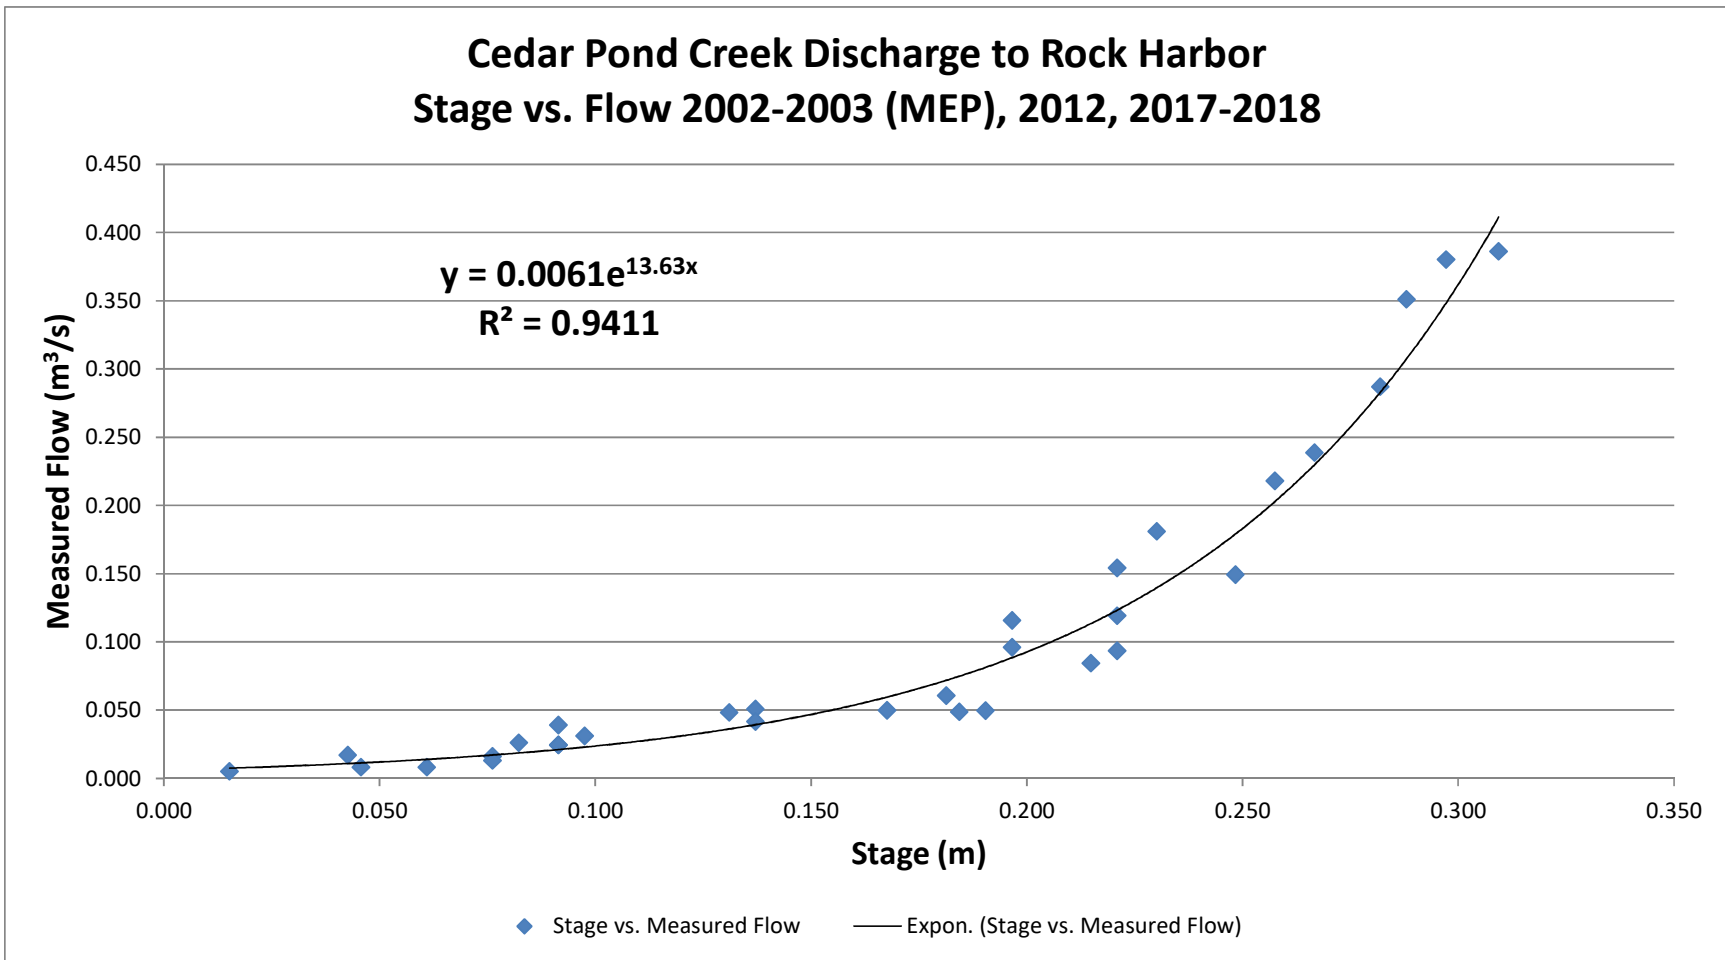
**Figure 12. Stage – Flow Relationship at Cedar Pond Creek.** Stream flow measurements from 2002 to 2003 (MEP), 2012 (Cedar Pond Management Plan), and 2017 to 2018 (current project) were combined with stage readings at the same location to develop a stage-flow relationship for the Cedar Pond Creek just north of Route 6. All flow readings were collected during outflow from Cedar Pond. Most of the 2002 to 2003 readings were collected at the lowest portion of the curve, while most of the 2017 to 2018 readings were collected at the upper end of the curve.
